# Tornado and Wind Event Over Northeast Missouri and South Central Illinois

October 2<sup>nd</sup>, 2007

## Overview

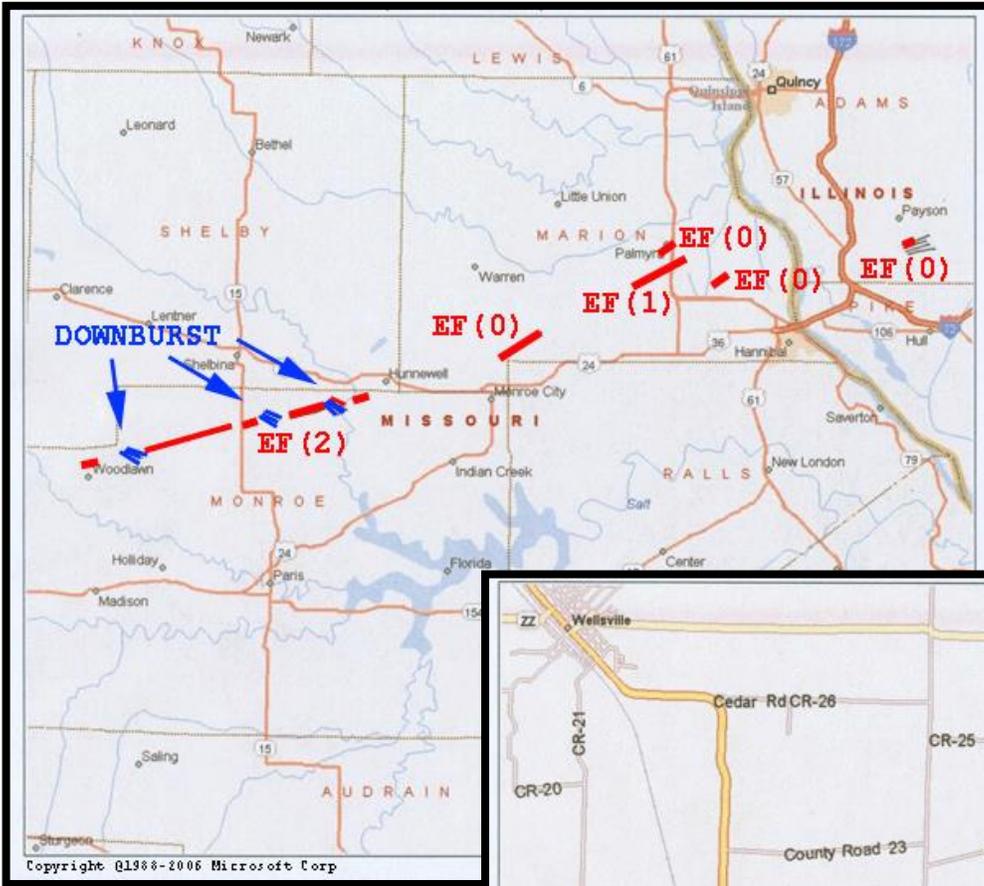
Detailed damage map of the wind and tornado tracks in Monroe, Marion and Adams Counties on October 2<sup>nd</sup>, 2007.

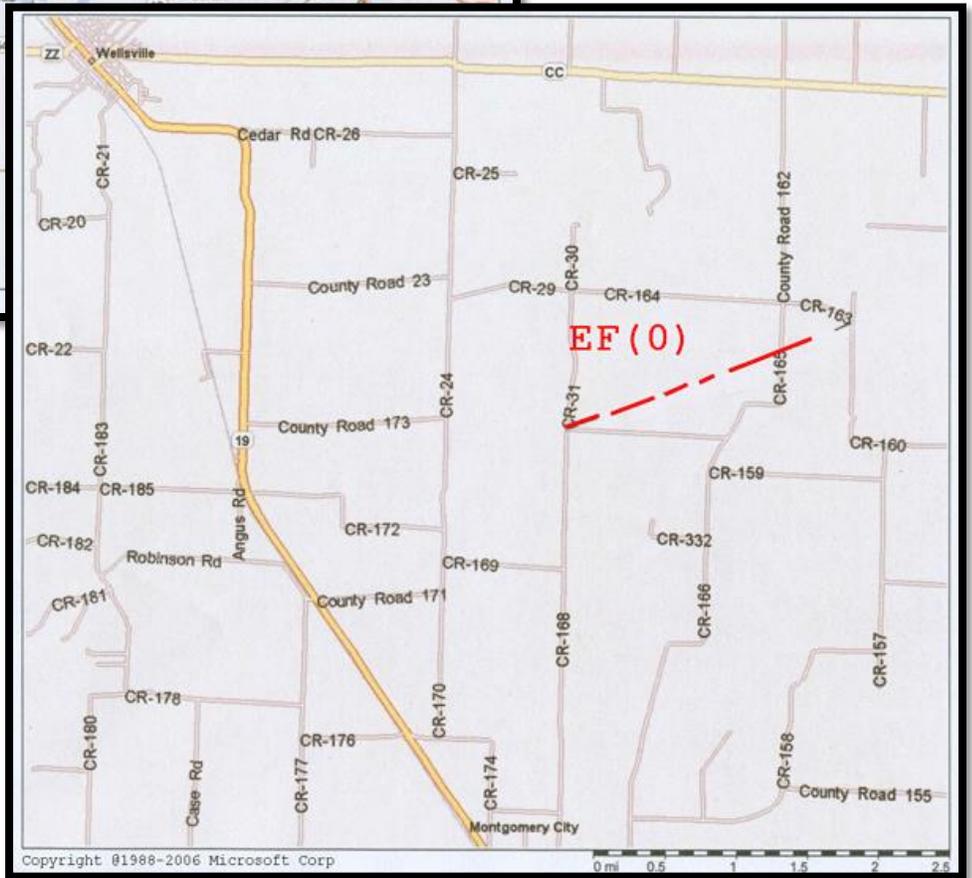
Detailed damage map of the tornado track in Montgomery County on October 2<sup>nd</sup>, 2007.
