## Severe Thunderstorm Winds Affect Borden County on June 4th, 2020

## Wind Damage in Gail, TX

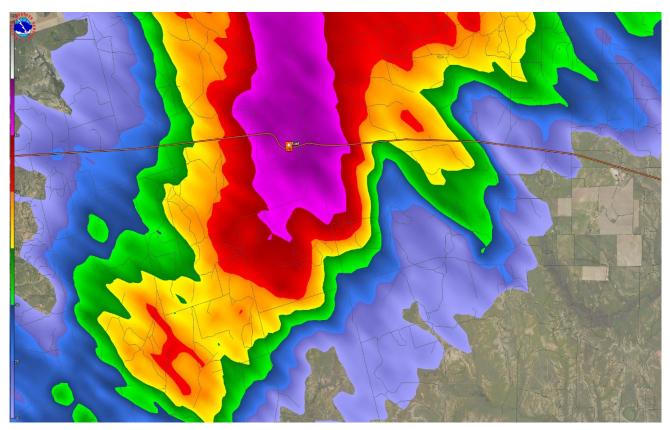
**Figure 1:** KMAF 0.5 deg reflectivity showing 60dbz core over the town of Gail, TX at 11:11PM CDT

Around 11:11 PM CDT, the strongest portion of the storm moved over Gail near the Borden County School (Figure 1). The storm continued southeast over the town for the next 10 minutes, leaving a path of damage in its wake. The damage swath across Gail roughly a mile wide. It was noted during the survey that all damage in the city of Gail was laying/oriented to the southeast and is evidence of straight-line winds of 80-85 mph. At the same time that the storm was crossing through Borden County, a Mesonet site located 3 miles southeast of town measured wind gusts of 83 mph (Figure 2). Some of the damage in town included a roof torn off a mobile home (Figure 3), damage to the fence

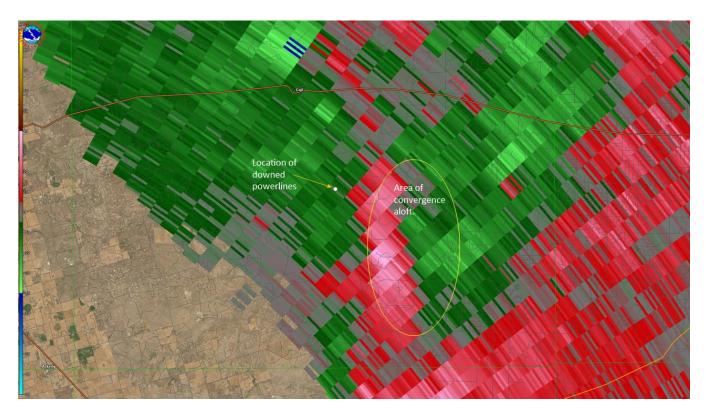
consistent with winds of 100-120 mph, similar to that of a weak EF-2 tornado. The damage observed indicated that a microburst had occurred, and examination of radar data helped to solidify this conclusion. The velocity imagery shown in Figure 8 illustrates strong convergence in the upper portions of the storm (outbound connecting with inbound velocity) which lead to a strong downdraft and air rushing outwards at ground level where the damage occurred. The localized microburst was determined to have a width of 255 yards.

**Figure 8:** KMAF 4.0 deg base velocity showing strong convergence aloft leading to a microburst just east of Willow Valley Road where several powerline poles were snapped.
