## May 4<sup>th</sup> 2024 Severe Weather

### Pecos County Straight-Line Winds and Hail

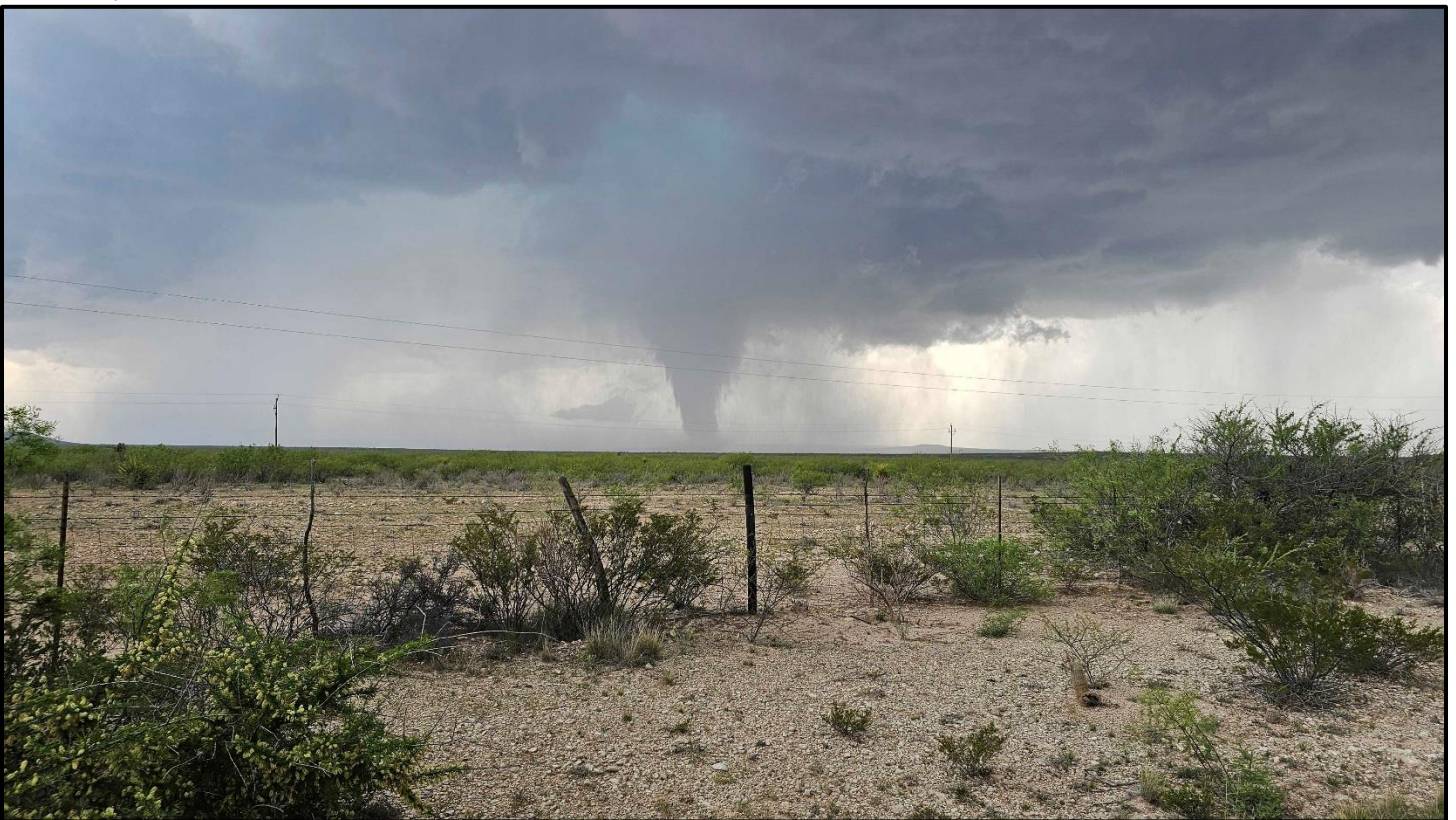
The same supercell thunderstorms that produced the very large hail spawned several tornadoes as well. The first tornado began just east of US Highway 385 south of Fort Stockton in rural central Pecos County. This tornado was documented by numerous observers and an NWS employee, quickly developing into a photogenic stovepipe before becoming increasingly wrapped in rain. The tornado slowly moved southeast, before completely wrapping in rain and likely dissipating. This tornado occurred over mainly open terrain only causing damage to vegetation and a few wooden electrical power poles in the area. This tornado was rated as a mid-range EF-2 given the degree of damage to these wooden power poles which were snapped cleanly from near the base.

**Photo of the first tornado during its photogenic stovepipe phase. Photo courtesy of Justin Weaver.**

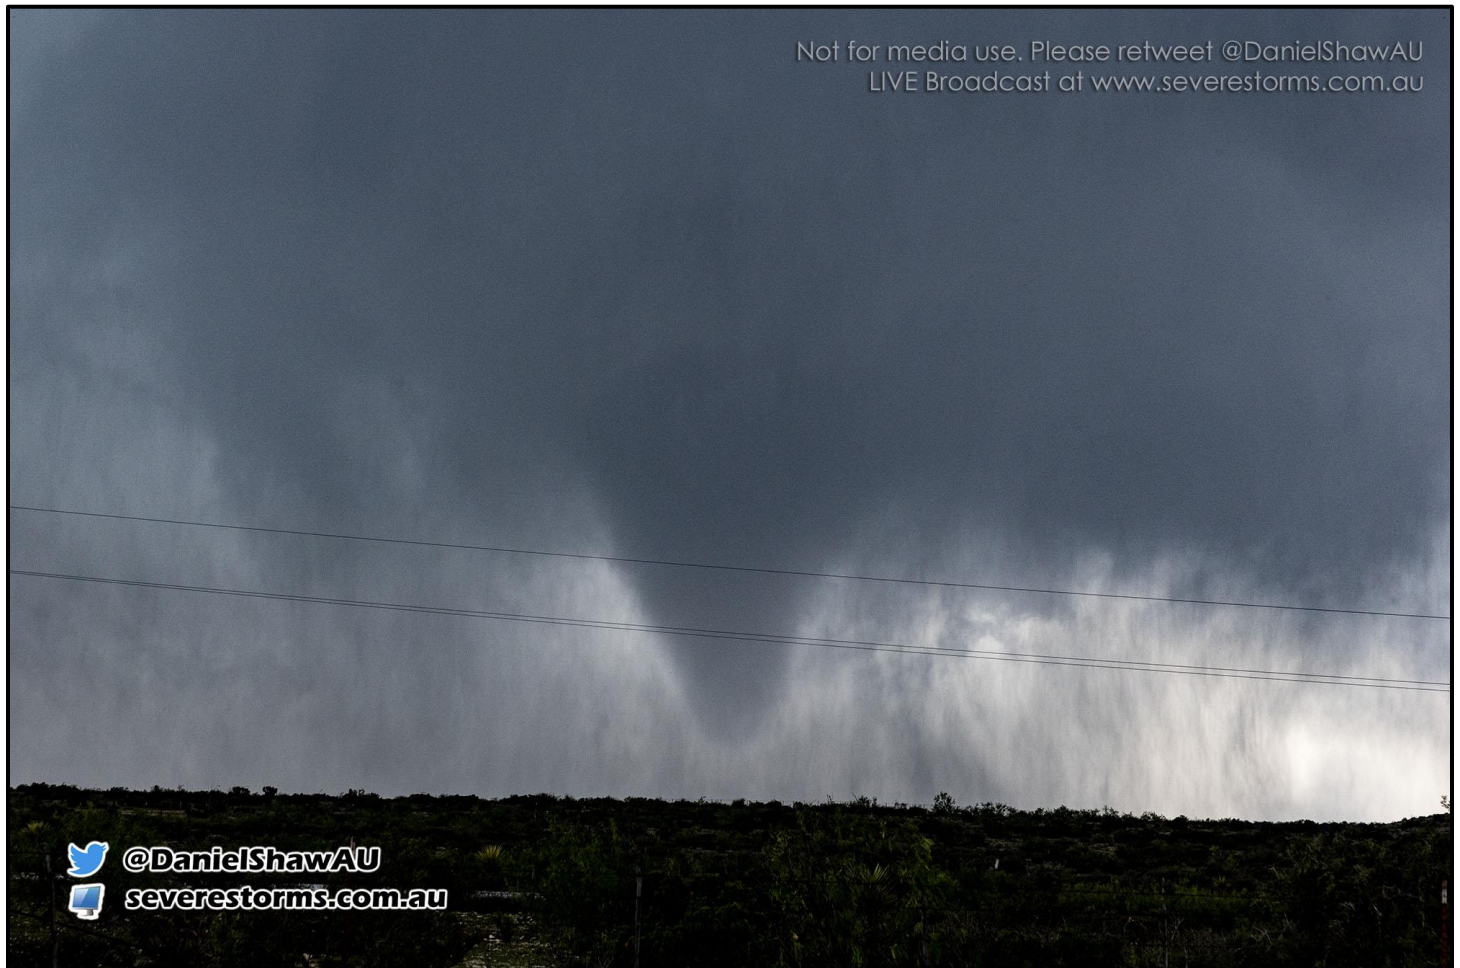
lost. Rapidly rotating rain curtains were noted afterward and the tornado was likely still ongoing. This tornado was later photographed by numerous observers when it was briefly visible through the rain. This tornado slowly traveled southeast before observers lost visual of the tornado within the rain and it likely dissipated.

**Photo of the third tornado as a partially rain-wrapped stovepipe. Photo courtesy of Daniel Shaw.**

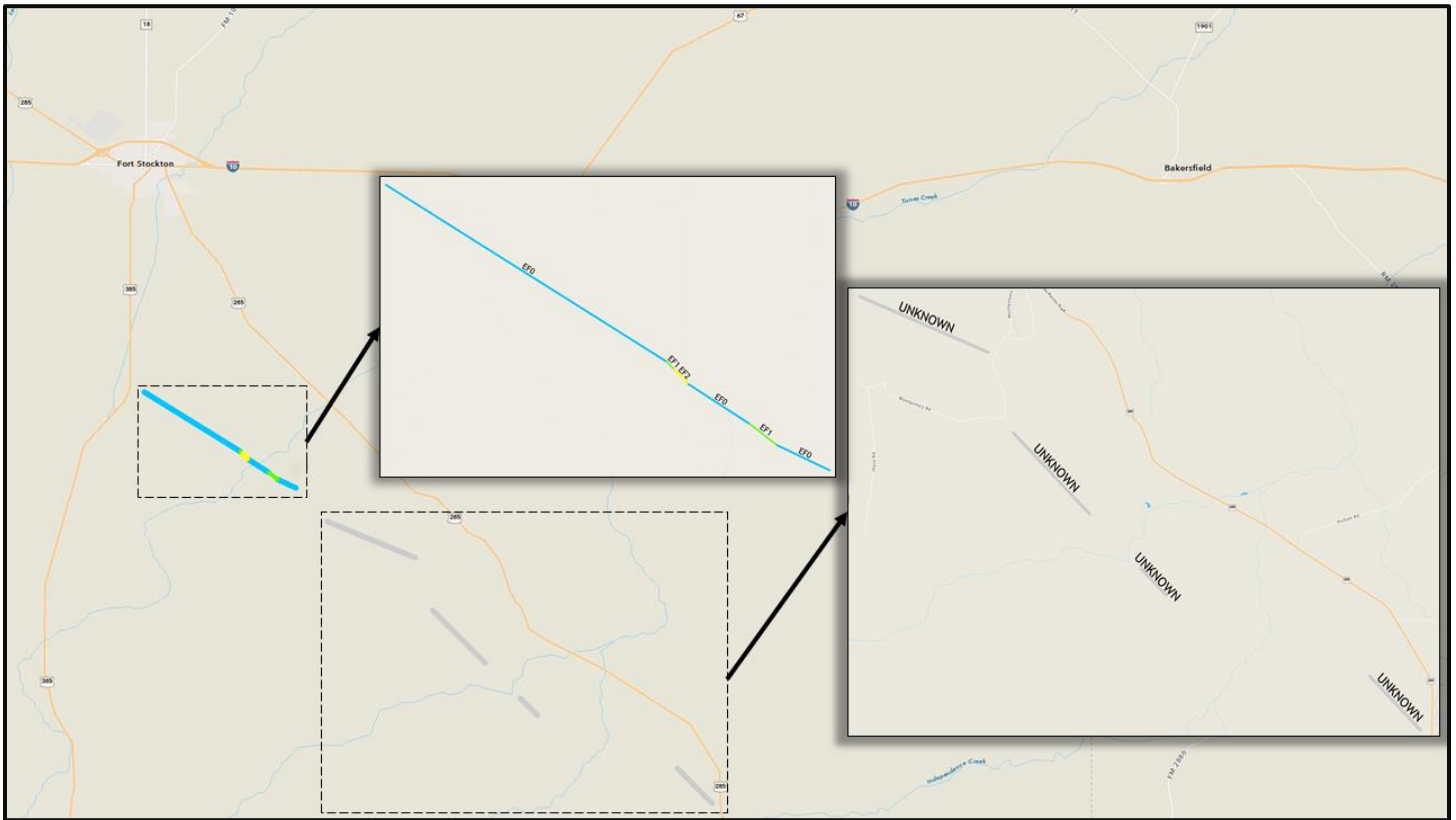
map below) of these tornadoes were estimated based on observer reports and radar data.

**Summary of surveyed and estimated tracks of all tornadoes reported in central Pecos County.**
