Southern Dwight, IL Tornado – June 5, 2010

Maximum Tornado Intensity:	EF-2
Estimated Maximum Winds:	125 mph
Estimated Maximum Path Width:	300 yards
Tornado Path Length:	5.8 miles
Tornado Began:	9:12 pm CDT
Tornado Lifted:	9:22 pm CDT
Injuries:	6

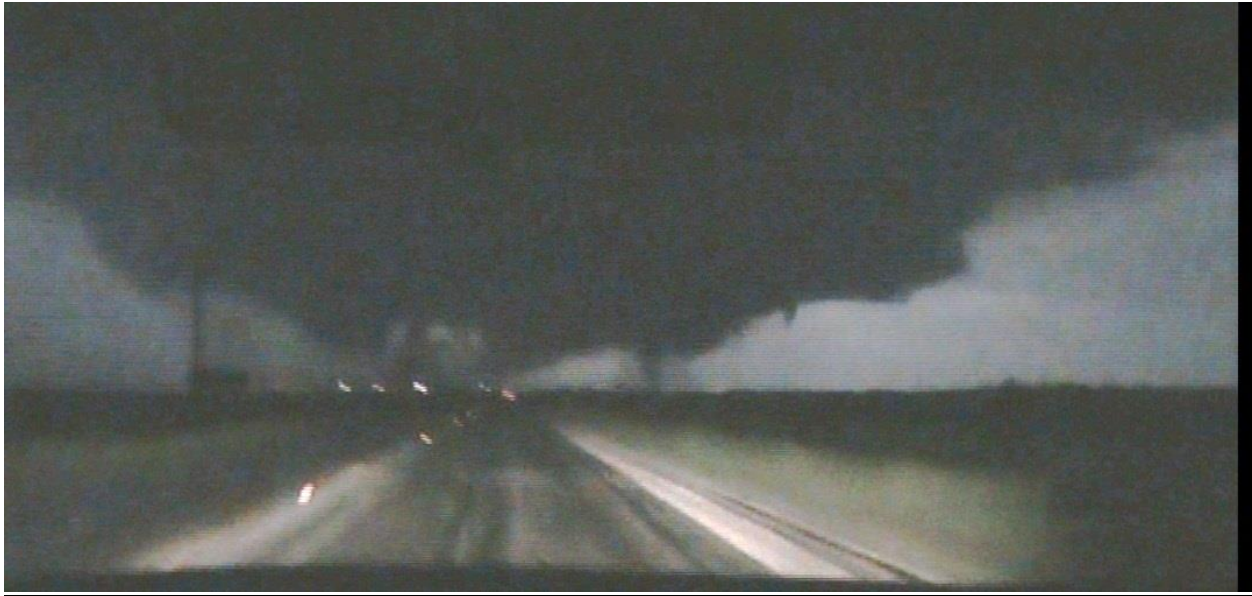
Picture of Dwight, IL tornadoes on Rt. 17 looking east, 1 mile west of Dwight. Taken by Peter Nichols. June 5, 2010
Huge wall cloud, 2 tornadoes, and funnel cloud to right.

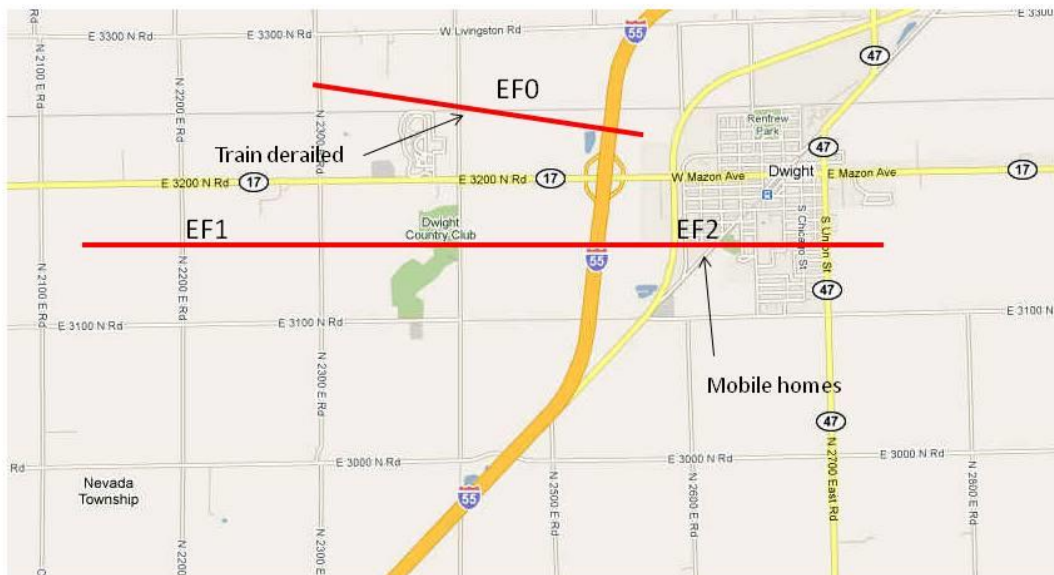
Map of the two tornado tracks in Dwight, IL on June 5, 2010

The beginning of the Dwight tornado occurred at around 9:17 PM CDT about 6 miles west of Dwight and about a quarter mile south of IL Route 17. On N 2100 E Rd 0.3 miles south of IL Route 17 a farm house sustained damage to windows, siding, and shingles with many tree branches nearby snapped off. The tornado at this point was rated EF1, with a path width of 70 yards. Debris were spread 200 yards across the field at N 2300E Rd.

The tornado proceeded to strike the golf course at N 2400 E Rd where numerous large trees were snapped and uprooted. Golf card sheds were unroofed or severely damaged. At this point the tornado was rated low end EF-2 with a path width of 300 yards. The tornado then moved east across I-55 and moved into Dwight, damaging a lumber yard. At Williams Street and old route 66 a mobile home park was hit. Six people were injured, one seriously, and a dozen mobile homes were destroyed, with several more significantly damaged. Damage here was rated EF-2. Large trees were uprooted and power poles were snapped at the railroad tracks. At a ball field a little farther east, trees and fences were damaged. Slightly farther east, there was minor damage to a church and the high school auditorium roof. A storage garage was destroyed at the high school.

The tornado then continued east into a subdivision between Philmar Street and Prospect Avenue where many large trees were downed on top of homes. At Sunset Drive and Wilmac Street a garage door and roof were taken off. A roof was taken off a house on Linden Street a half block west of IL Route 47. Damage in Dwight was rated high end EF-1 to low end EF-2. The tornado dissipated in an open field east of Route 47. The tornado reformed along the north side of E 3100 N Rd between, N 3100 E Rd and N 3200 E Rd for ¼ mile, and was rated EF-0 here. There was additional minor damage to tree limbs and a metal farm outbuilding for ½ mile along the north side of E 3100 N Rd between N 3400 E Rd and N 3500 E Rd. The tornado here was rated EF-0 with a path width of 20 yards.
