Location	Date/Time	Deaths & Injuries	Property & Crop Dmg	Event Type and Details
TEXAS, South				
	00 141 1 1 WNW I OS SAENZ	126 44 00 021

08/01/10 00:00 CST	0	Flood (due to Planned Dam Release)
08/10/10 02:30 CST	0	Source: River/Stream Gage

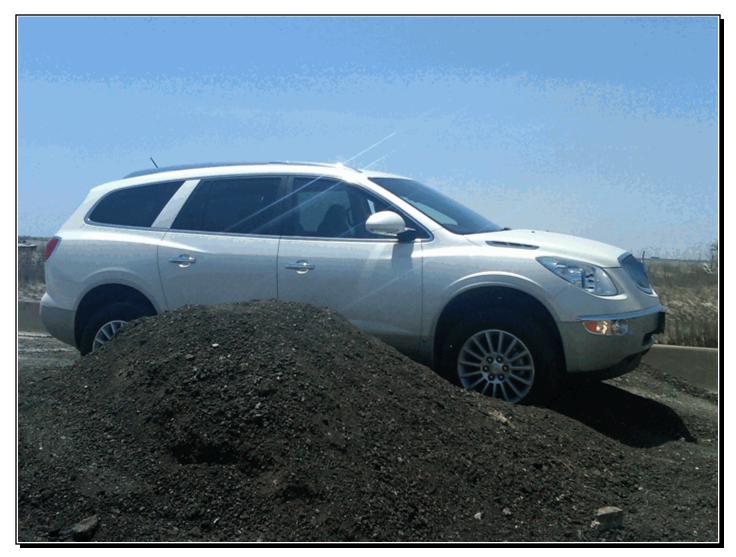
Residual dirt and mud left behind after 6 weeks of flooding in the Main and North Floodways of the Lower Rio Grande Valley Flood Control Project, Hidalgo County, TX. Photograph taken August 23rd by Hidalgo County Emergency Management.
