Pre-Kyle Severe Flooding Across Southeastern Puerto Rico

Althea Austin-Smith
Service Hydrologist
San Juan, Puerto Rico

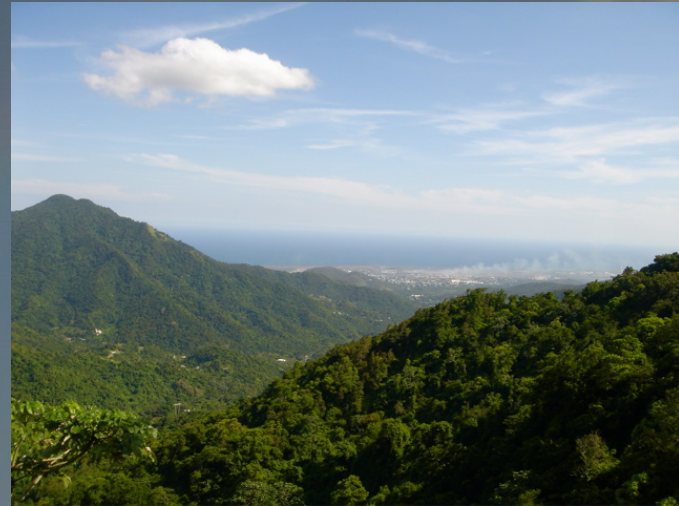
- La Cordillera Central of PR ... up to 4,390 feet
- The range crosses the island from west to east
- It ends in a fork with two lower ranges which includes the Cuchillas de Panduras (1,700 feet) which runs between the towns of [Yabucoa](#) and [Patillas](#)

Notes... Why did this occur? Let's start with a brief intro to Puerto Rico. There is a chain of mountains running across Central Puerto Rico – aligned from west to east...ending with the Cuchillas de Panduras (in the SE) with peaks of up to 1700 feet.

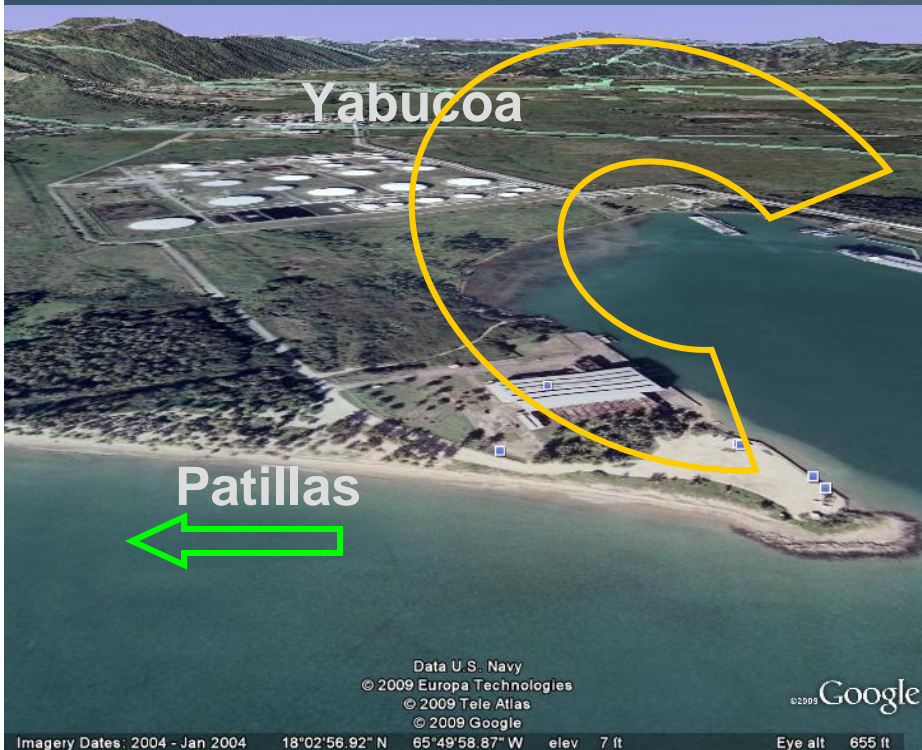
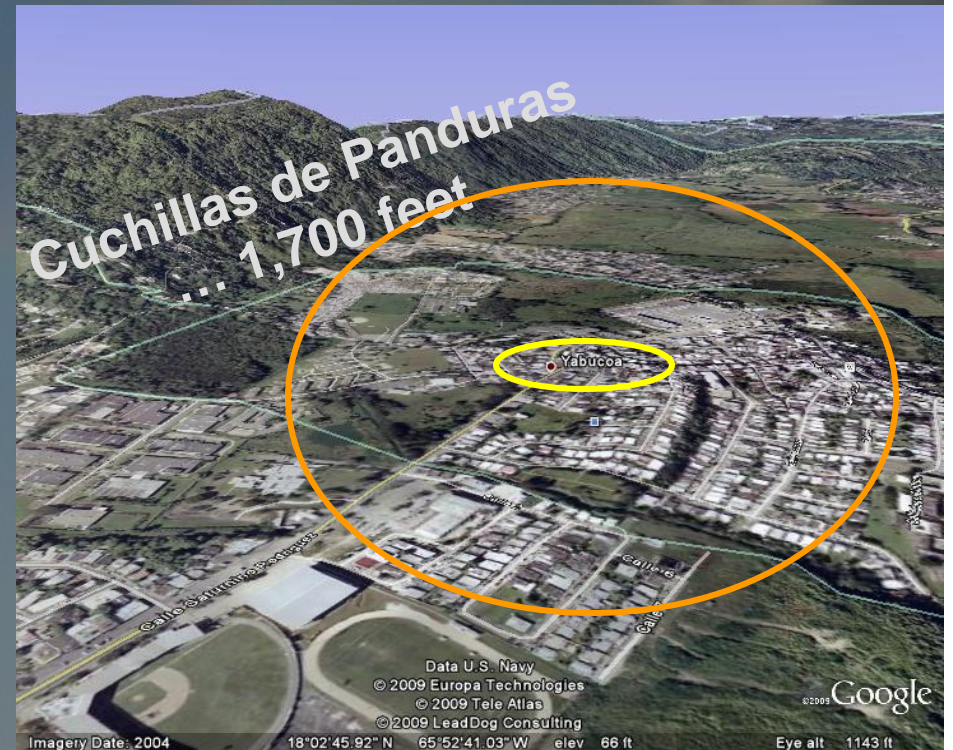
Cuchillas de Panduras which runs between the towns of Yabucoa and Patillas

Notes...Notice the horseshoe shape of the Yabucoa area ... plains with mountains on three sides. Patillas is to the west.

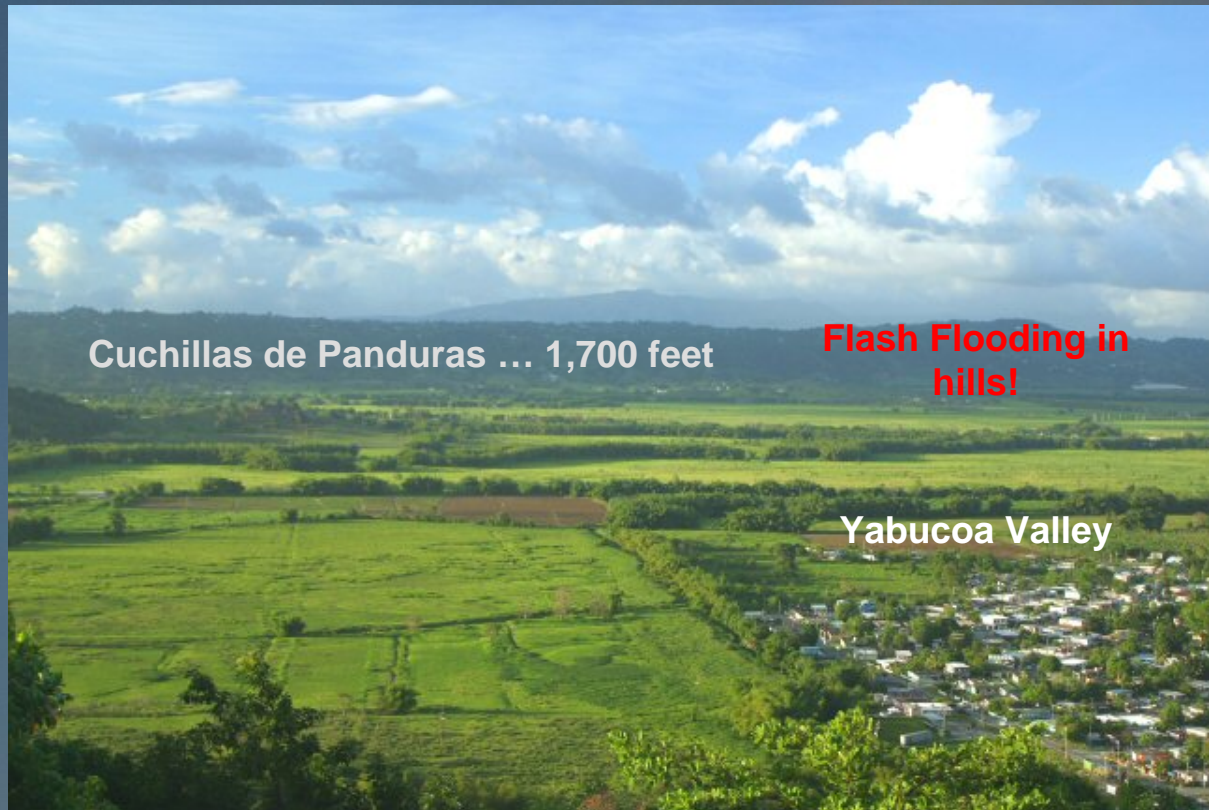
Southeast Puerto Rico Yabucoa Pluvial Valley

Cuchillas de Panduras ... 1,700 feet

**Flash Flooding in
hills!**

Yabucoa Valley

Notes...Flash Flooding in the hills ... areal flooding in the valley!

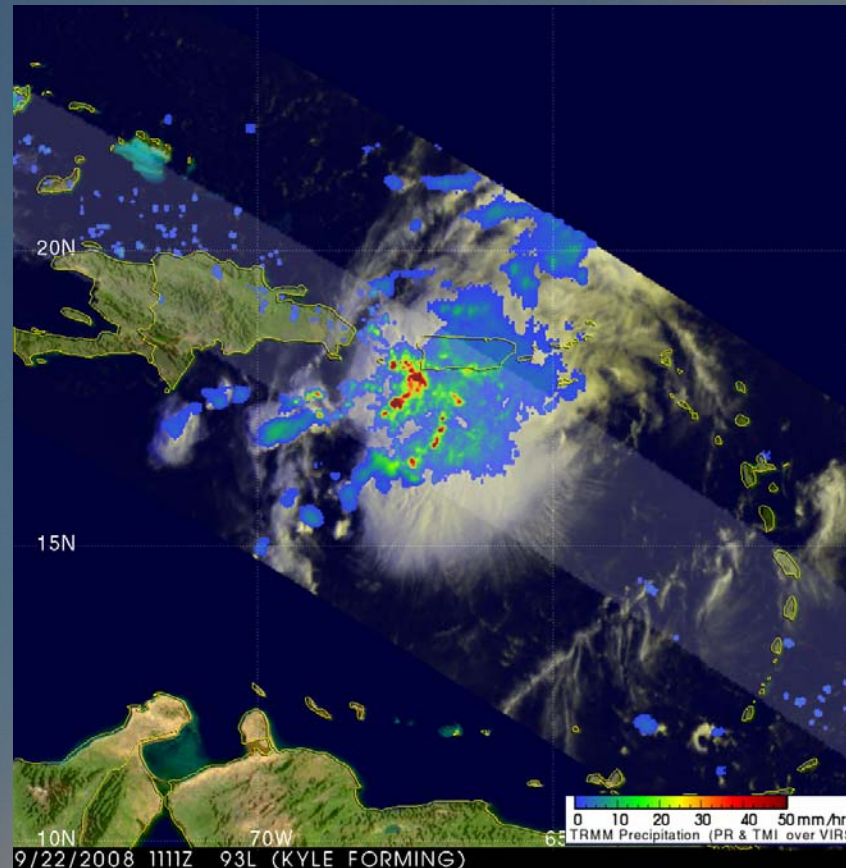
Notes...This is early Monday morning ... 9/22/08 – the heaviest of the rainfall is already over for SE PR as the precursor of Kyle treks on to the north. Kyle has not yet been formed but the damage has been done for SE PR.

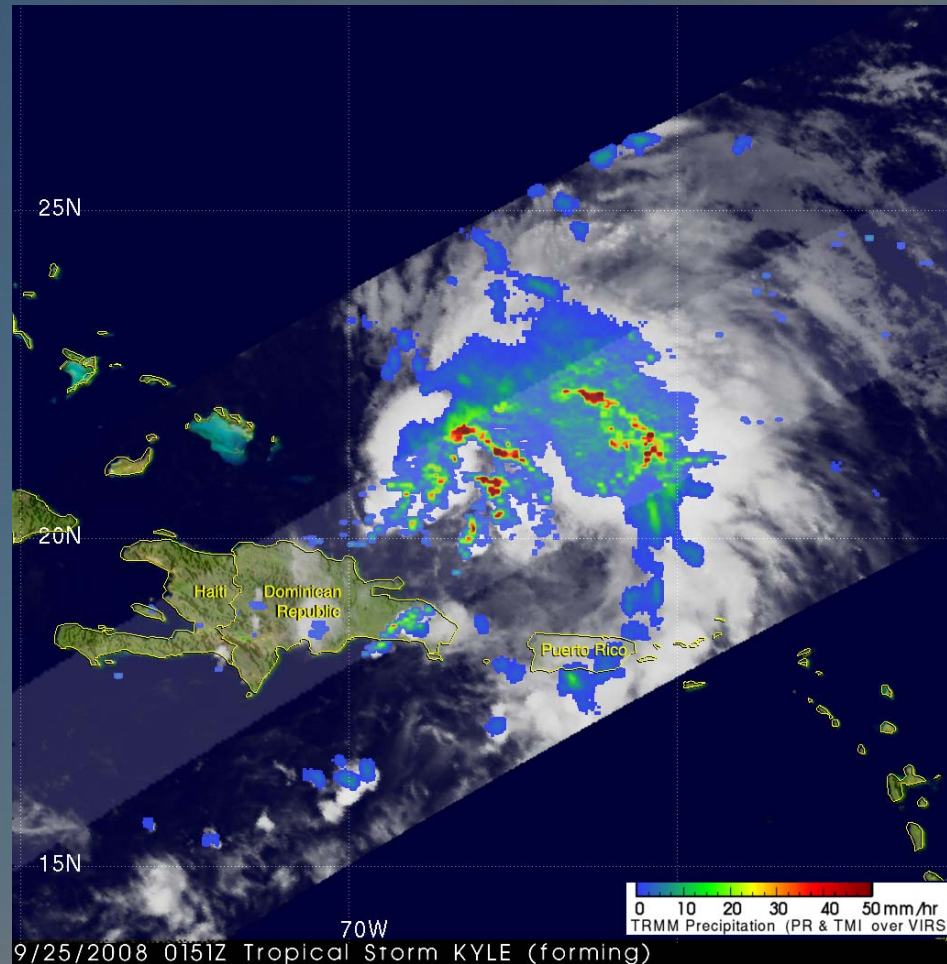
Notes...Finally, it is beginning to look like a Tropical Storm but the damage has already done to Southern PR. Catastrophic Flooding already ending in Southern PR. Approximately 630 People evacuated ... 4 people dead ... agriculture damaged – 5 to 15 inches of rain elsewhere across the island and no Kyle yet! On Thursday at 5pm NHC named the storm TS Kyle.

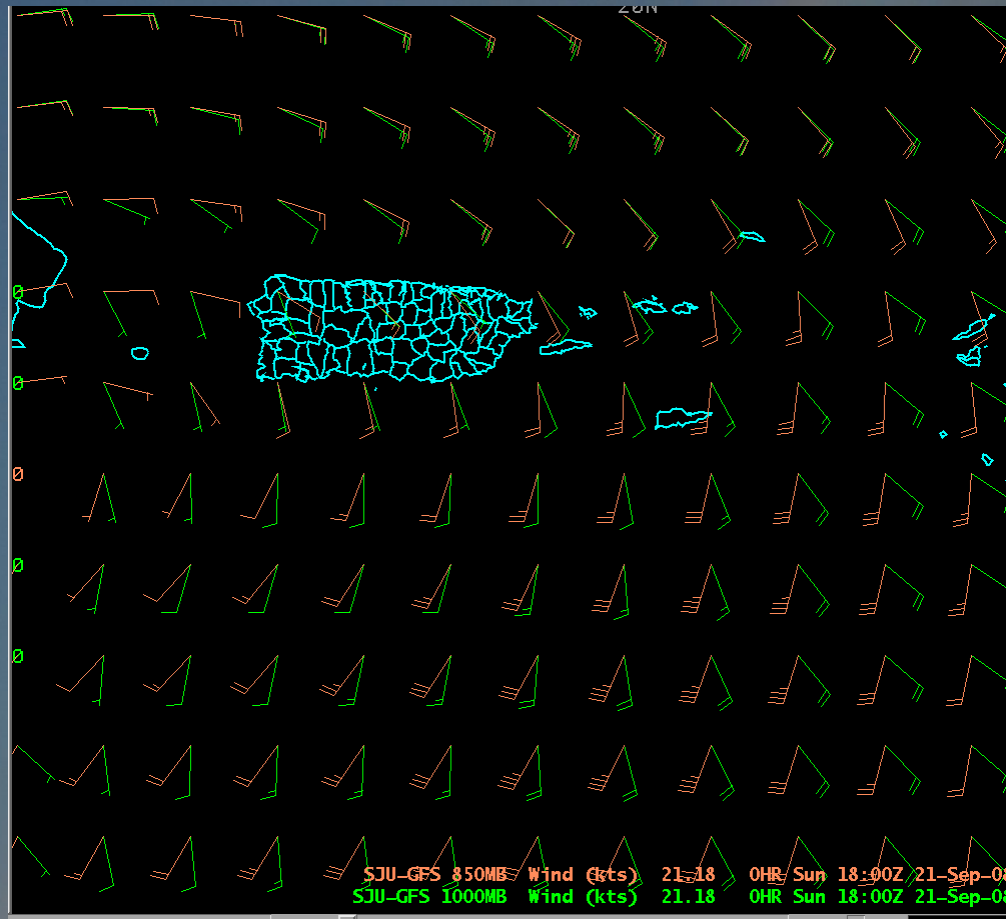
Notes...Flow varied from the southeast to the southwest for 3 days. The day with the highest 1 day total ... flow from the southeast at the surface and the south at 850mb.

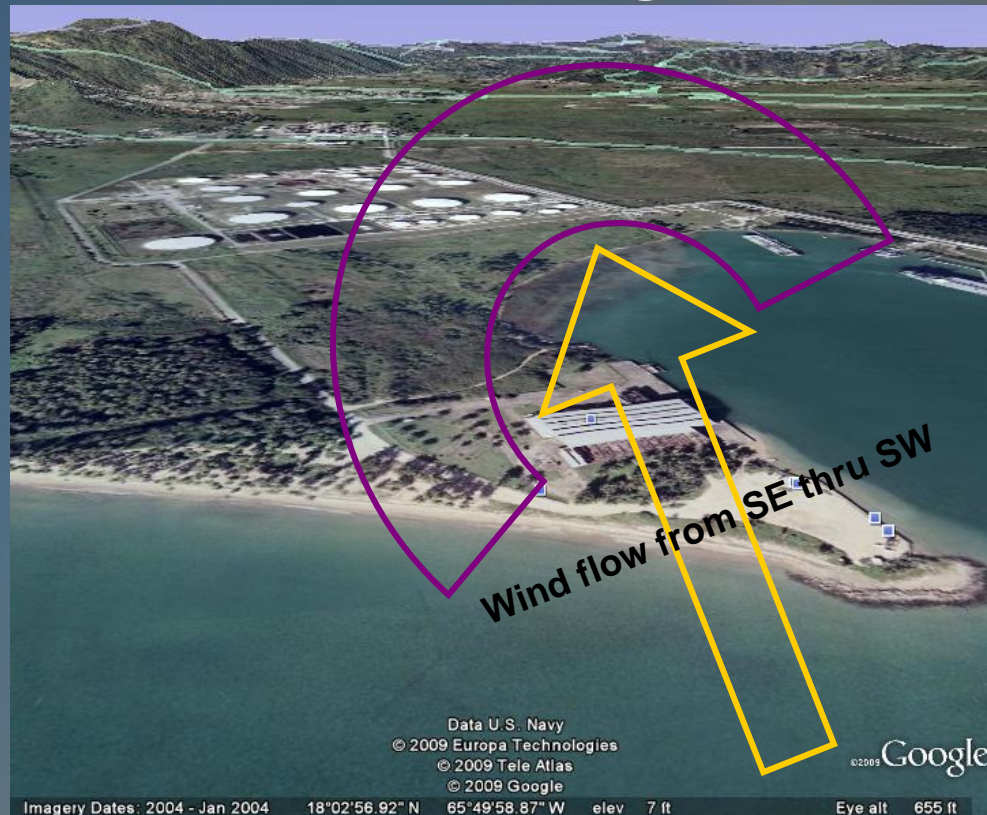
Pre-Kyle Severe Flooding Across Southeastern Puerto Rico ... wind flow interacting with mtns

Notes... Wind flow from the southeast thru southwest into the “horseshoe” ... rapidly ascending the mountainside ... rapidly developing high intensity rainfall ... rapid runoff back towards the plains and the ocean. This is the setup for the severe flooding that occurred as all these ingredients were available. Moisture – instability – lift in a geographical horseshoe designed basin with mountains on three sides.

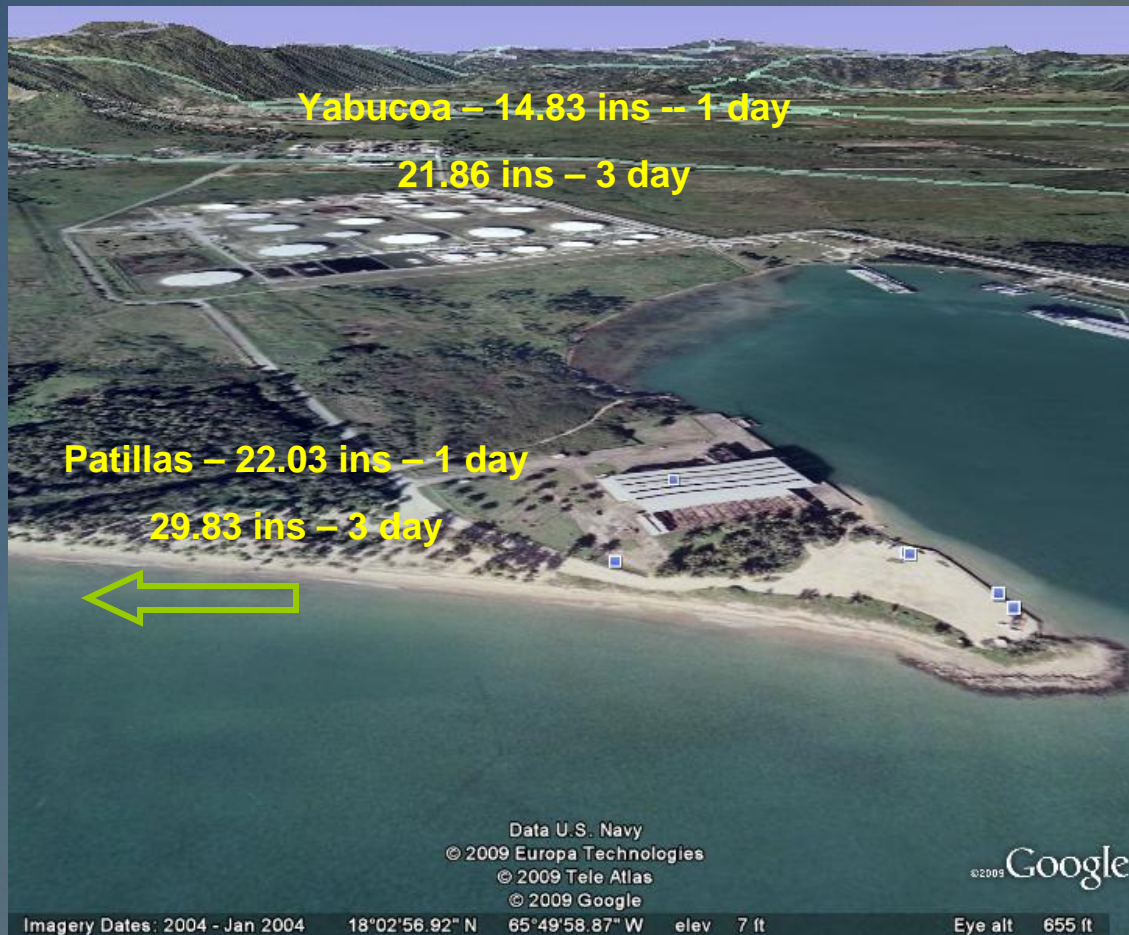
***Notes...What was the result? Patillas exceeded the 500 yr 24 hour rainfall totals.
Yabucoa exceeded the 25 yr 24 hour rainfall totals.***

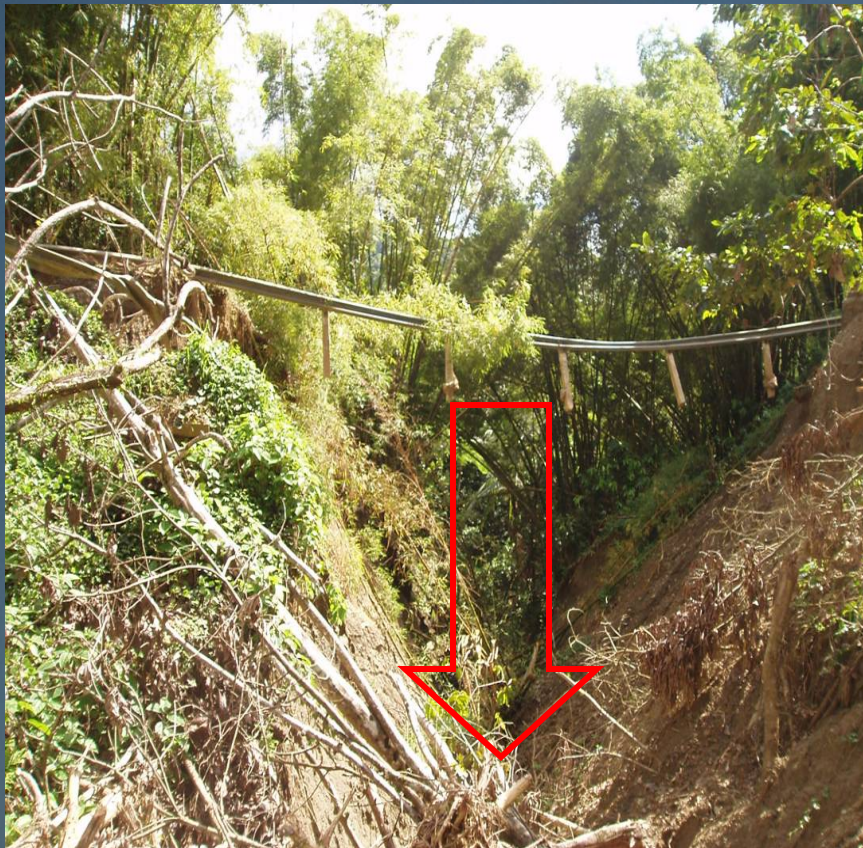
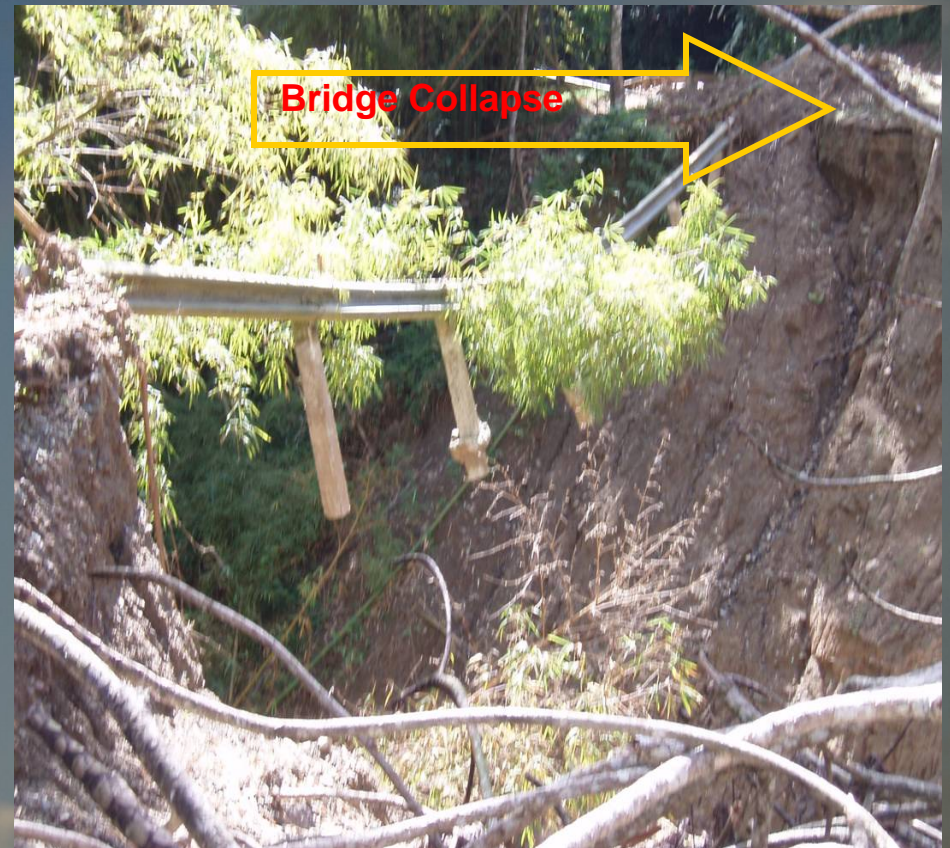
Pre-Kyle Severe Flooding Across Southeastern Puerto Rico ... the bridge is gone

**Notes...Almost every bridge in Maunabo and Yabucoa was damaged (source EMs of Yabucoa and Maunabo).
This crevice/bridge (photo on left) served as a dam (trees, rock and debris) and then eventually with a loud bang - as described by residents – technically a dam break which took the bridge with it.**

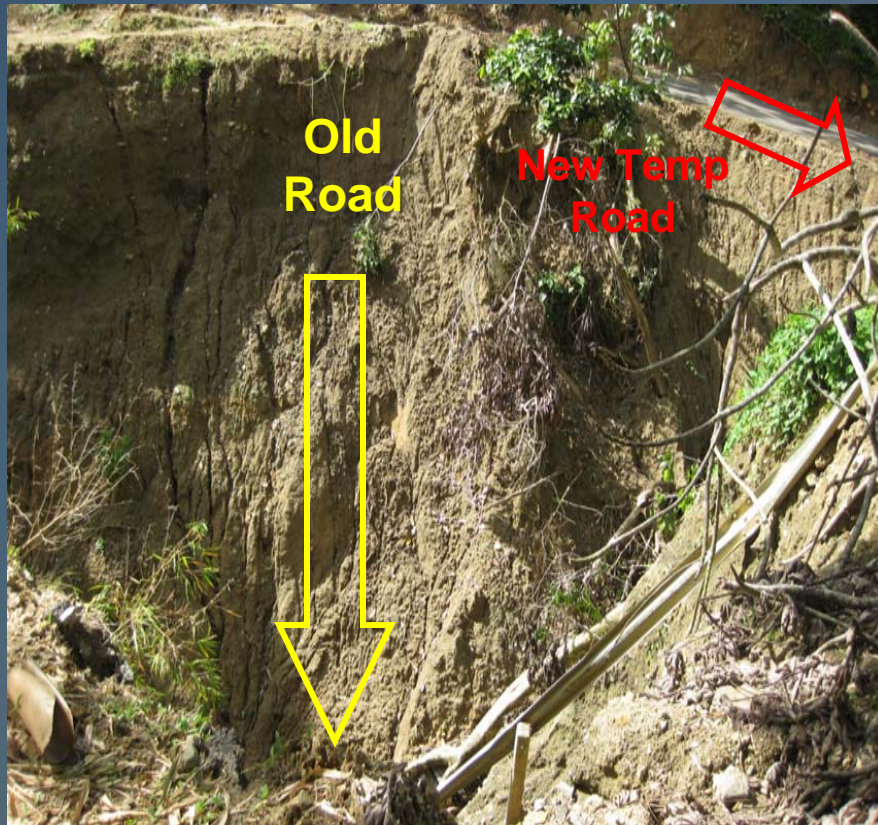
Notes...Many temporary roads had to be built within 3 weeks to re-connect the communities that were cut off from remainder of island.

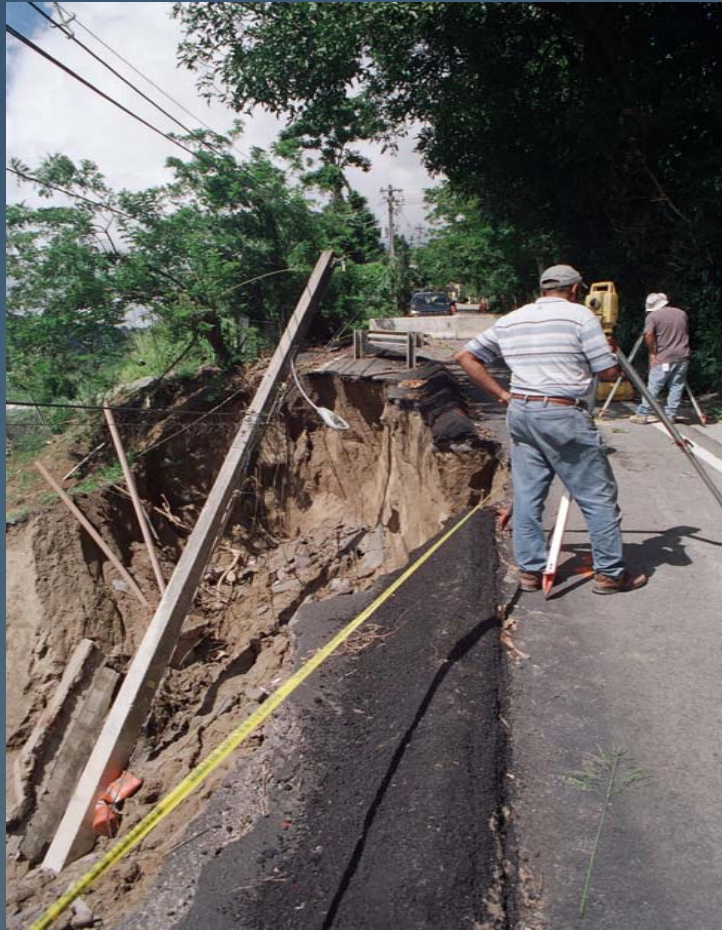
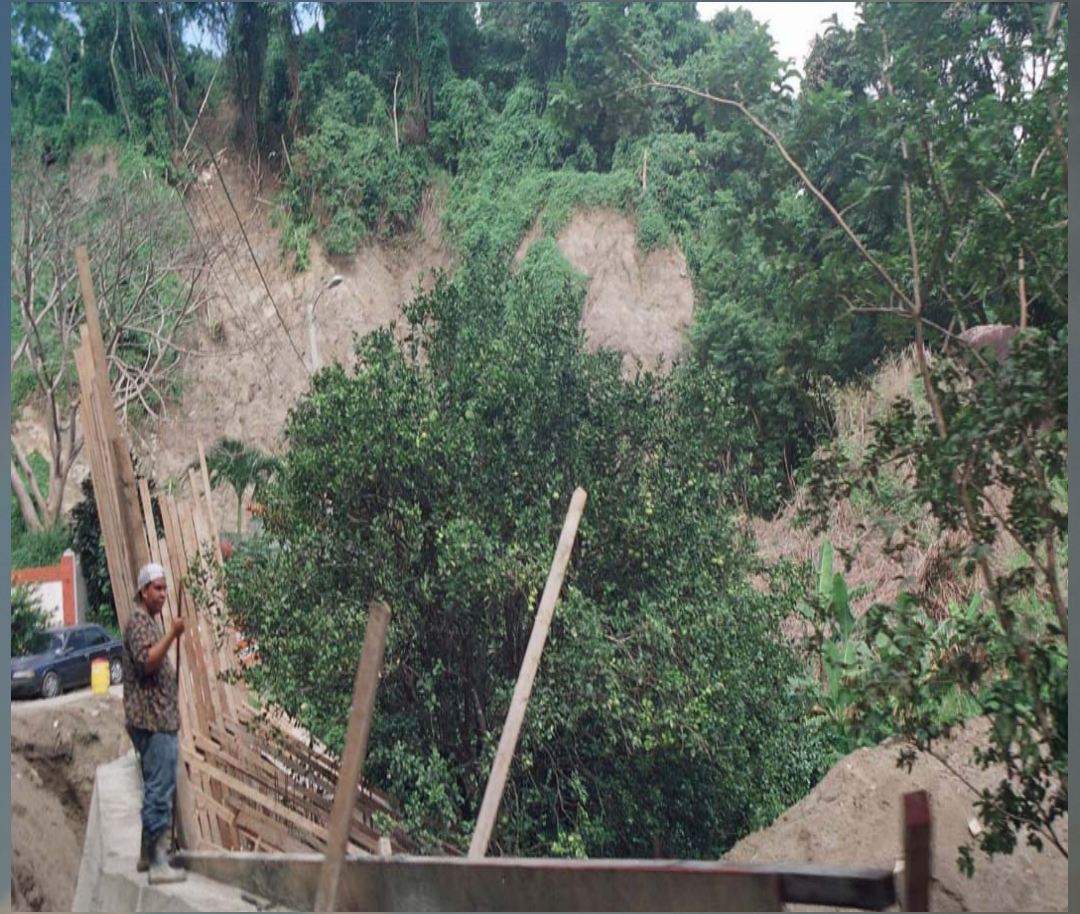
Notes... Road closures and detours everywhere.

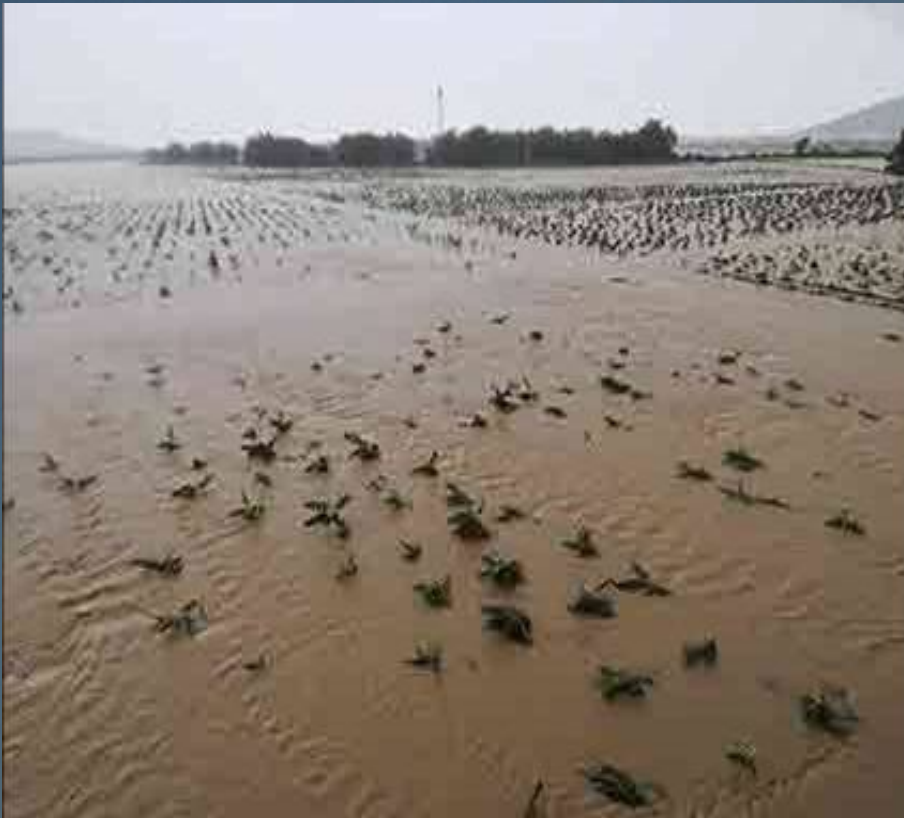
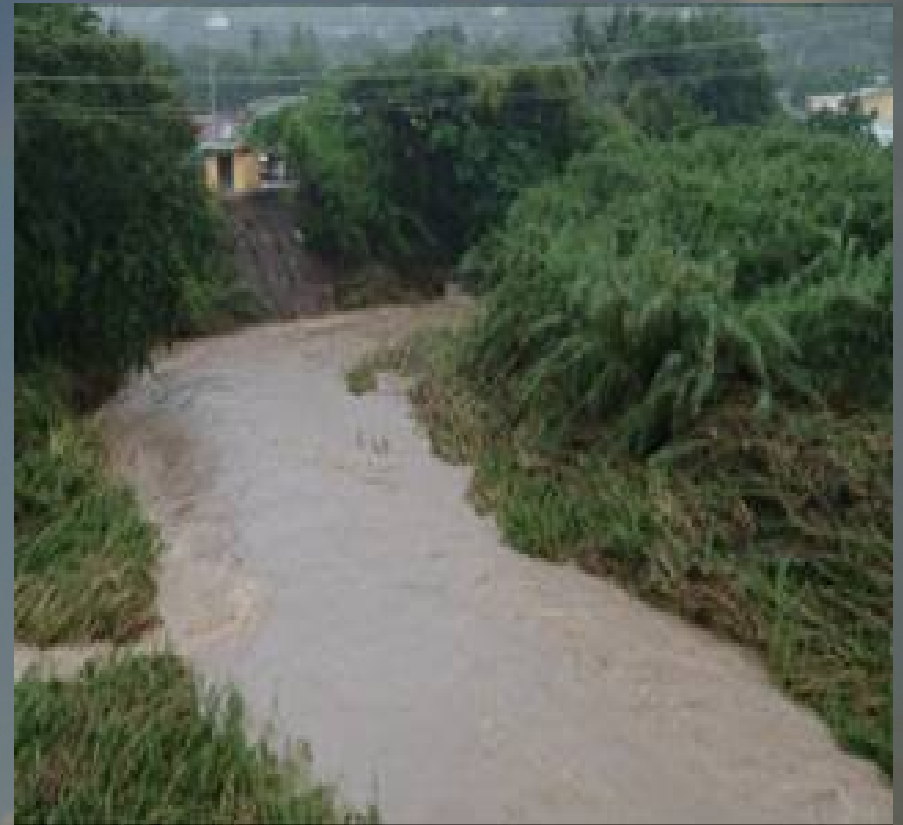
Notes...Rivers were flooding and swollen and the crops were damaged/destroyed.
