## Storm Data and Unusual Weather Phenomena - March 2018

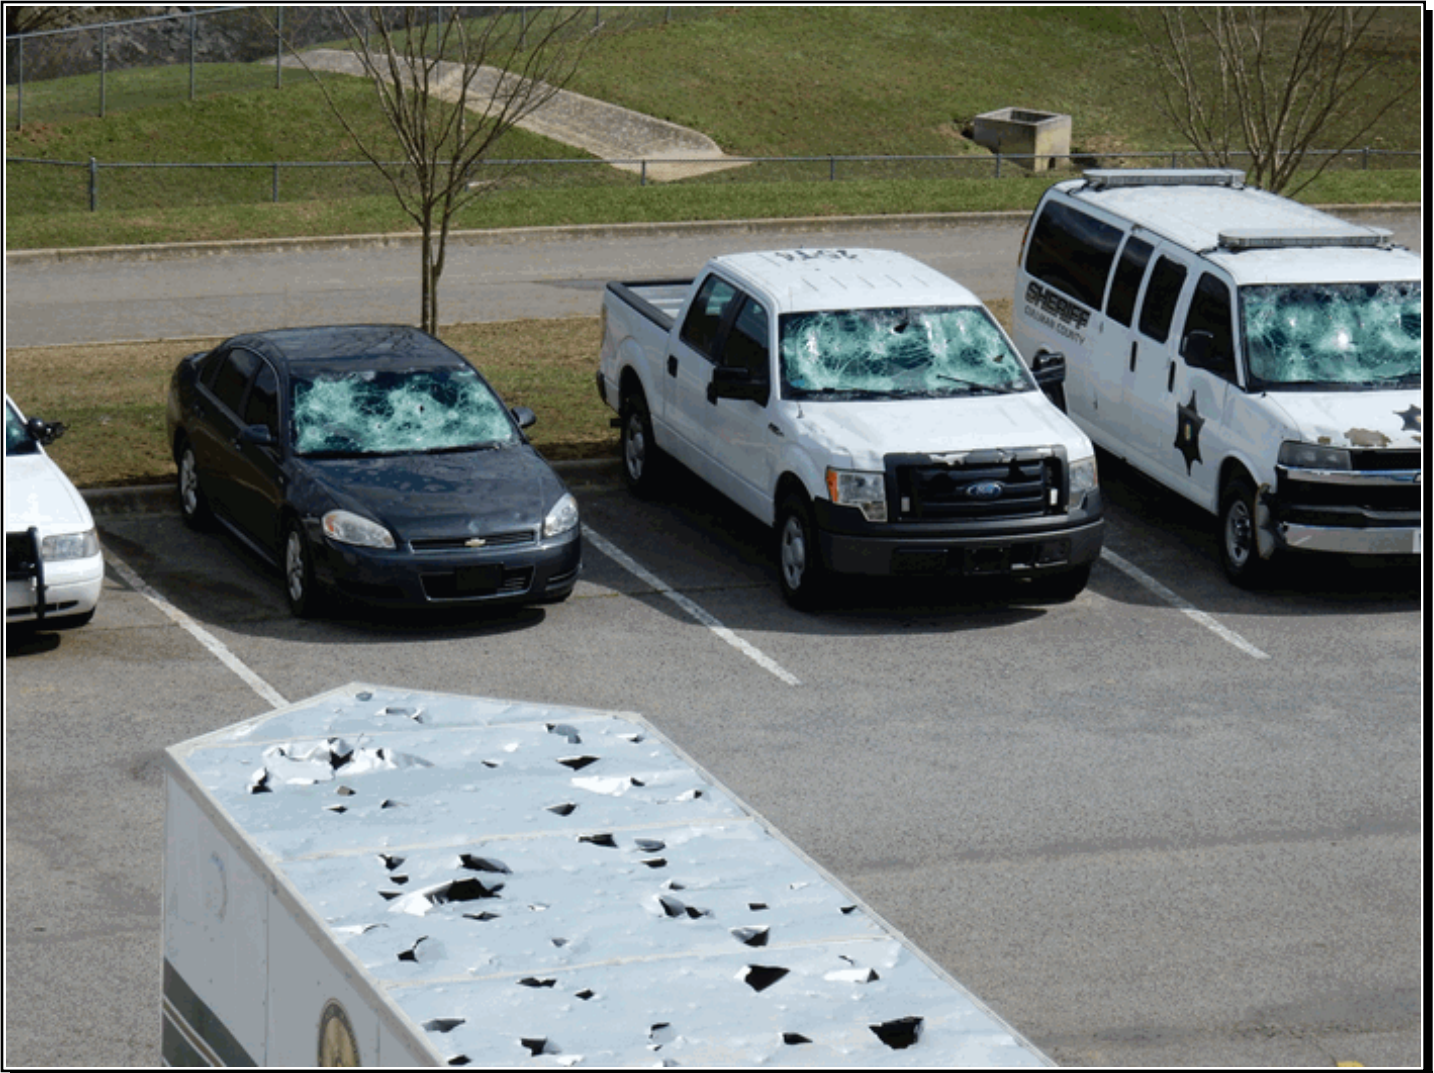
*Photo by National Weather Service, Huntsville AL. Hail of tennis and baseball size produced a swath of significant damage in central, south and southeast Cullman. In this photo, the Cullman County Jail sustained serious damage to all vehicles and their building. Hail penetrated the roof of the structure and damaged HVAC and other metal structures atop the roof of the facility.*
