Streator, IL Tornado – June 5, 2010

Maximum Tornado Intensity:	EF-2
Estimated Maximum Winds:	130 mph
Estimated Maximum Path Width:	¼ to ½ mile
Tornado Path Length:	~ 18 miles
Tornado Began:	8:35 pm CDT
Tornado Lifted:	8:57 pm CDT
Injuries:	17

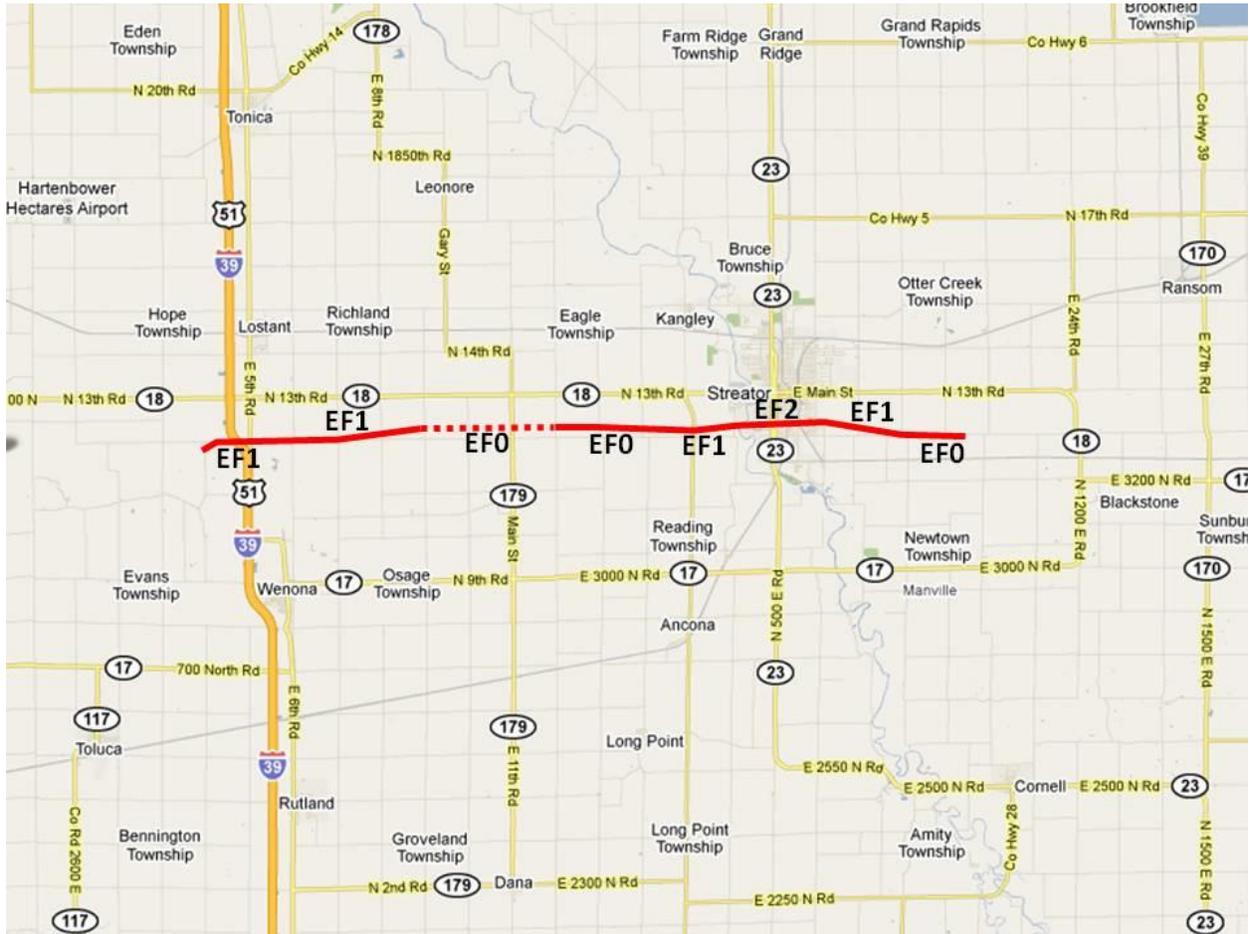
Map of the tornado track through Streator, IL on June 5, 2010

Shortly after the Magnolia, IL tornado lifted, the same supercell thunderstorm went on to produce another tornado shortly thereafter near the Marshall and LaSalle County line. National Weather Service damage survey teams found the damage from this tornado began just west of 2900 E and about one quarter mile south of 1250 N or N 12th Rd...which is the road that marks the county line. This tornado continued eastward tracking along and just north of N12th Rd producing primarily EF-0 to EF-1 intensity damage, largely in the form of downed trees...powerlines...and very minor structural damage.

After the tornado moved past E 9th Rd the damage became more sporadic...which corresponded with spotter and storm chasers who reported that the tornado was not continuously on the ground before it reached Streator. Damage became more consistent again as the tornado moved east of E 12th Rd remaining just north of N12th Rd...so the tornado appears to have remained on the ground from this point east into the city of Streator. The damage from E 9th Rd east to E 15th Rd was rated EF-0 intensity and consisted primarily of minor tree damage.

The tornado appears to have intensified as it moved into the city of Streator with EF-2 intensity damage near the Eagle Pass subdivision where there was significant tree damage along with portions of roofs removed from well built single family homes. The tornado continued eastward across southern portions of the city of Streator damaging numerous homes and completely destroying several homes. Some of the most intense damage in Streator occurred along Hall St and near Southside Athletic Park where damage was rated higher end EF-2. The most intense damage occurred in approximately one quarter mile wide path through the city of Streator.

The tornado then continued eastward out of the city of Streator producing additional EF-0 to EF-1 intensity damage along the Livingston and LaSalle county border. The tornado appears to have jogged slightly southward before lifting just east near the county line just to the west of E 22nd Rd.
