# Austin/San Antonio Weather Forecast Office WEATHER EVENT SUMMARY

## 2015 Memorial Day Weekend Tornadoes

23 – 25 May 2015

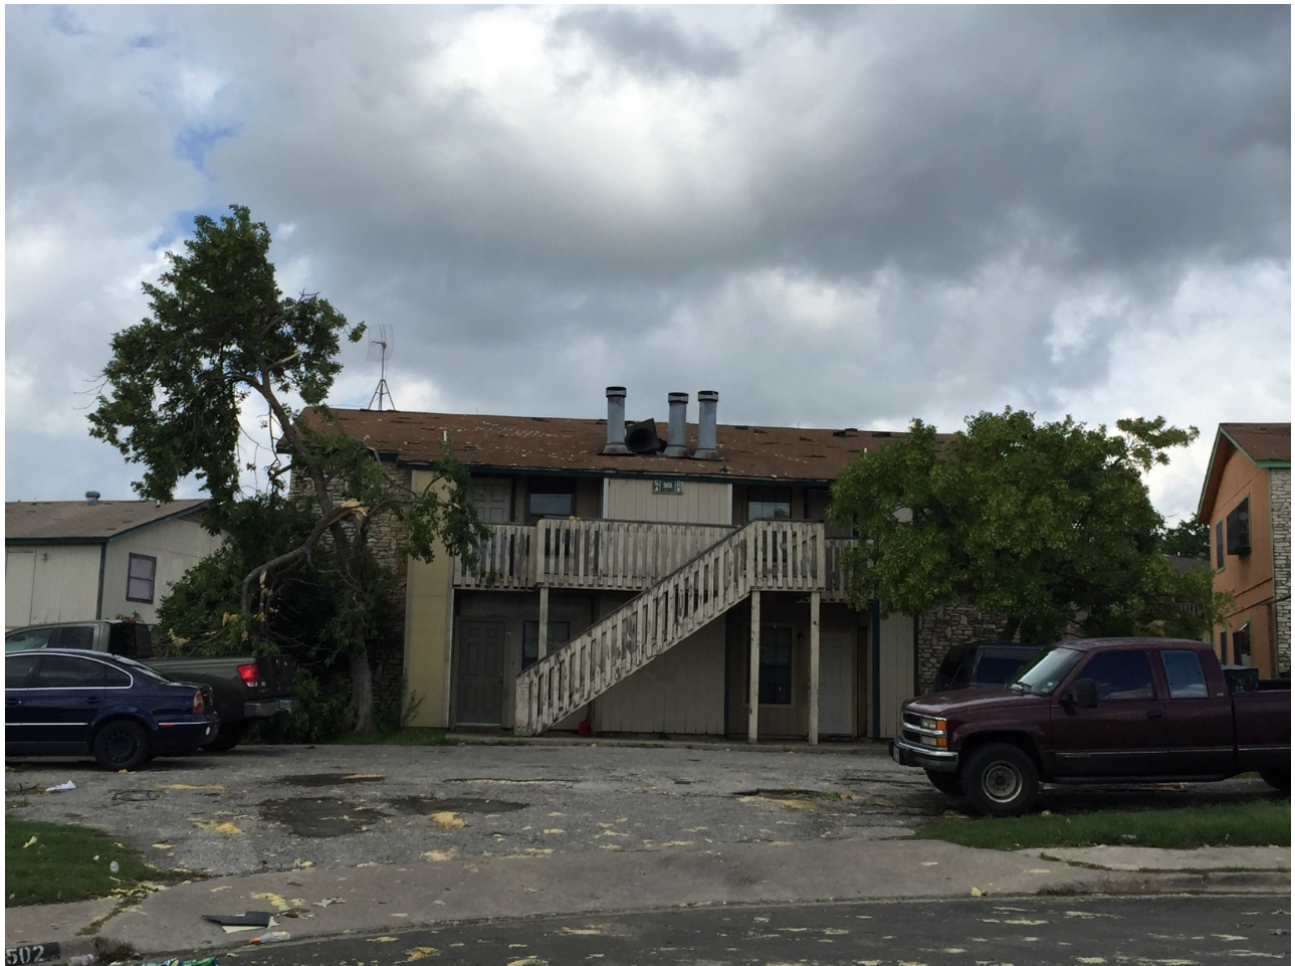
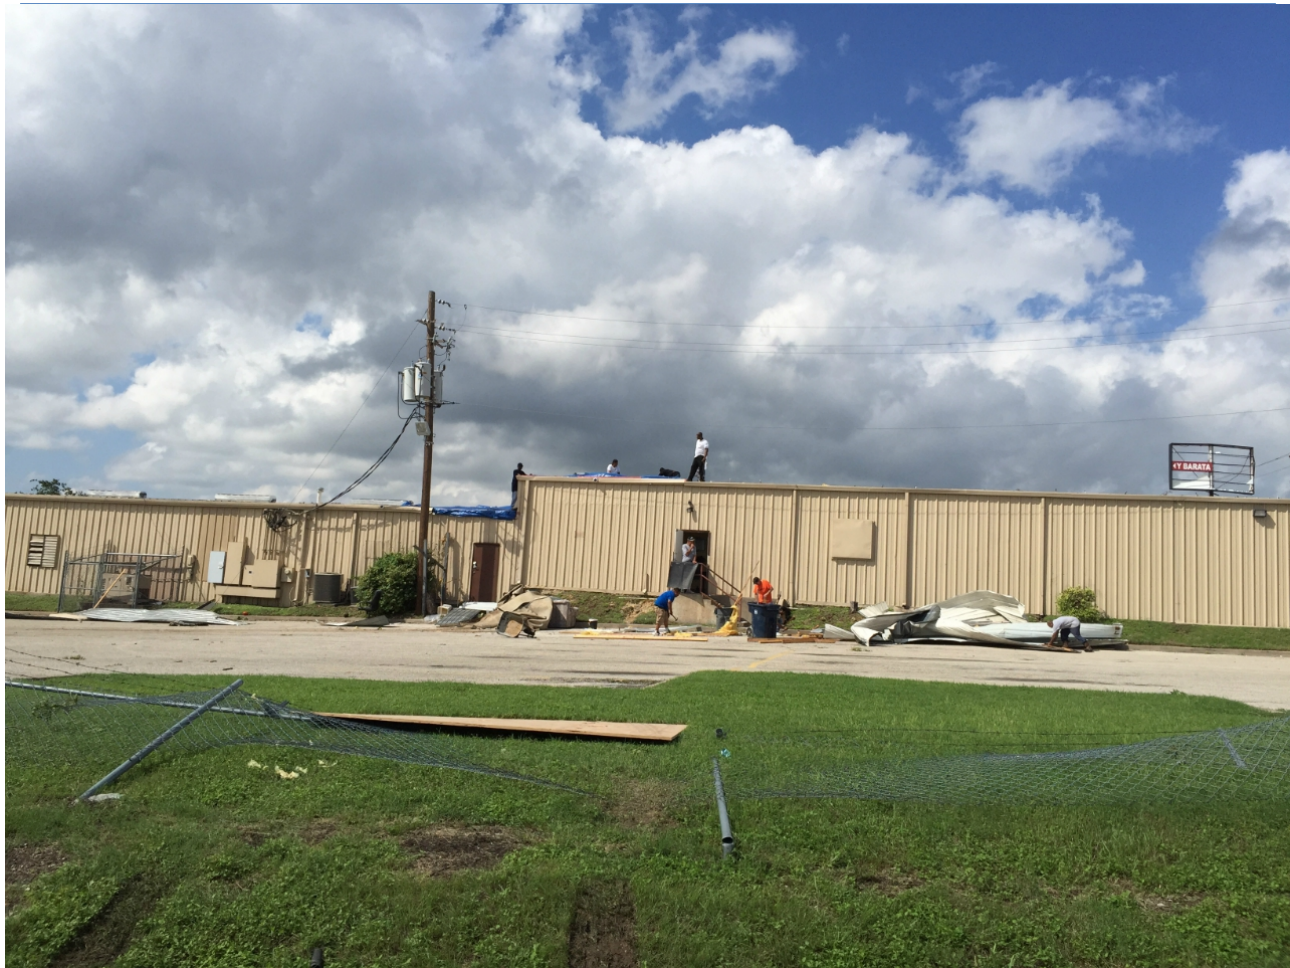
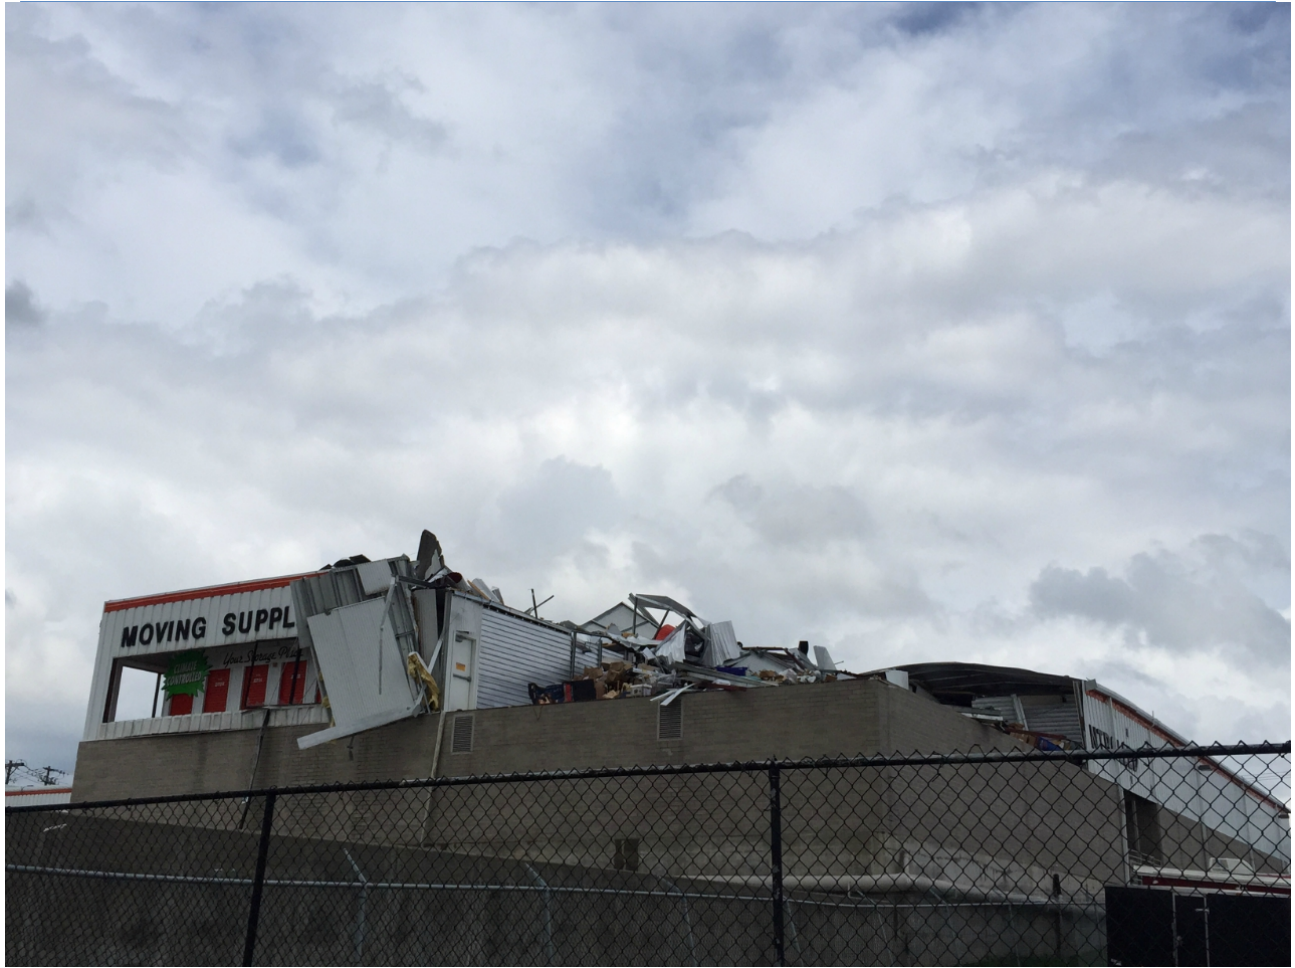
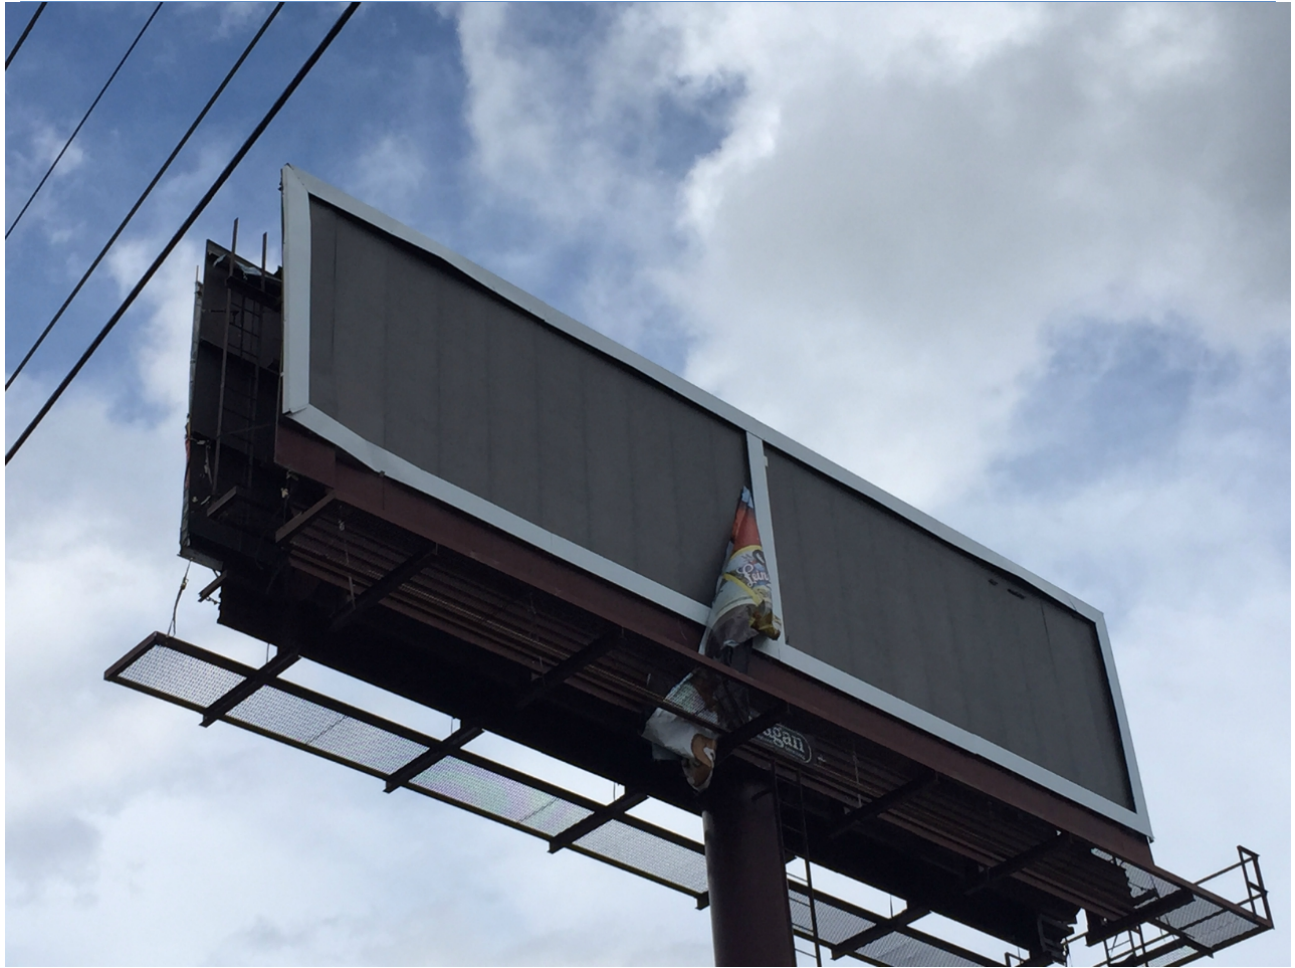
Austin Tornado Near Braker Lane (Travis County)									
#	Rating	Max Winds	Time	Start	End	Length	Width	Fatalities	Injuries
1	EF1	95 MPH	2139-2142	30.3650/-97.6850	30.3660/-97.6750	0.6 mi	250 yds	0	0

A NWS survey team concluded a tornado touched down on the west side of Interstate 35 in Austin near Brownie Drive and Diamondback Trail. The tornado peeled back a sheet metal roof to a business on the west side of interstate 35 and demolished a stone brick sign. The tornado also caused damage to roofing shingles...snapped large tree limbs and tossed a garbage dumpster at an apartment complex near Hardin court. The tornado moved east-northeast...crossing Interstate 35...where it caused significant damage to the second floor of a storage facility. The metal roof and walls were collapsed in on the southwest side of the storage facility. Ten small moving trailers were lifted and tossed in various directions...with two tossed back across to the west side of Interstate 35. Several power poles were blown over along the access roads of interstate 35. The tornado continued east-northeast through the Windsor Hills Subdivision...snapping numerous large tree limbs throughout the subdivision. Peak winds were estimated to be around 90-95 mph near the businesses along interstate 35.

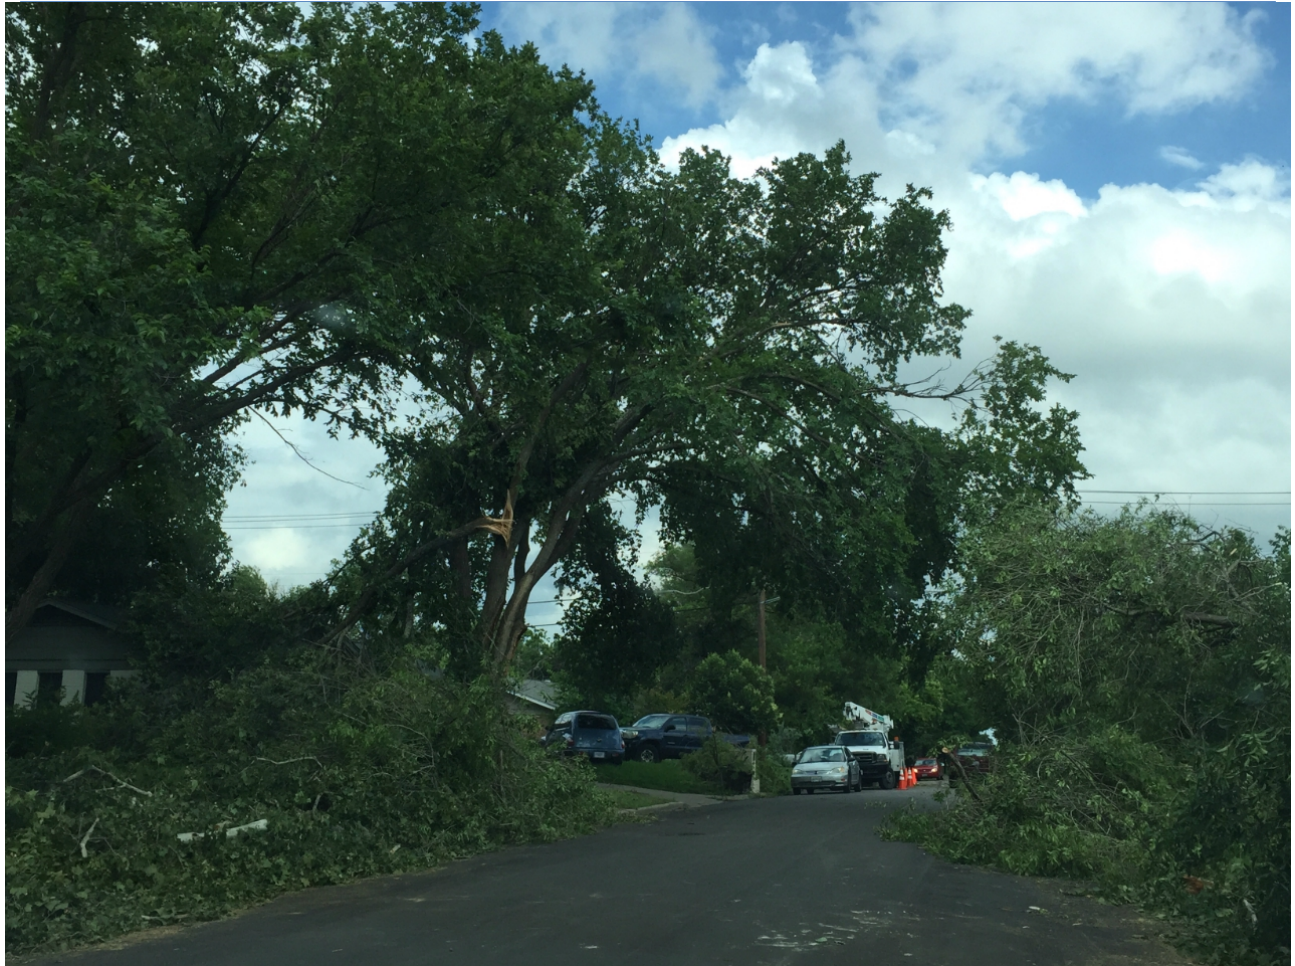
A NWS storm survey team concluded a tornado touched down in the Gabriels Overlook Subdivision in Williamson County, roughly four miles northeast of Leander. The tornado snapped large tree limbs through its path length. The tornado also caused damage to two homes...with roof decking on the corner of one home removed...and over half the roof decking on the second home completely removed. Two large storage sheds were also picked up and moved 20 yards. Peak winds were estimated to be around 95-100 mph, where the most significant damage occurred to the second home.

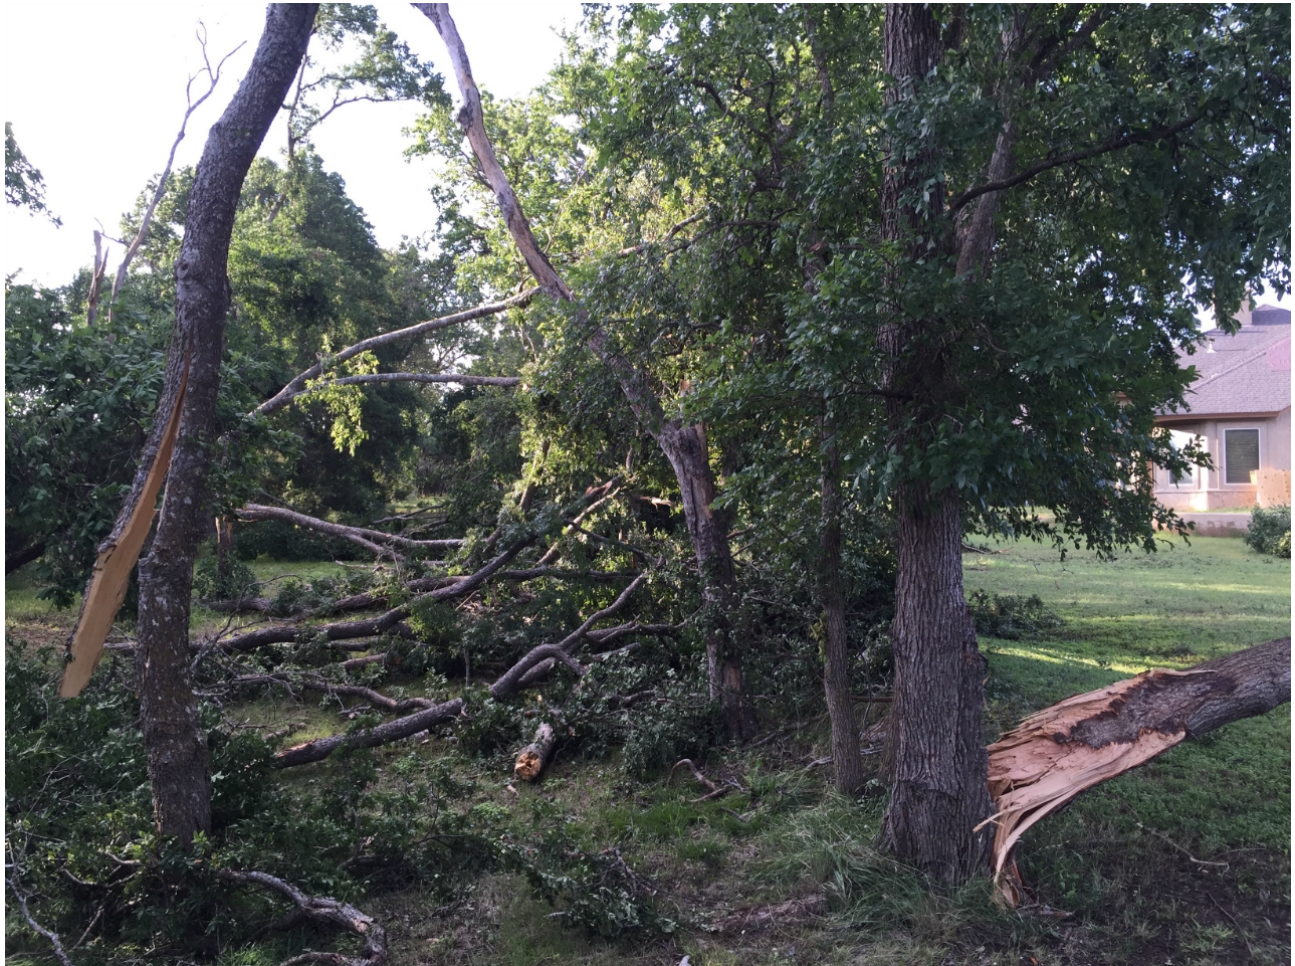
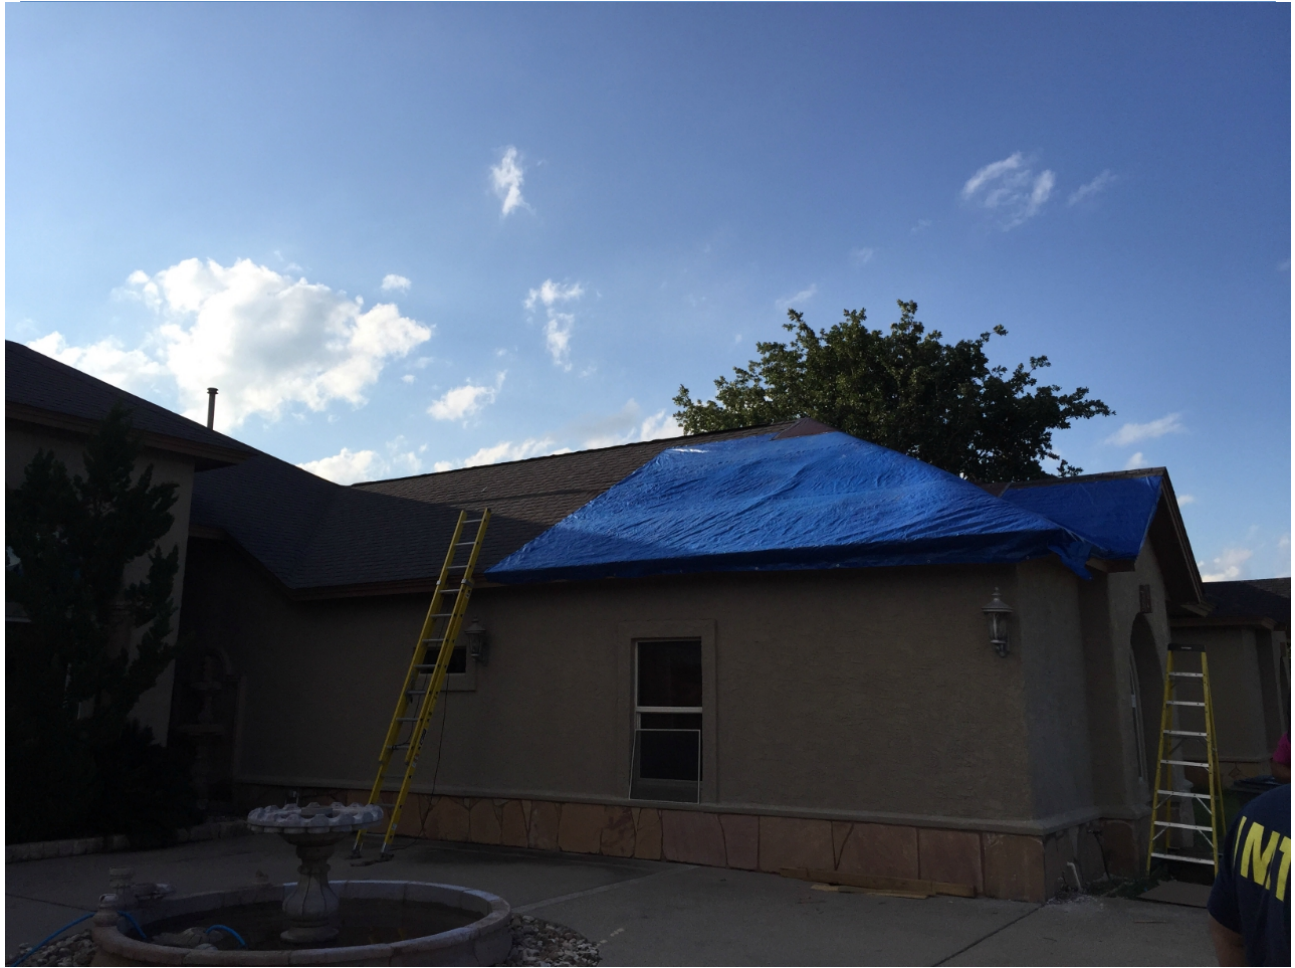
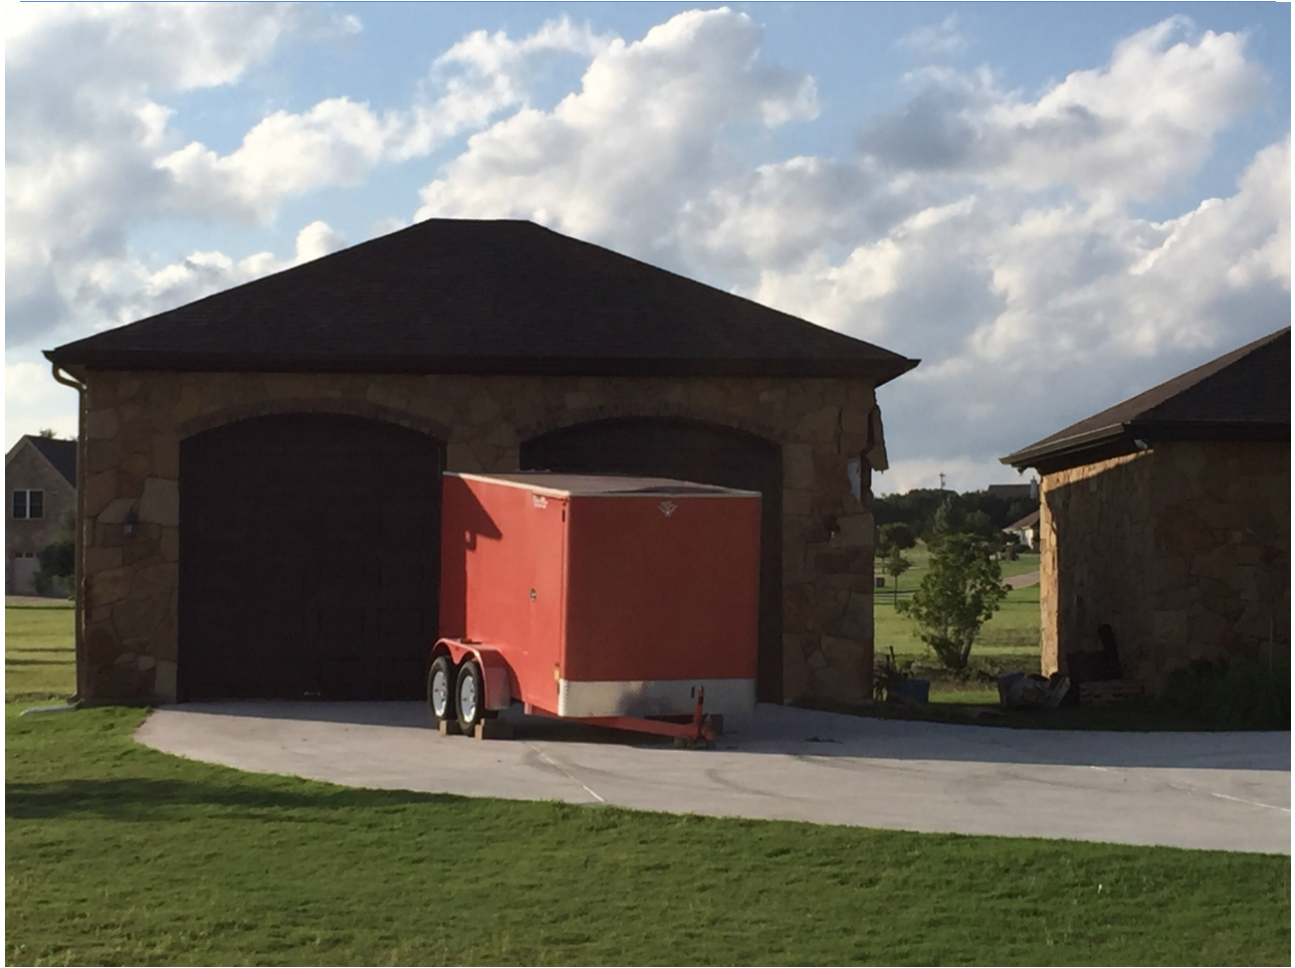
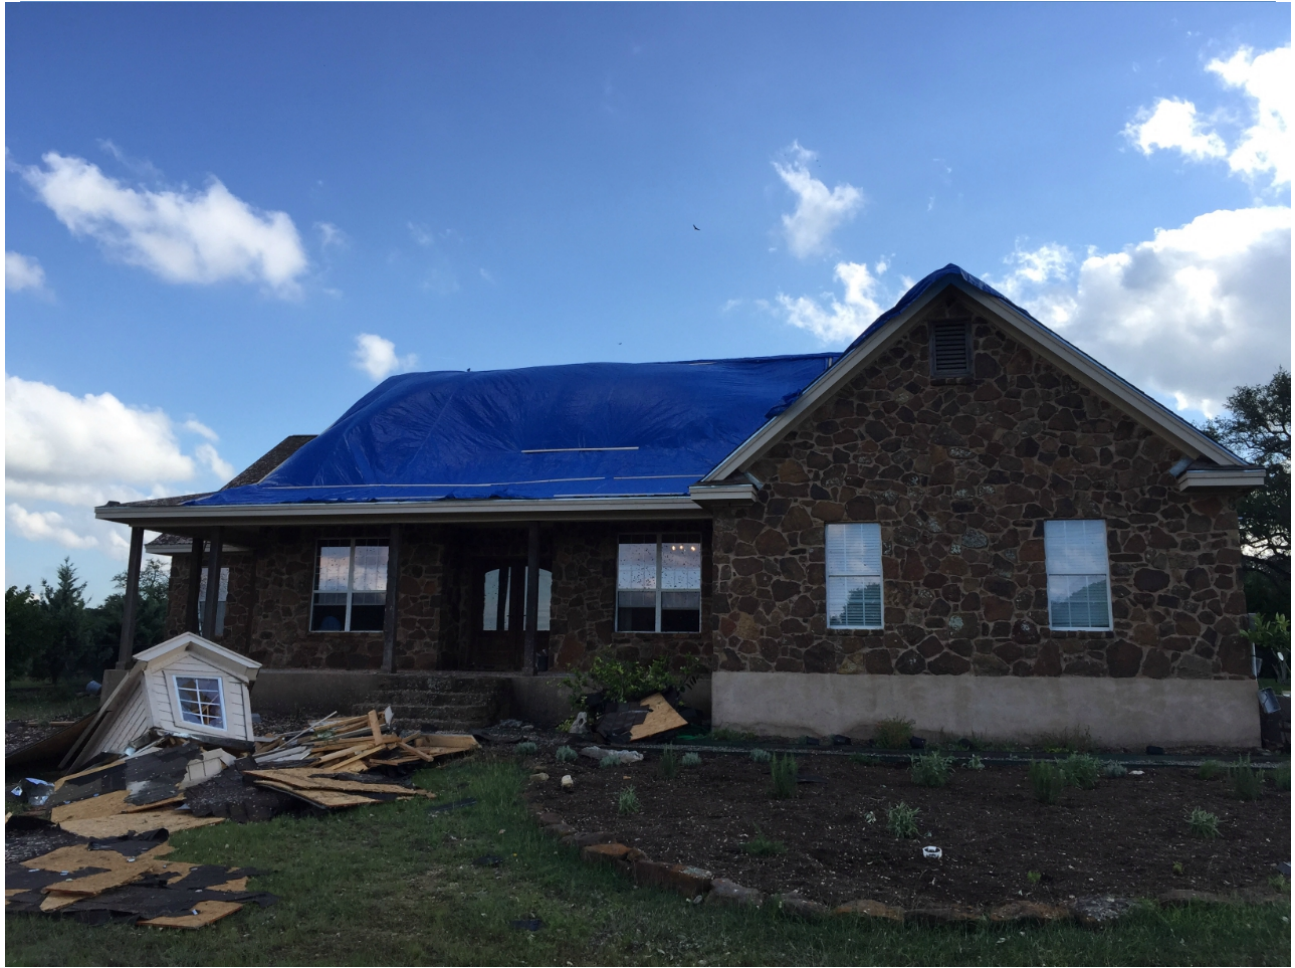
## Gabriels Overlook Tornado near Liberty Hill (Williamson County)

#	Rating	Max Winds	Time	Start	End	Length	Width	Fatalities	Injuries
2	EF1	100 MPH	2147-2150	30.6110/-97.8050	30.6170/-97.7990	0.5 mi	150 yds	0	0

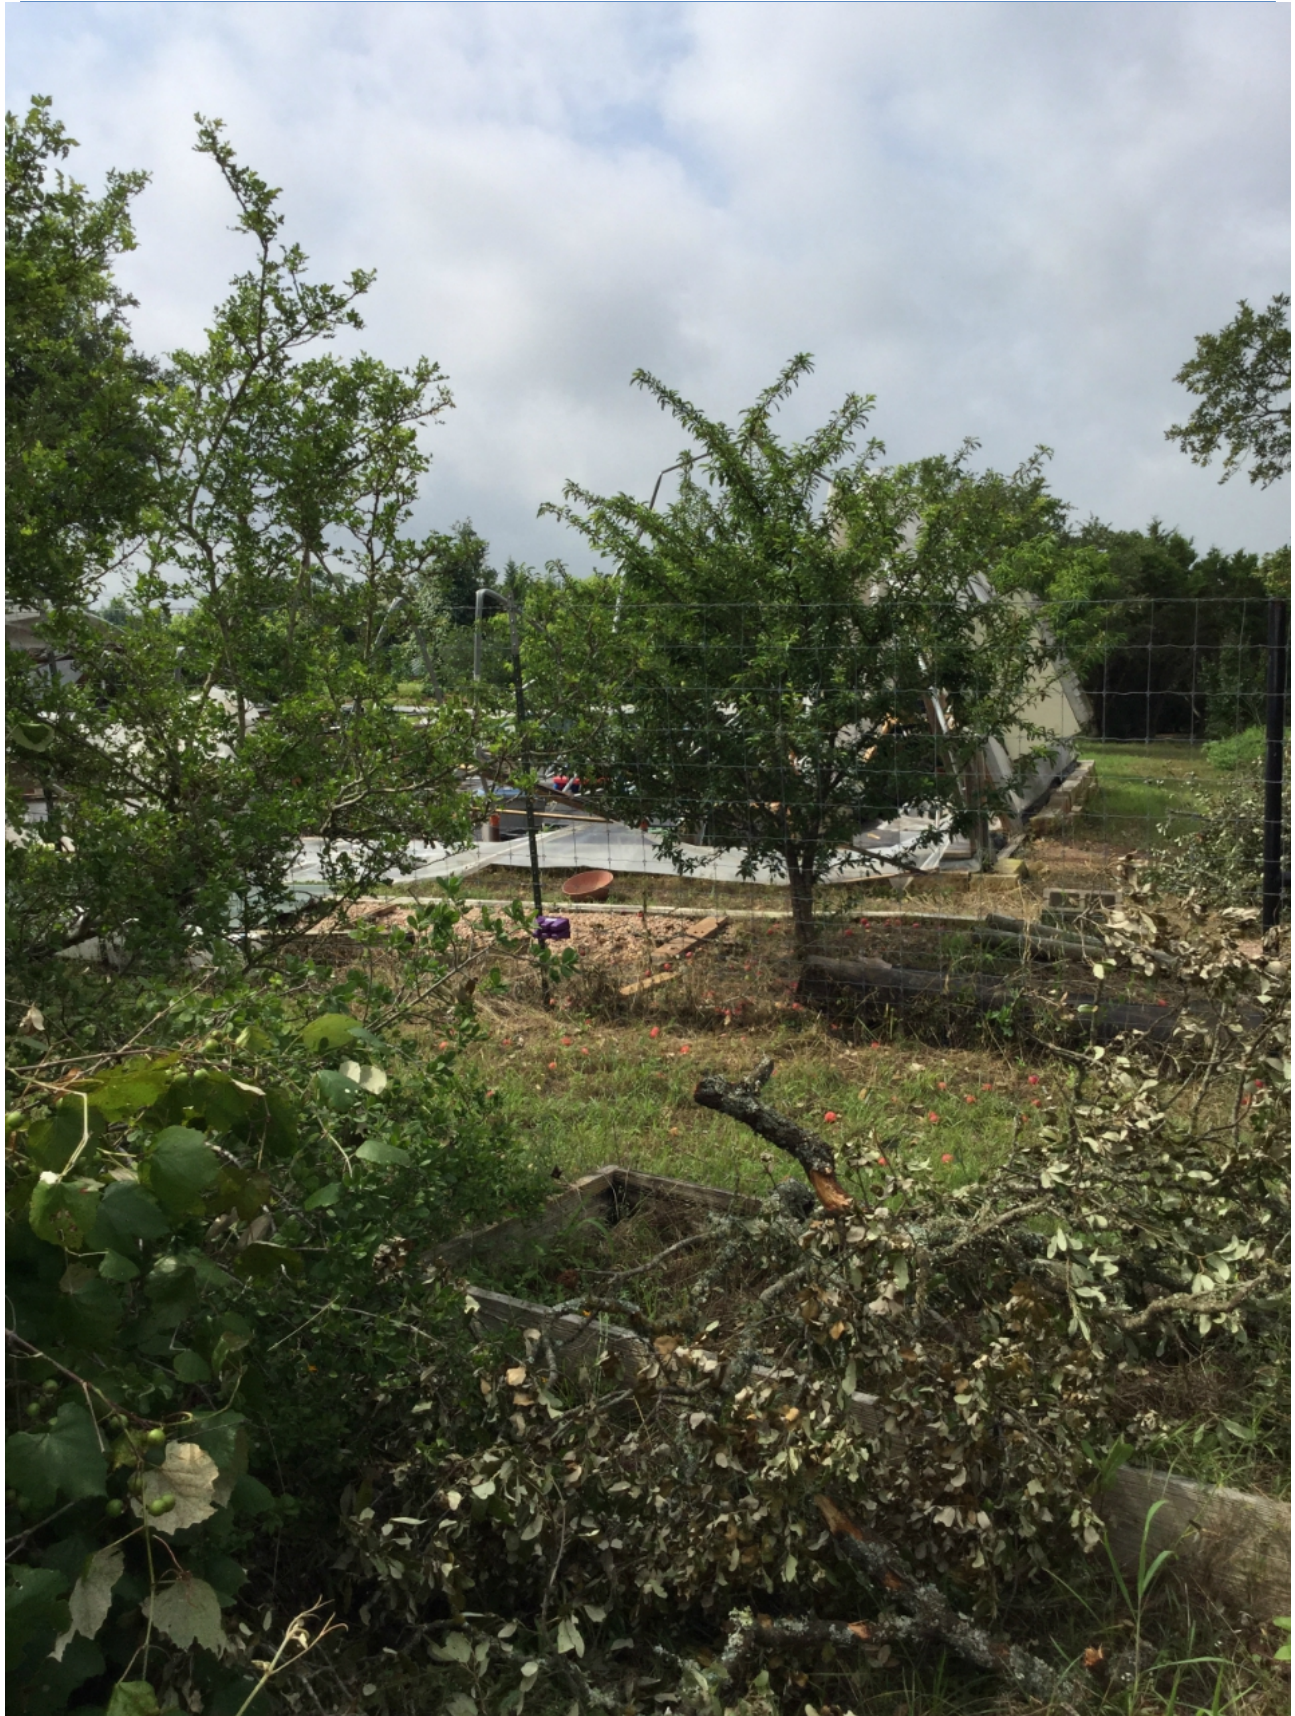
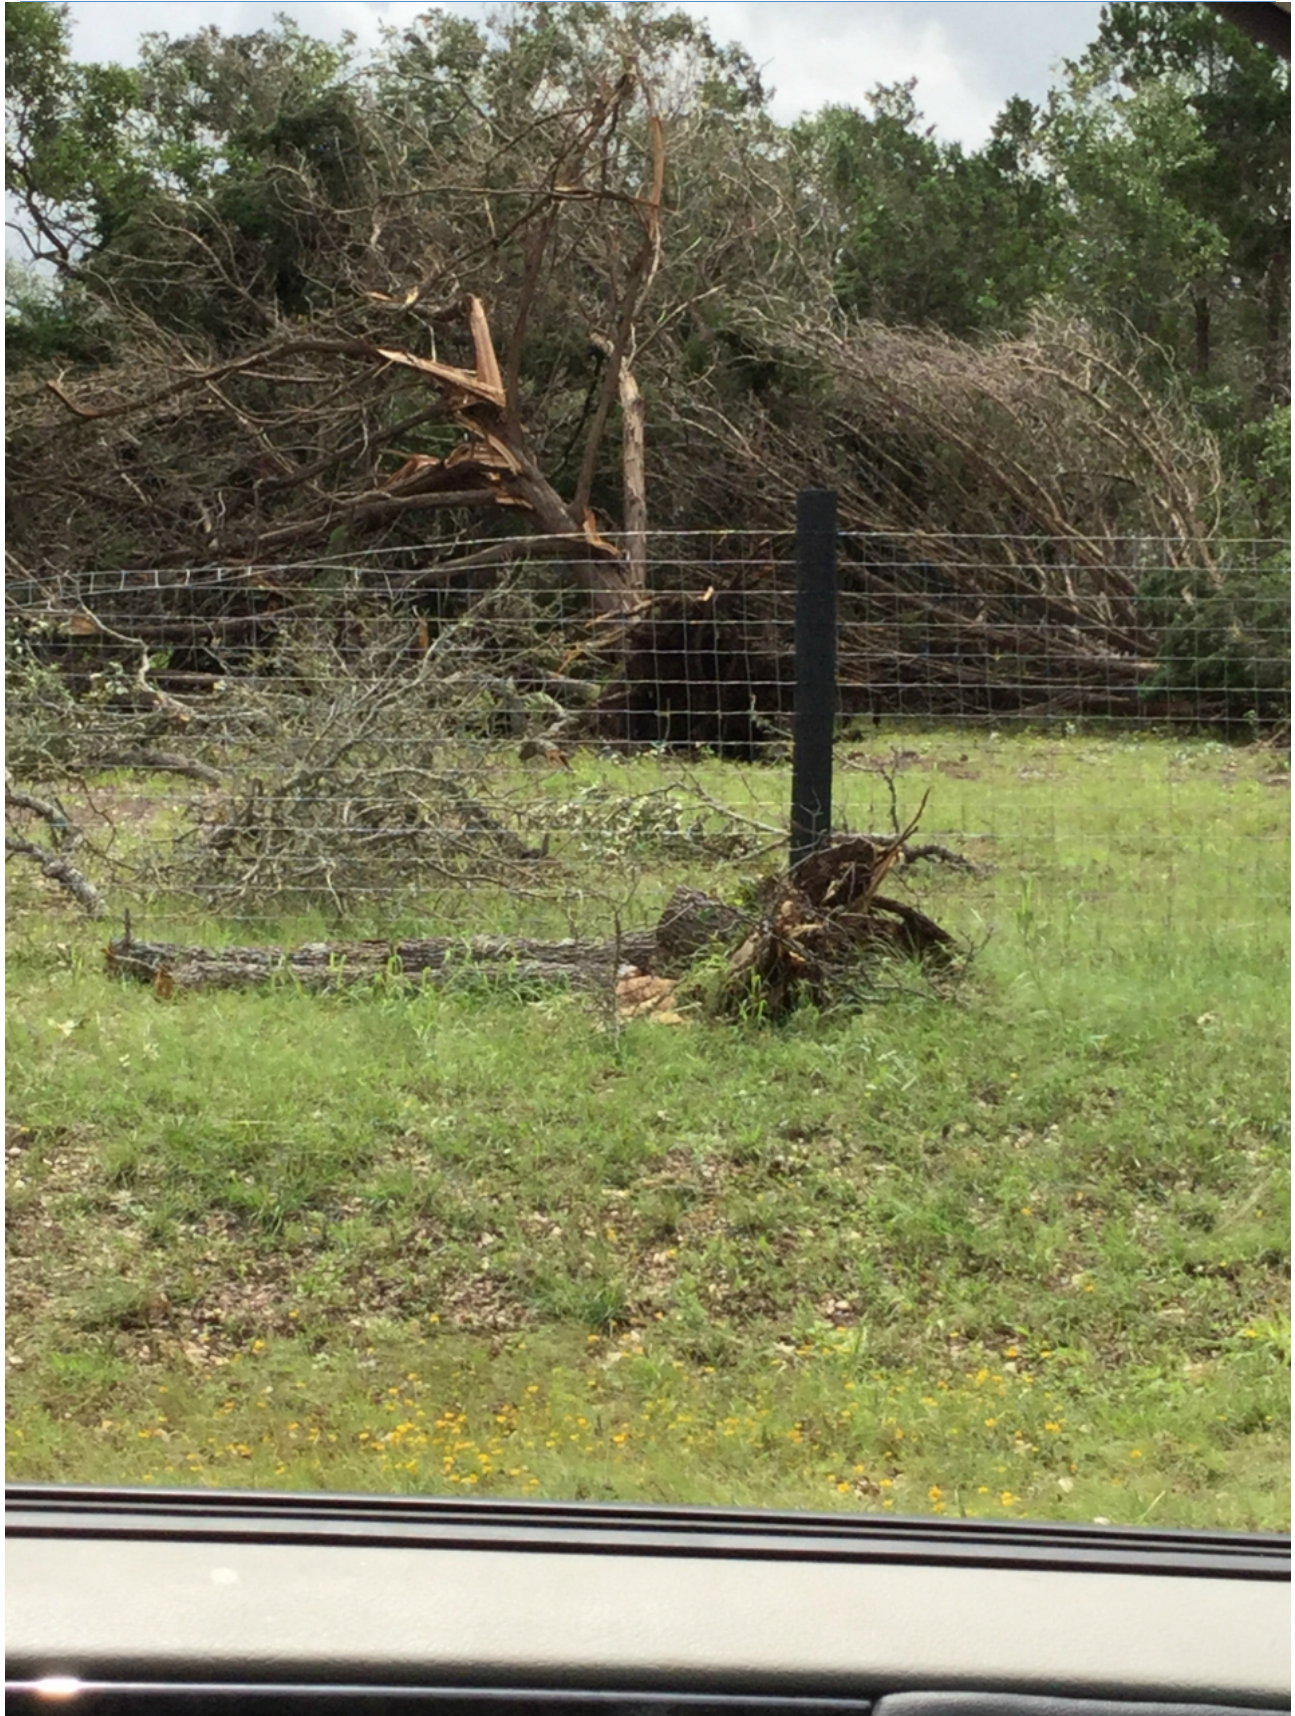
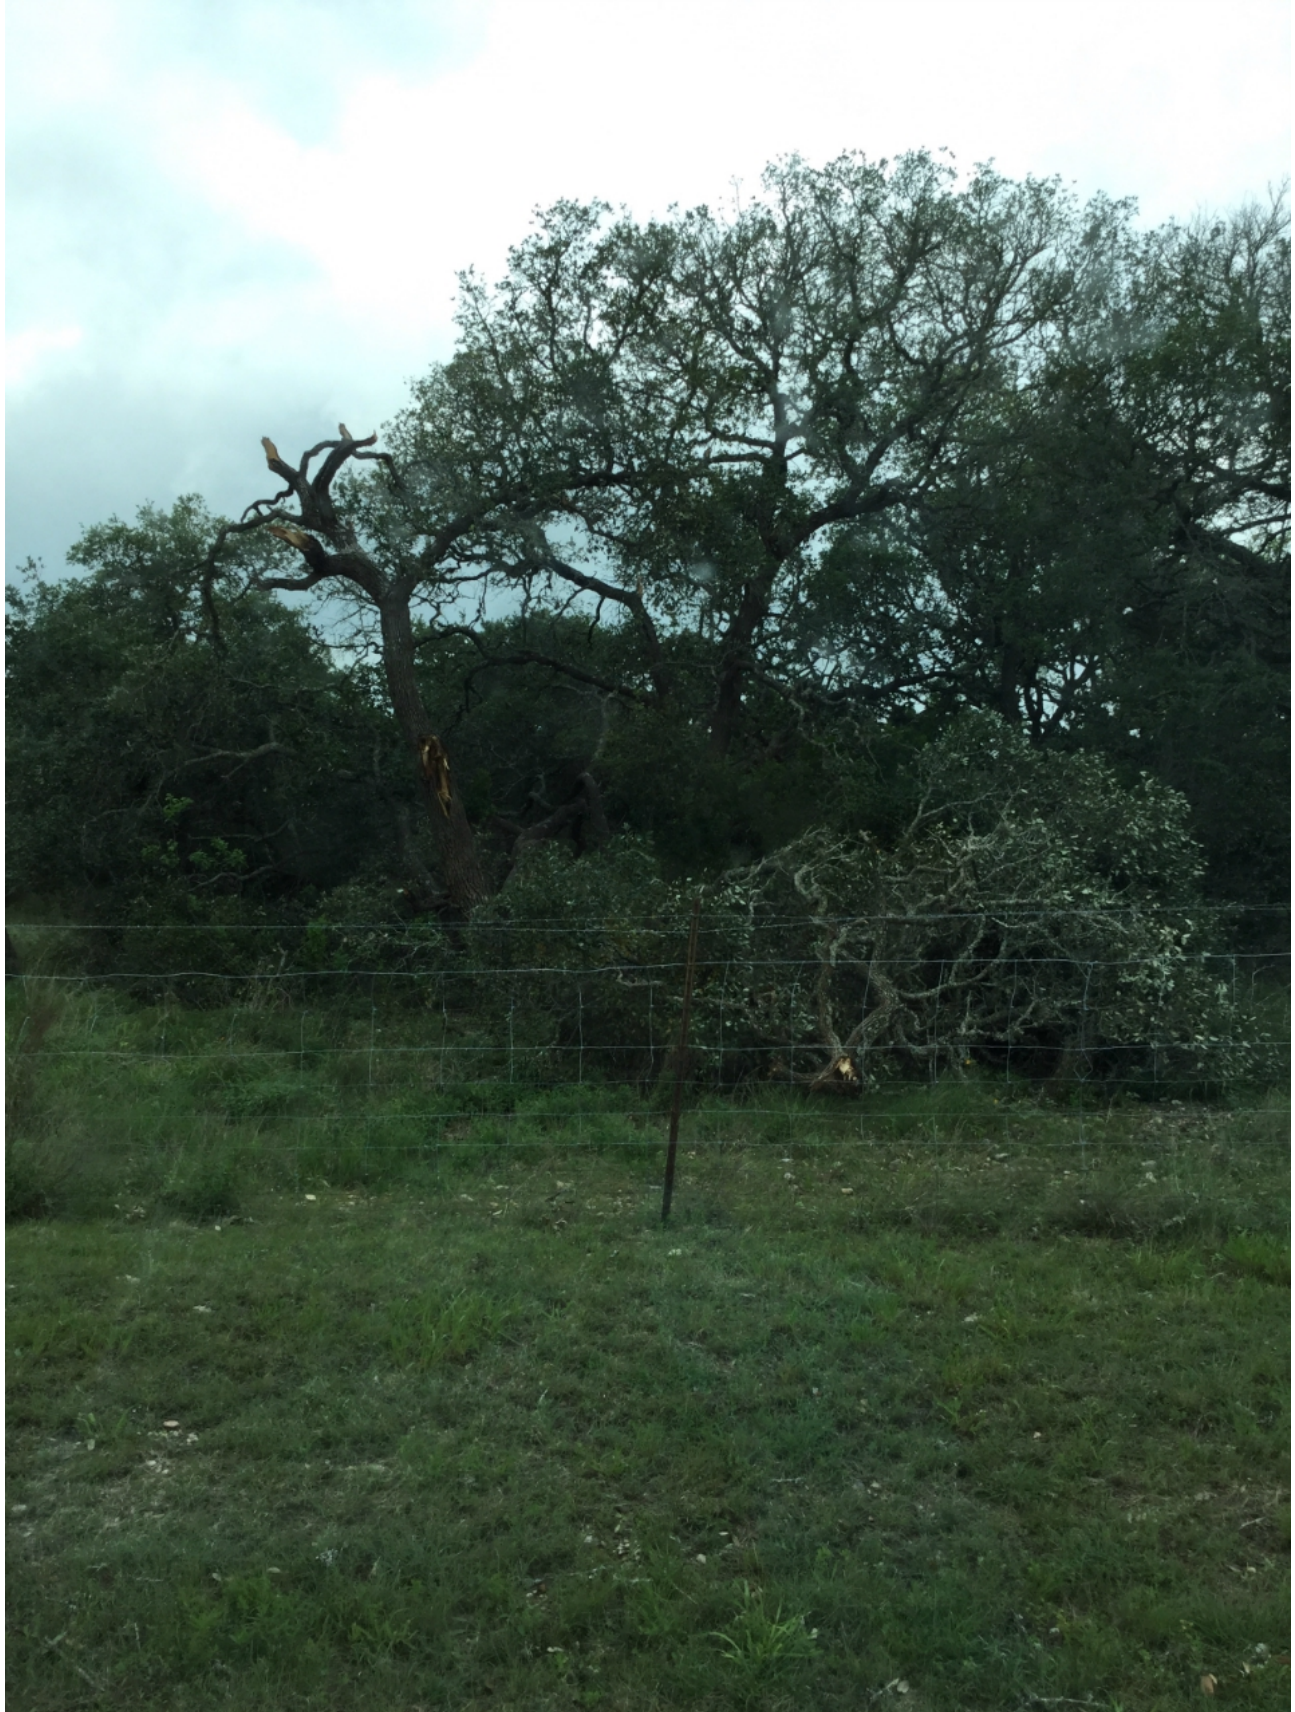
## Dripping Springs Tornado (Hays County)

#	Rating	Max Winds	Time	Start	End	Length	Width	Fatalities	Injuries
1	EF0	85 MPH	2053-2100	30.1269/-98.0909	30.1903/-98.0295	5.8 mi	100 yds	0	0

The NWS Storm Survey found a tornado initially touched down near the intersection of Ranch Road 12 and KC Memory Lane. The tornado traveled to the northeast and crossed FM-150 at Wood Springs. The tornado then crossed E. Creek Drive and lifted before crossing highway 290. The damage was primarily to trees...but about 15 homes suffered minor damage.

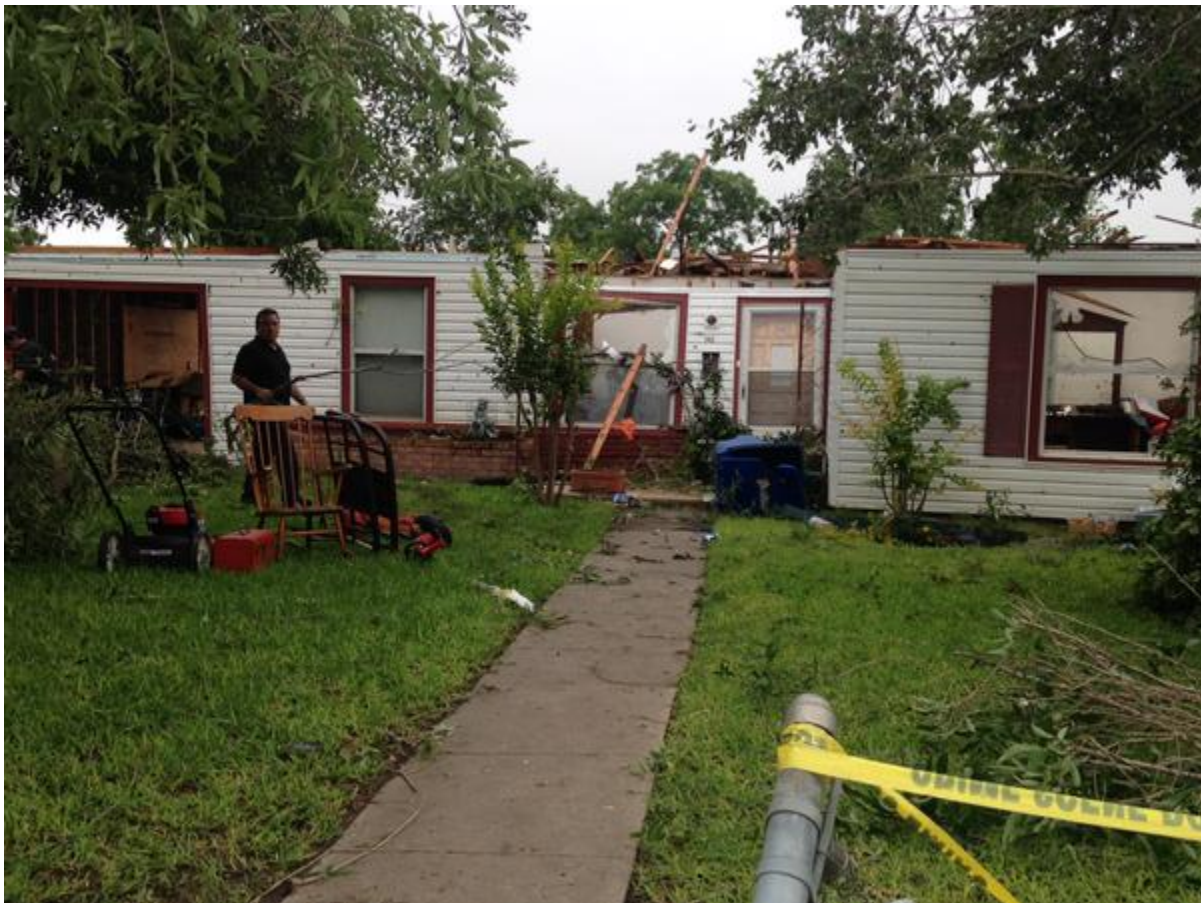
## Balcones Heights Tornado (Bexar County)

#	Rating	Max Winds	Time	Start	End	Length	Width	Fatalities	Injuries
1	EF1	100 MPH	2016-2017	29.4430/-98.5750	29.4434/-98.5750	0.4 mi	150 yds	0	0

The NWS Survey Team concluded a tornado touched down near the intersection of Maria Elena Avenue and NW 38th Street. The tornado traveled a couple of blocks before lifting near NW 36th Street. Damage was primarily to trees, but one house on Woley Drive did suffer major roof damage and several nearby houses suffered minor damage mainly to roofs and vehicles. Another home on Woley Drive was reported to have had a carport roof removed and displaced two blocks to the north onto the same street near Culebra Road.
