# Austin/San Antonio Weather Forecast Office WEATHER EVENT SUMMARY

## 2015 Memorial Day Weekend Tornadoes

23 – 25 May 2015

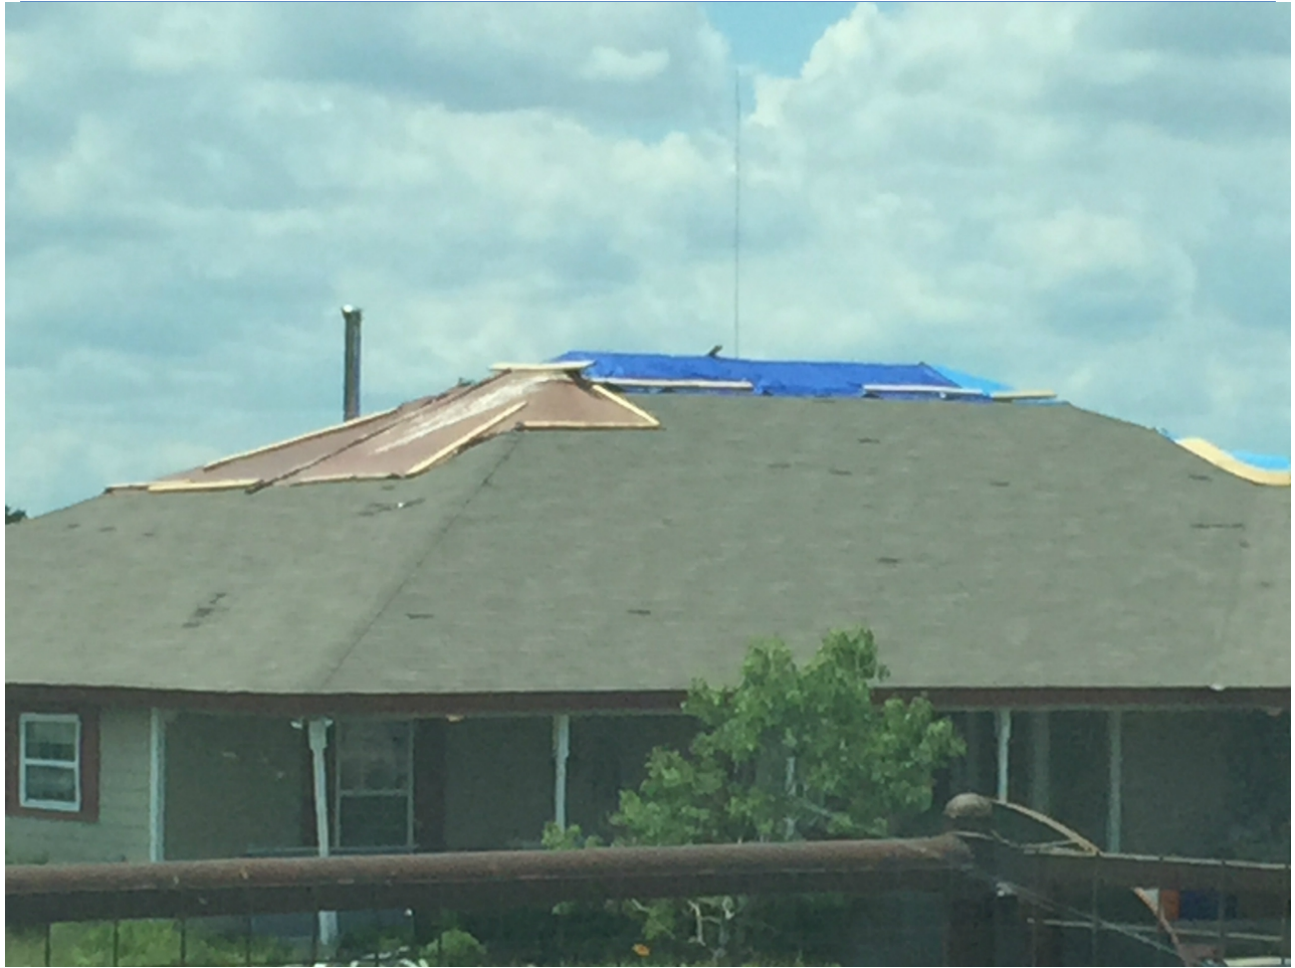
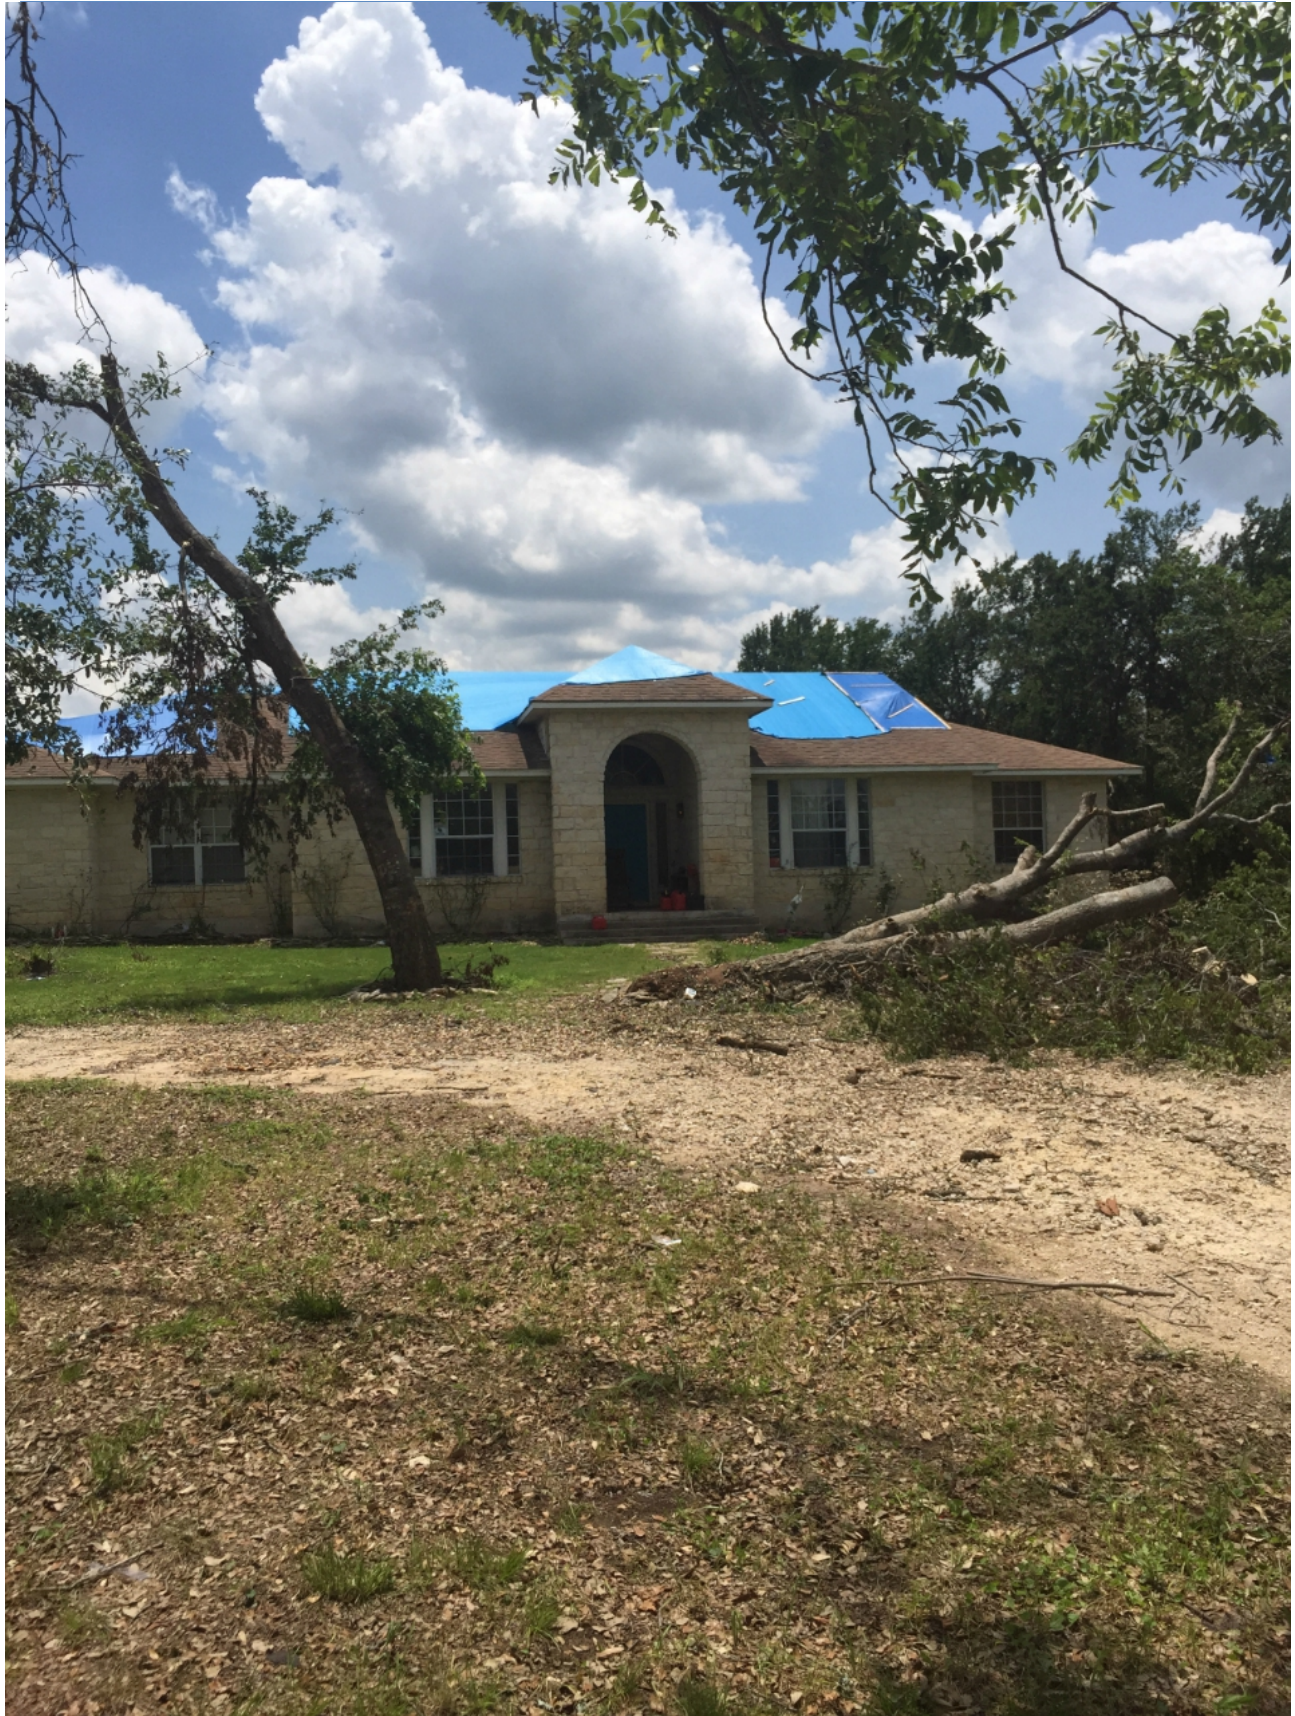
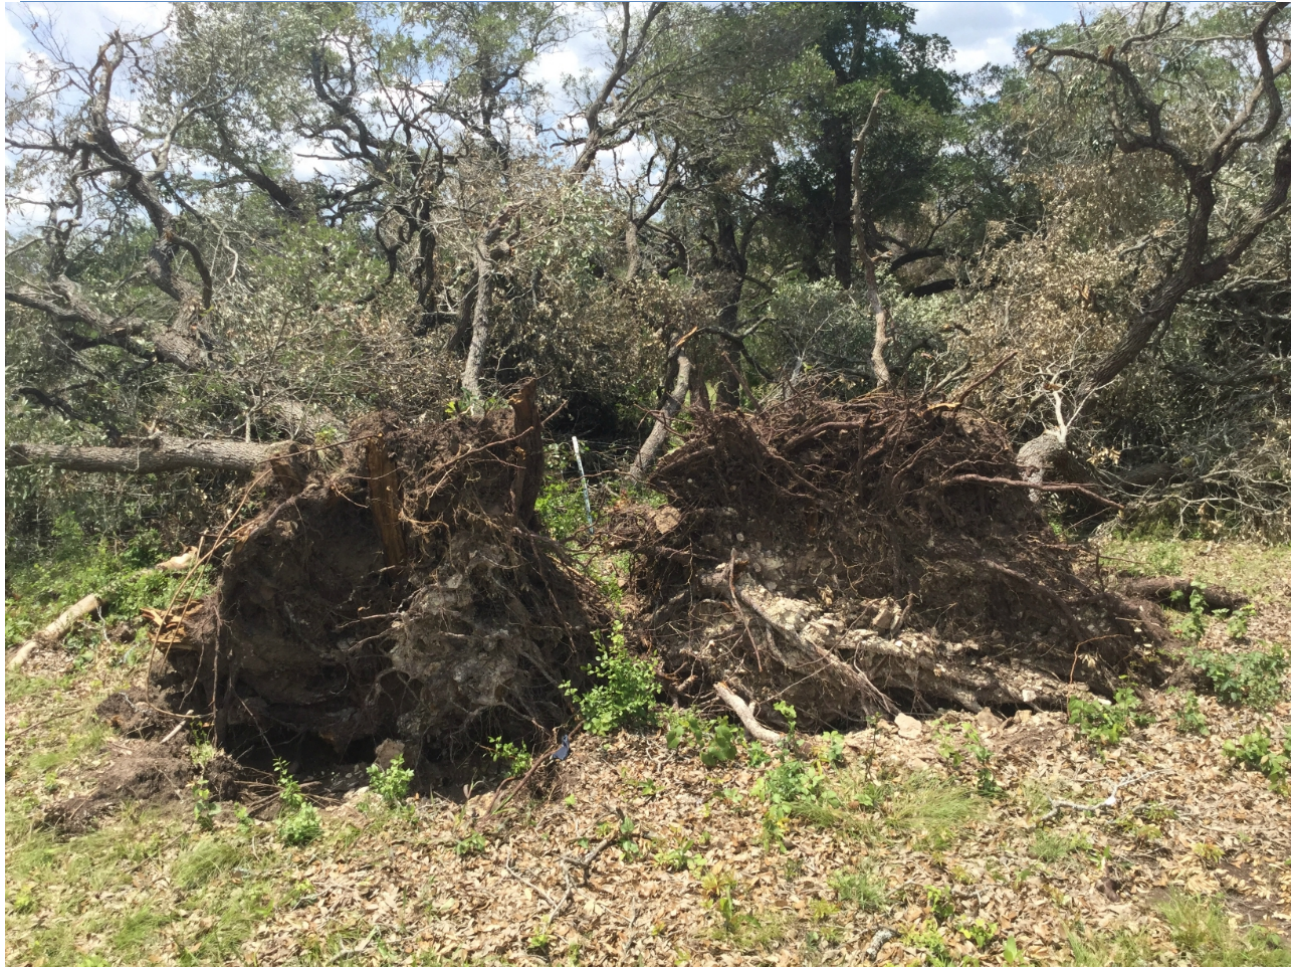
## Liberty Hill Tornado (Williamson County)

#	Rating	Max Winds	Time	Start	End	Length	Width	Fatalities	Injuries
1	EF1	100 MPH	2122-2134	30.6909/-97.9411	30.7338/-97.9272	3.1 mi	200 yds	0	0

The NWS Survey Team found an EF1 tornado initially touched down near County Road 201 just west of County Road 200. The tornado traveled to the north-northeast through the Indian Oaks and Carriage Oaks subdivisions before crossing County Road 200 and lifting near East Bear Creek Road. Damage was primarily to large oak trees, but about 7 to 10 homes suffered damage mainly to roofs. The most substantial damage was a complete loss of a chimney. Also, a barn lost part of its roof.

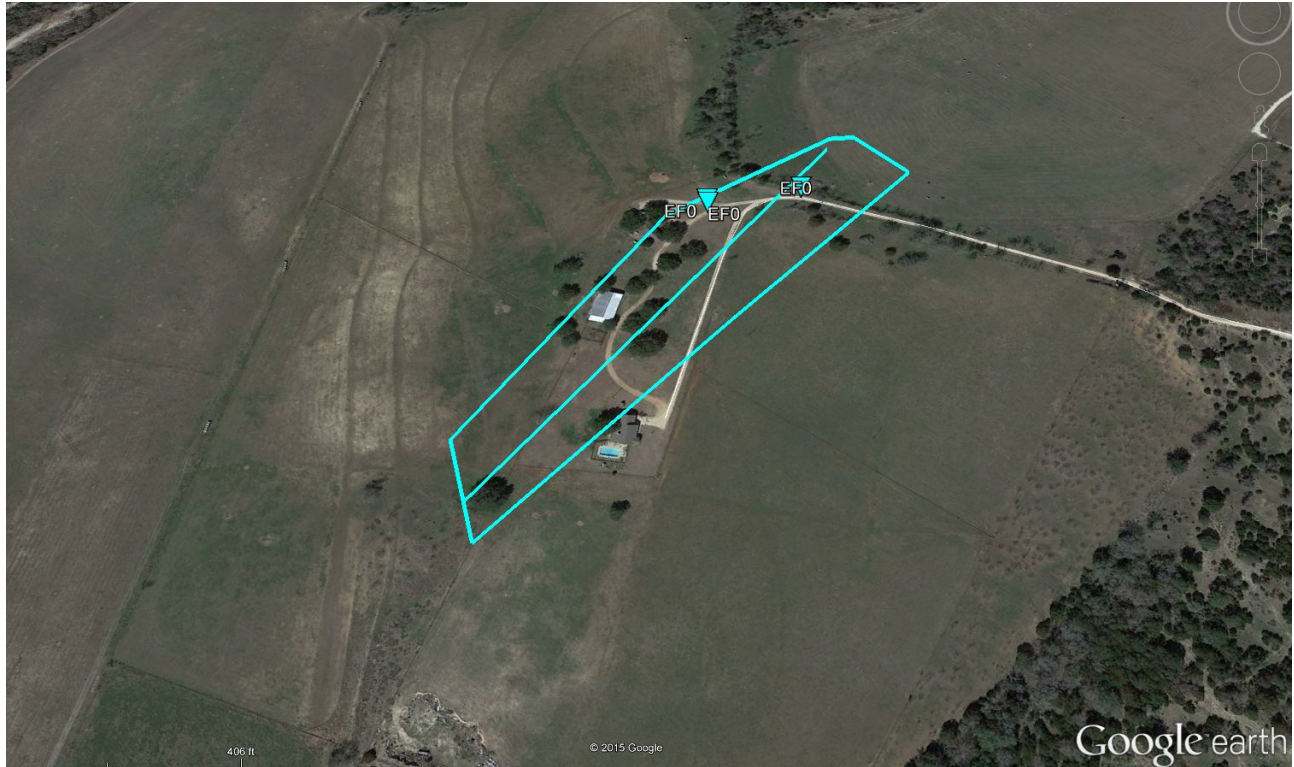
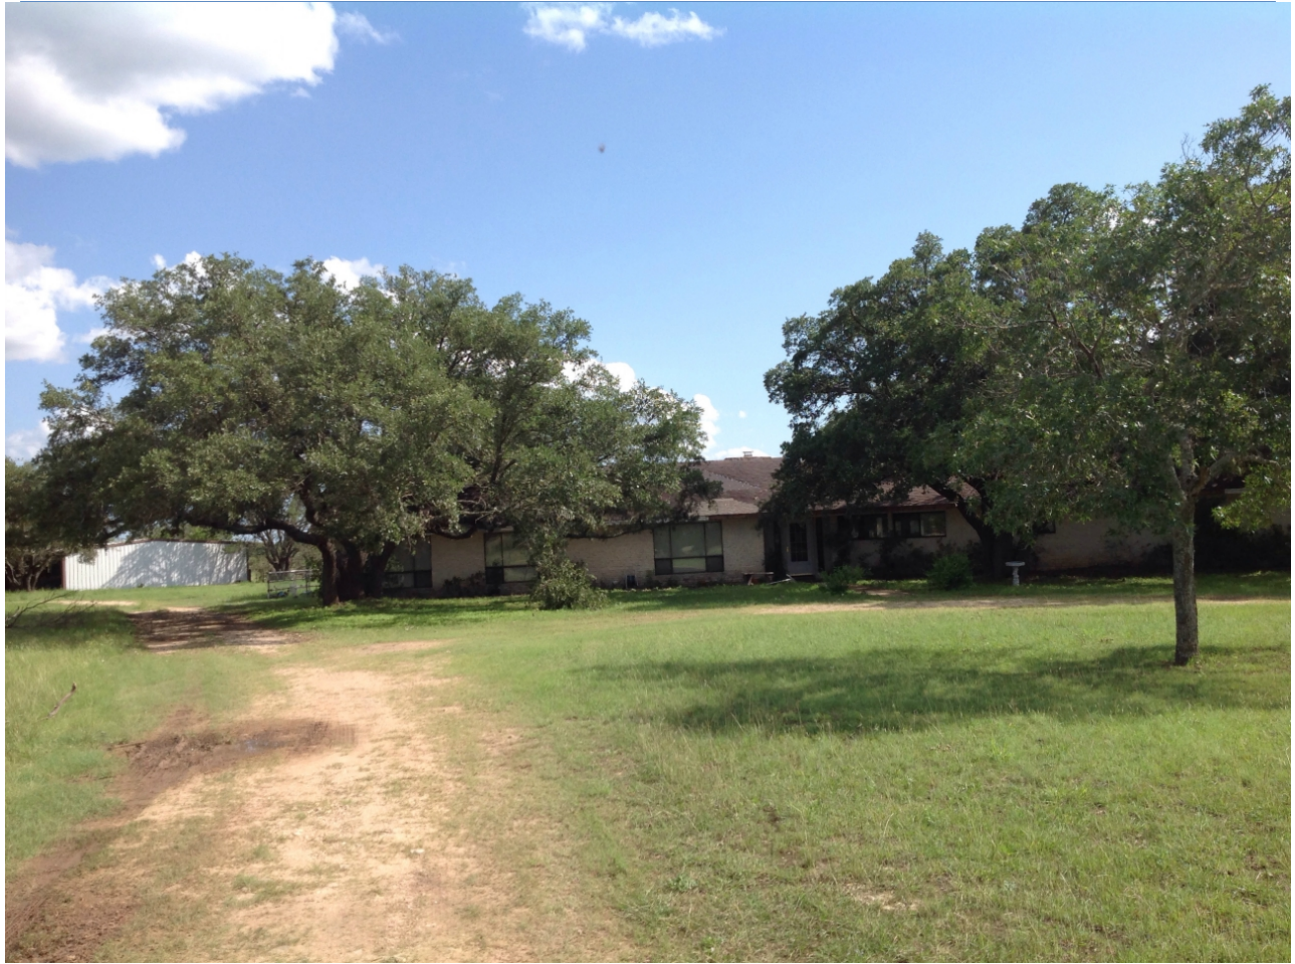
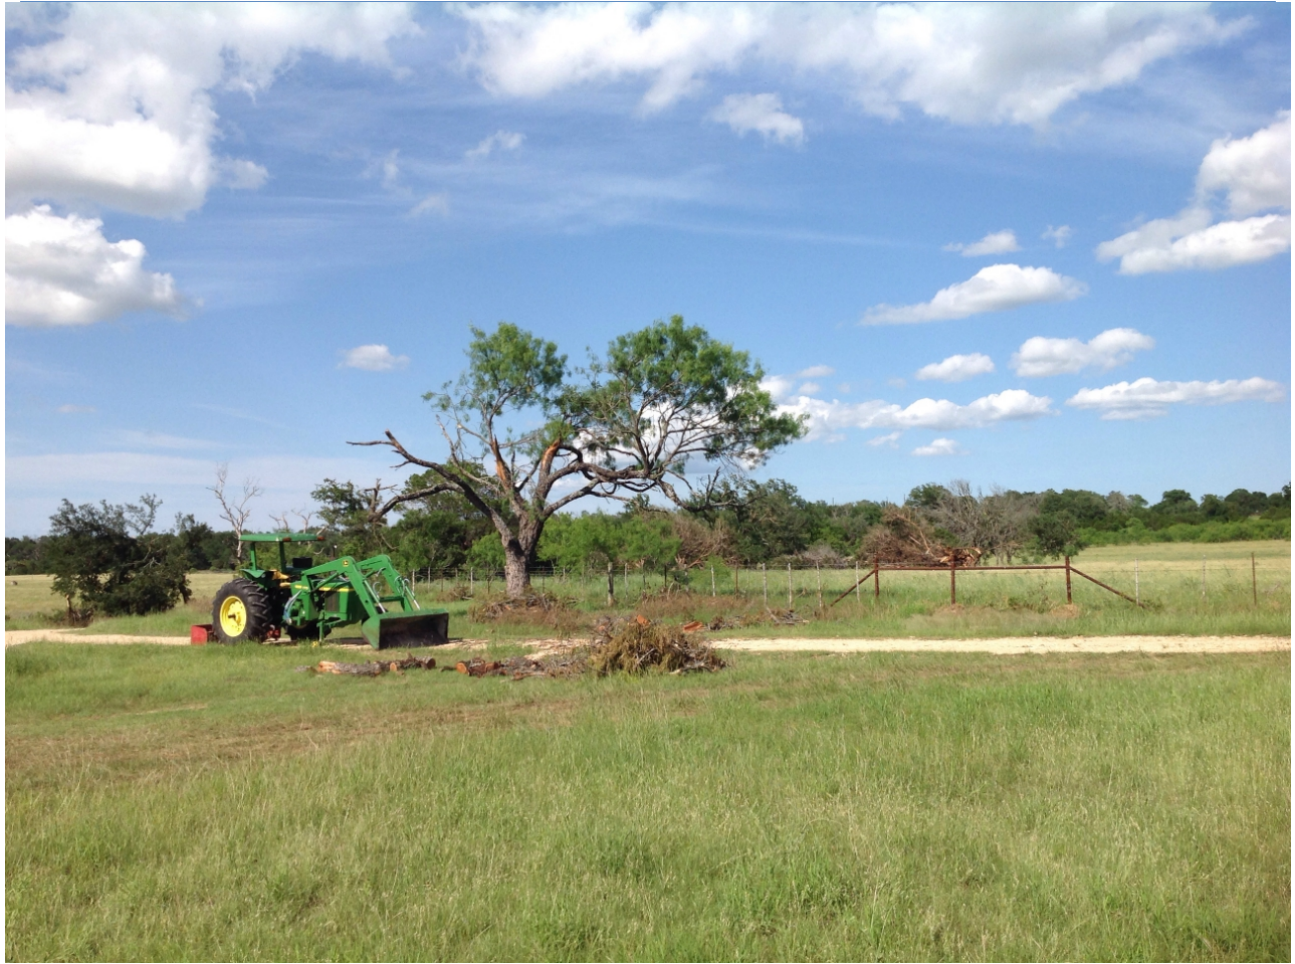
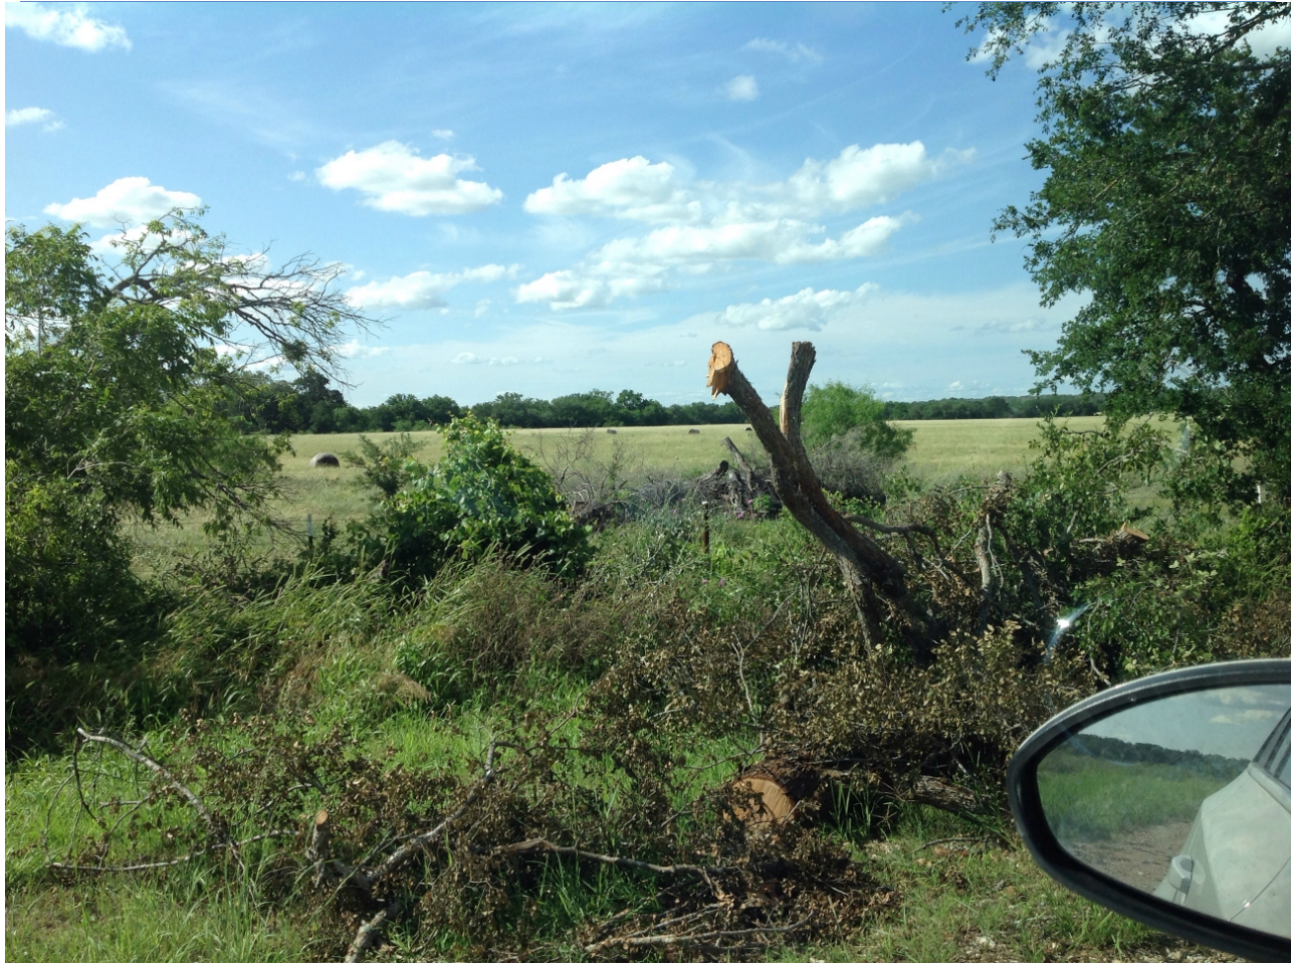
## Brizendine Road (Williamson County)

#	Rating	Max Winds	Time	Start	End	Length	Width	Fatalities	Injuries
1	EF0	85 MPH	2147-2147	30.7665/-97.9250	30.7702/-97.9255	0.25 mi	50 yds	0	0

The NWS Damage Survey Team concluded that a weak and brief EF0 tornado touched down near the end of Brizendine Road in far northwest Williamson County. Minor roof damage was observed along with tree damage.

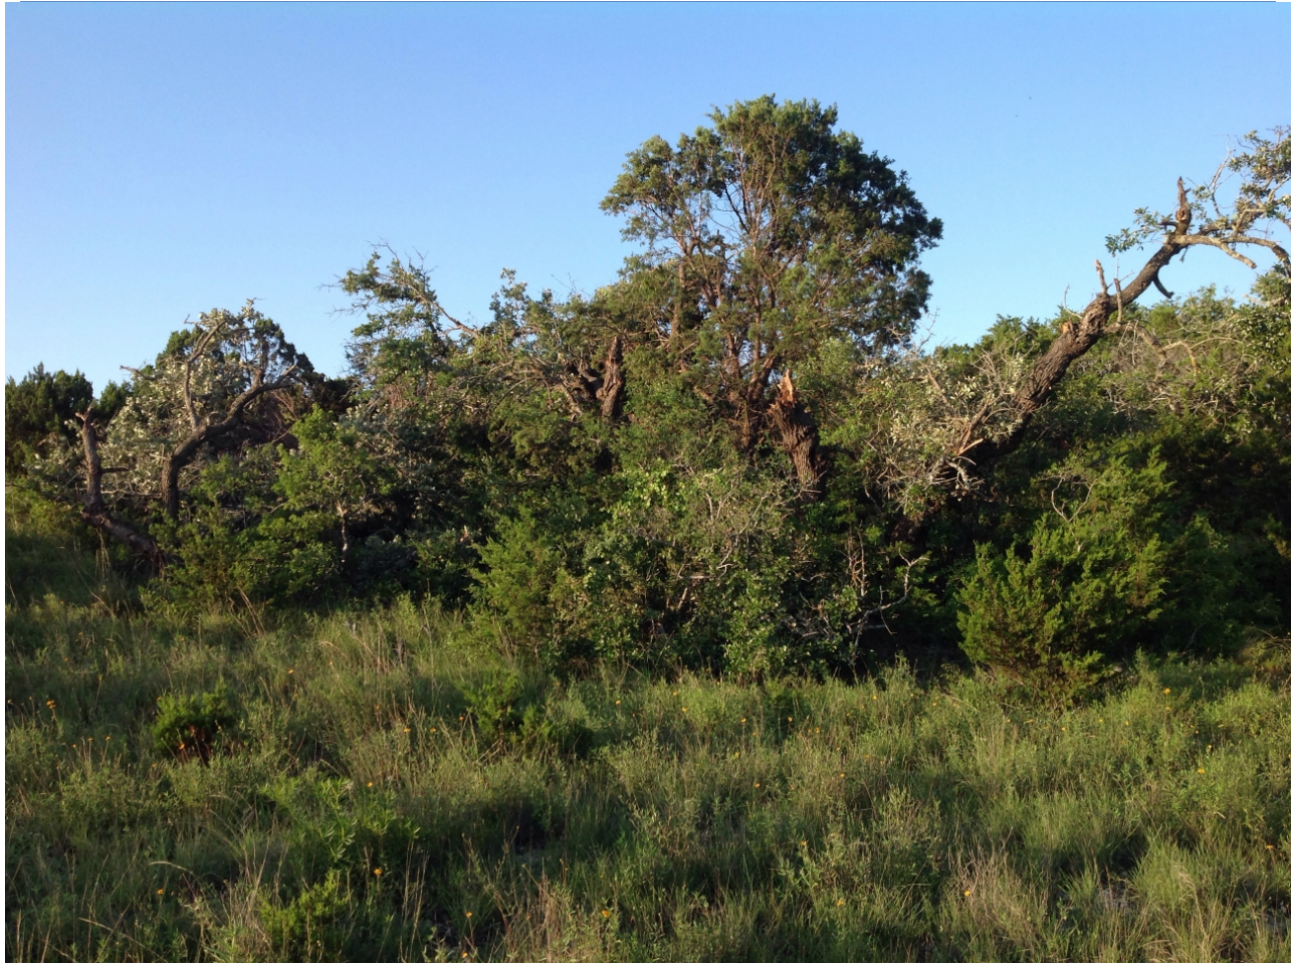
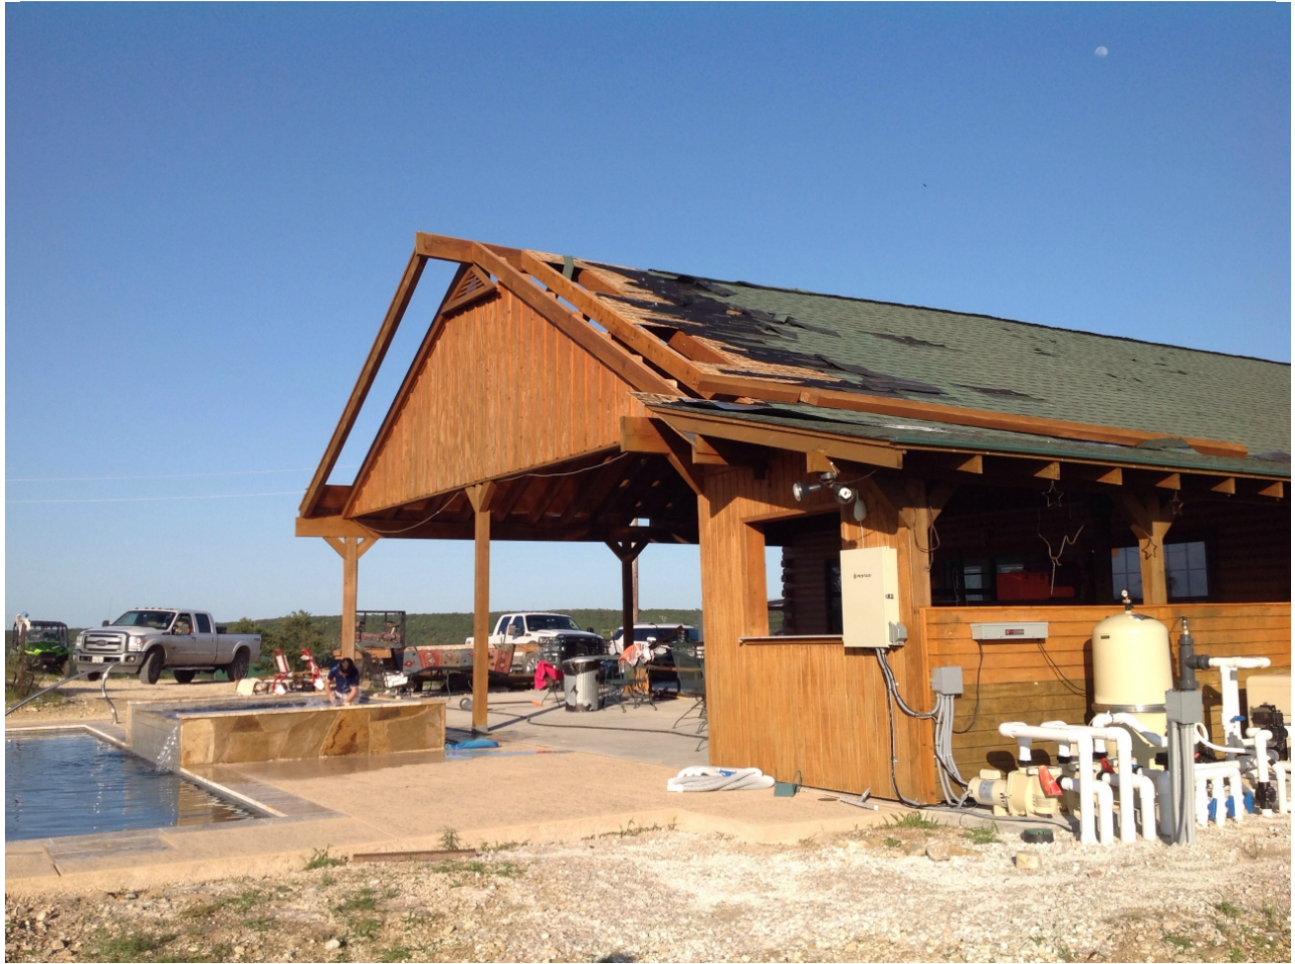
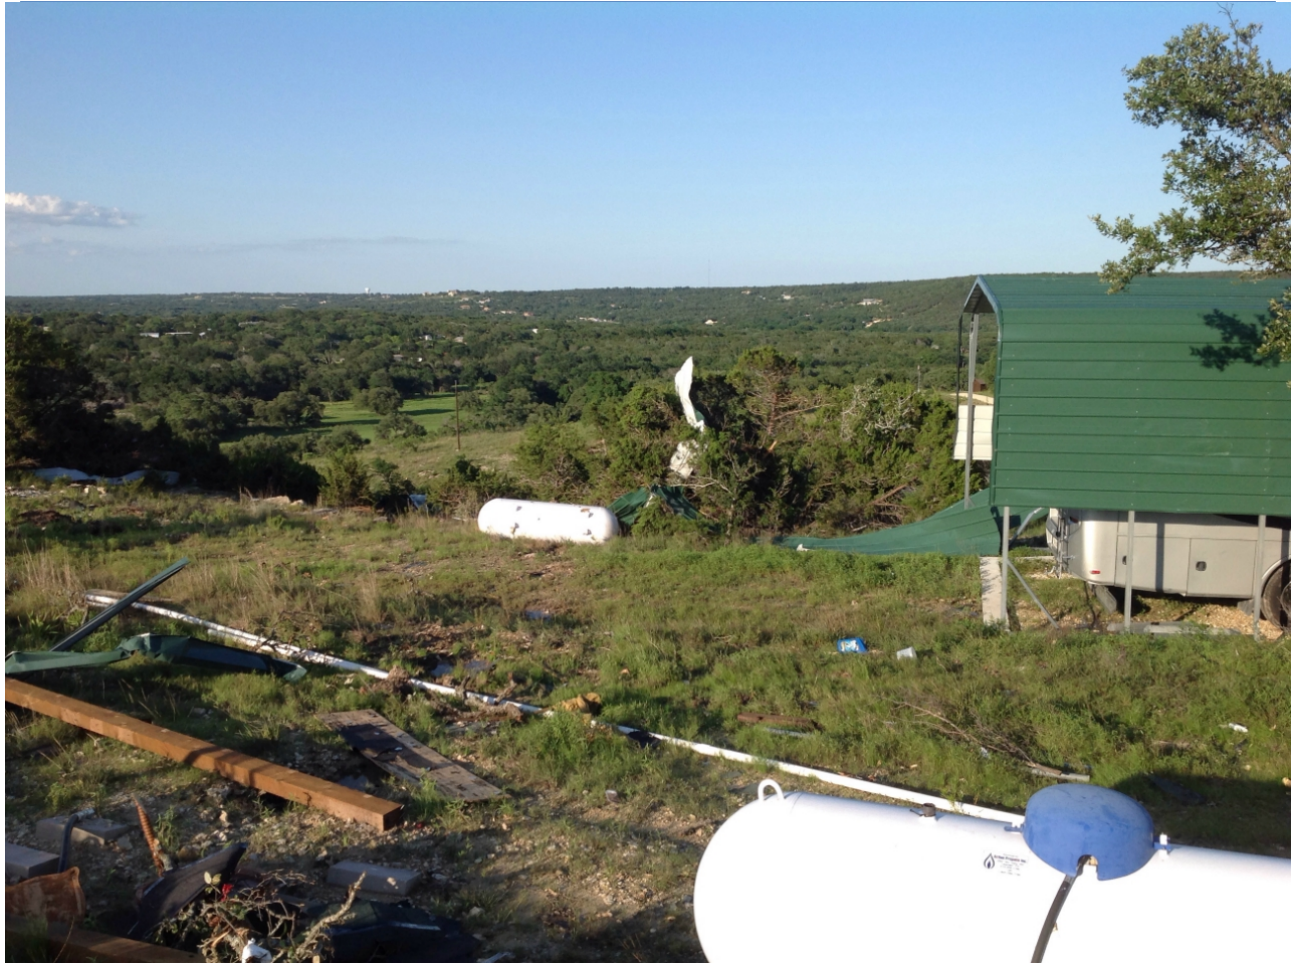
## Sunset Ranch/Nameless Road Tornado (Travis County)

#	Rating	Max Winds	Time	Start	End	Length	Width	Fatalities	Injuries
1	EF1	105 MPH	2058-2100	30.5465/-97.9708	30.5637/-97.9624	1.3 mi	200 yds	0	0

The NWS Damage Survey Team confirmed an EF1 tornado touched down on the Sunset Ranch in northwest Travis County. The tornado produced tree damage across the ranch and hit a residence which sustained roof damage along with damage to exterior of the residence as the front and back porches were destroyed. The tornado appears to have dissipated shortly after hitting the residence.

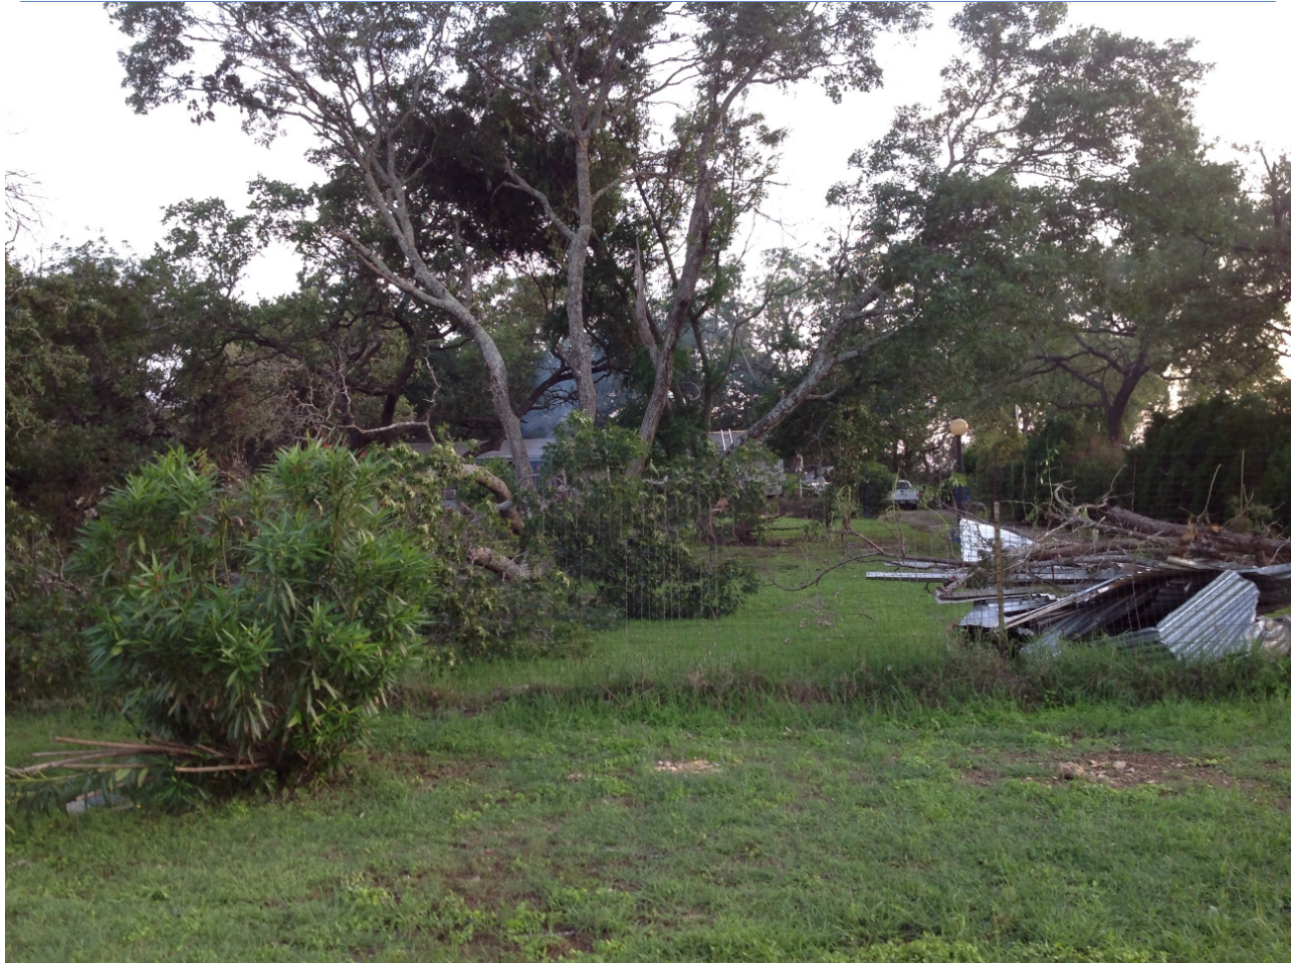
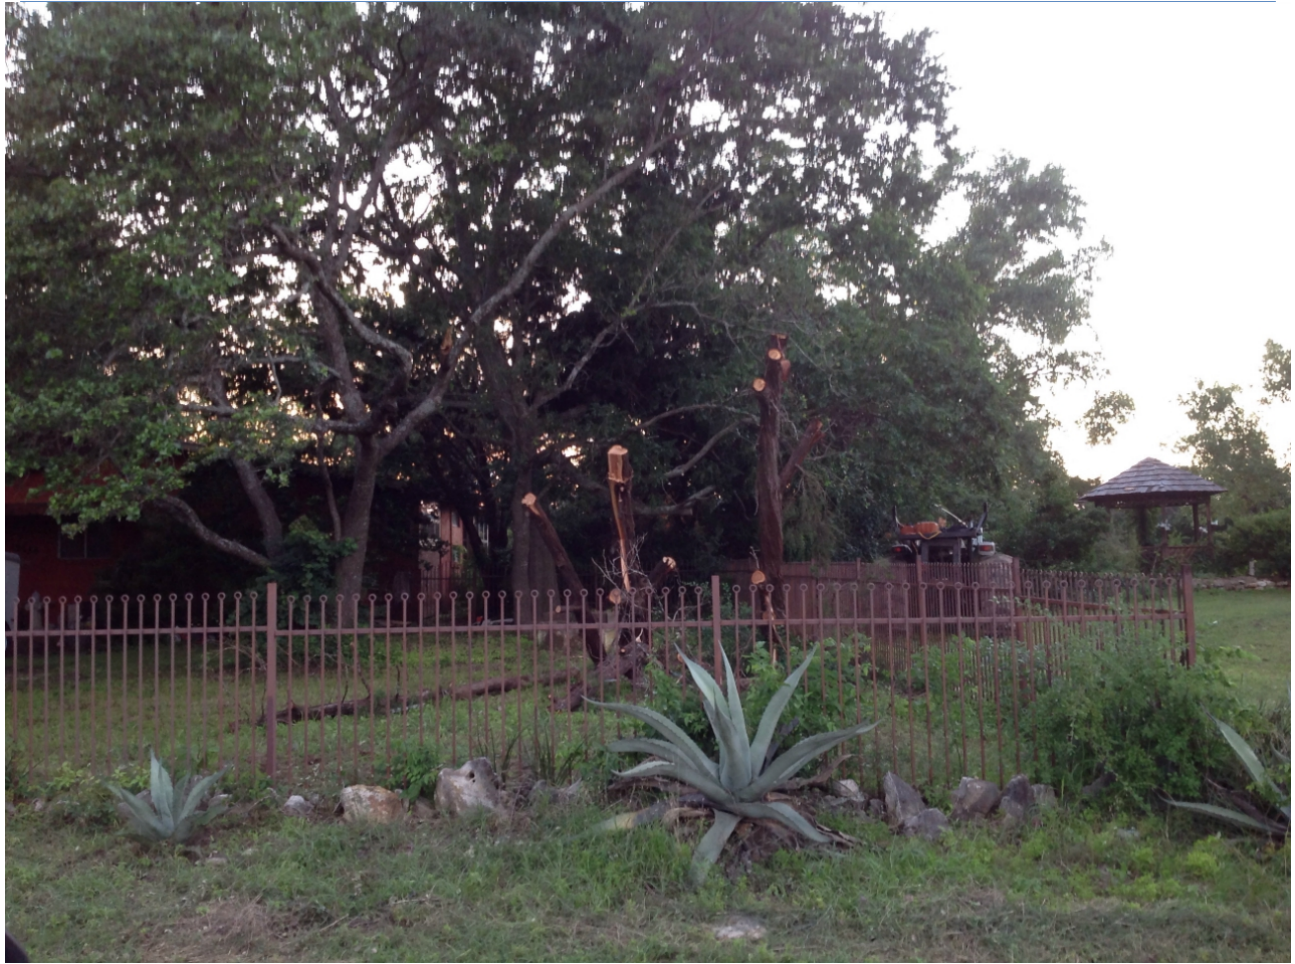
## Indian Springs [FM 1431] Tornado (Travis County)

#	Rating	Max Winds	Time	Start	End	Length	Width	Fatalities	Injuries
1	EF0	85 MPH	2137-2138	30.5155/-97.8883	30.5241/-97.8716	1.2 mi	125 yds	0	0

The NWS Survey Team found evidence of a weak EF0 tornado that initially touched down near FM 1431 and produced damage at a school. The tornado traveled northeast and caused considerable tree damage in the Indian Hills subdivision before dissipating right near the Williamson County line. Other wind damage was observed near New Hope Drive but could not conclusively be associated with this tornado path.

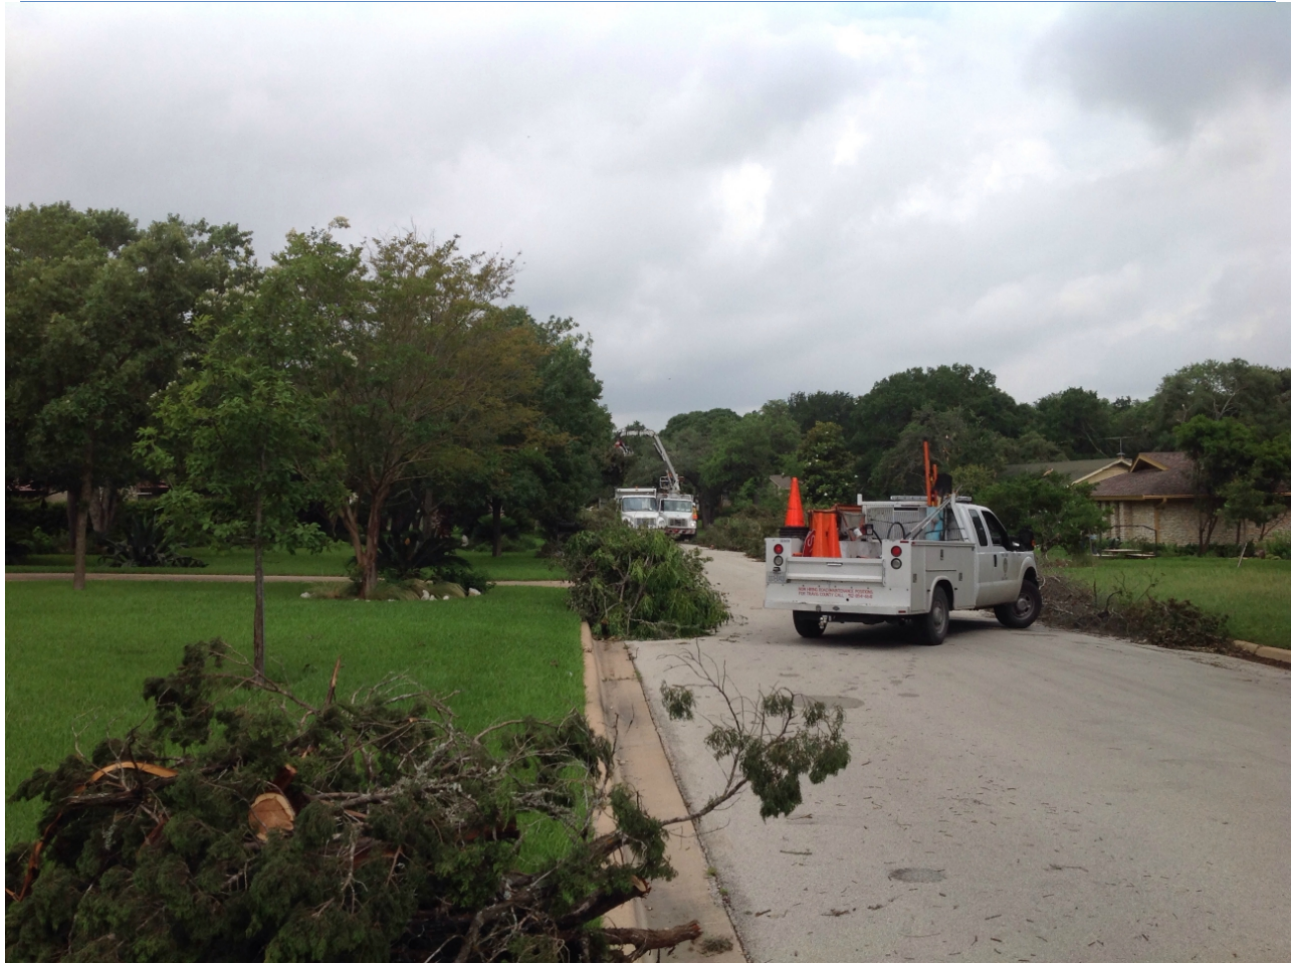
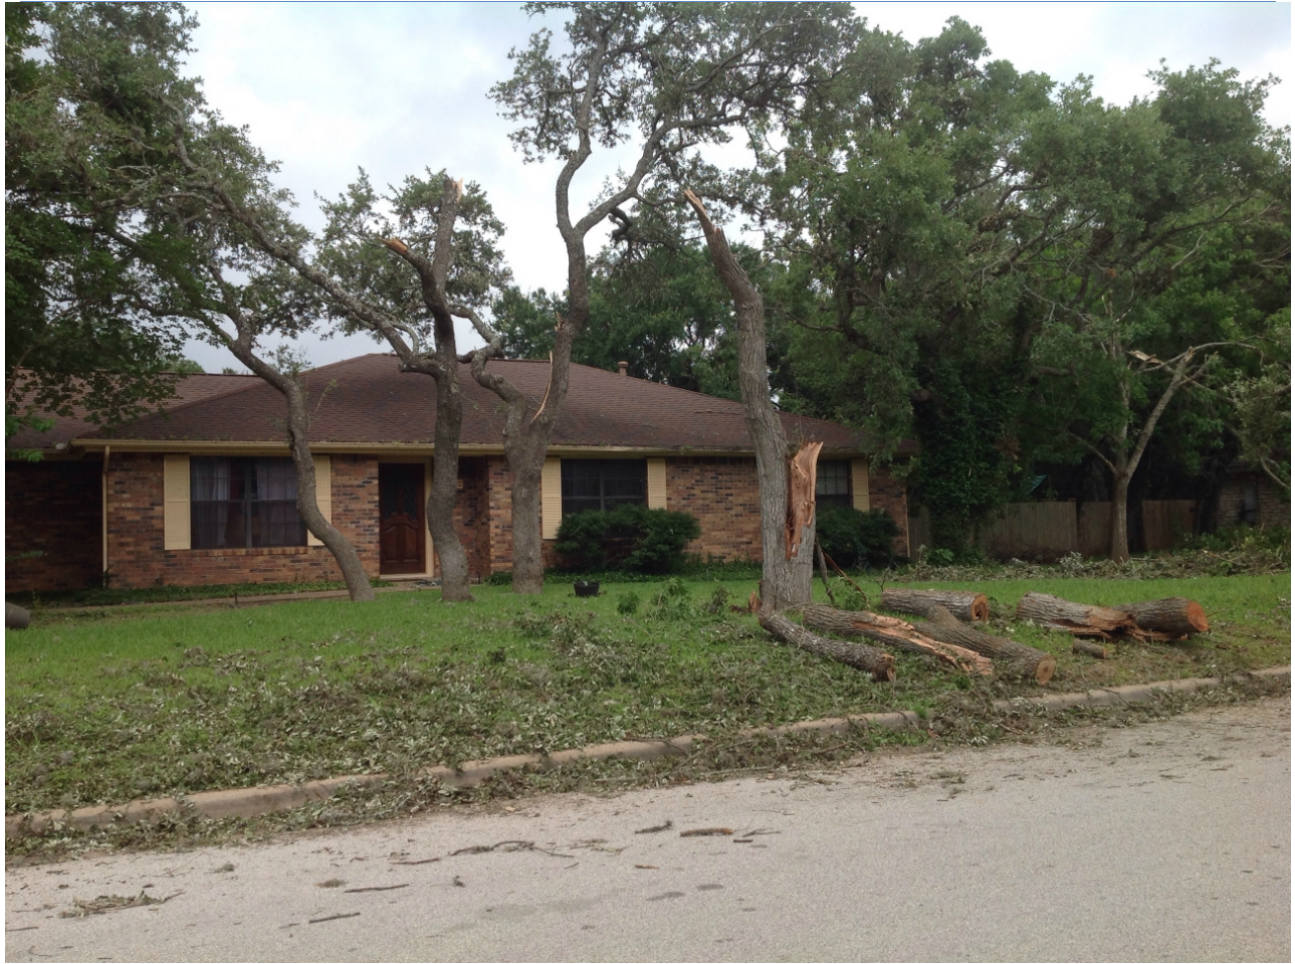
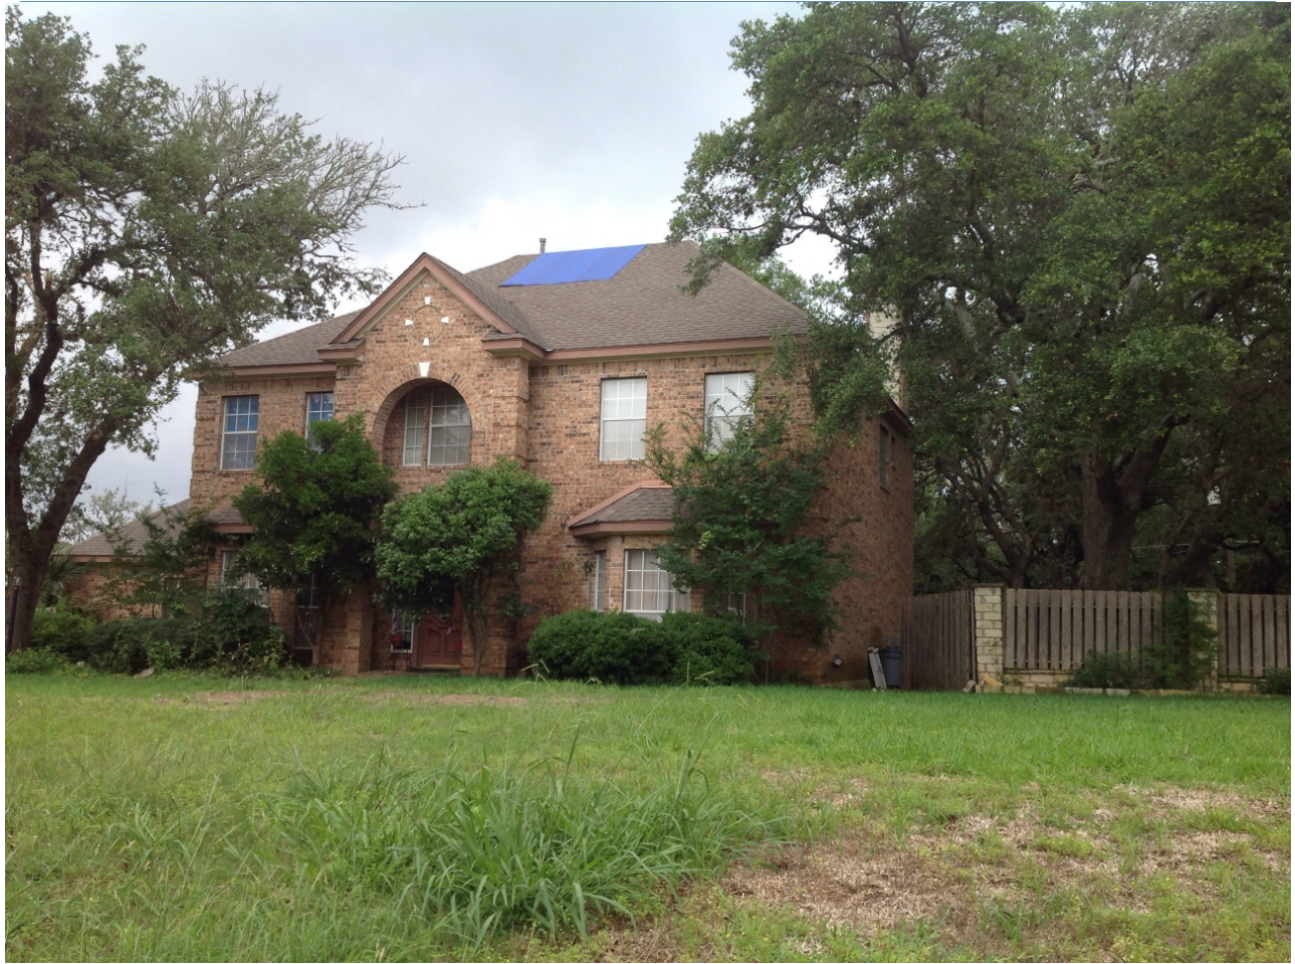
## Shady Hollow Tornado (Travis County)

#	Rating	Max Winds	Time	Start	End	Length	Width	Fatalities	Injuries
1	EF0	85 MPH	2111-2113	30.1533/-97.8694	30.1824/-97.8443	2.5 mi	200 yds	0	0

The NWS Storm Survey Team found evidence that an EF0 tornado went through the Shady Hollow area off Brodie Lane in South Austin. Numerous streets had significant tree damage along with some minor roof damage to some homes. The tornado moved northeast and appears to have dissipated near West Slaughter Lane. Wind damage was reported further northeast into the city of Austin but this damage could not conclusively be associated with this tornado path.

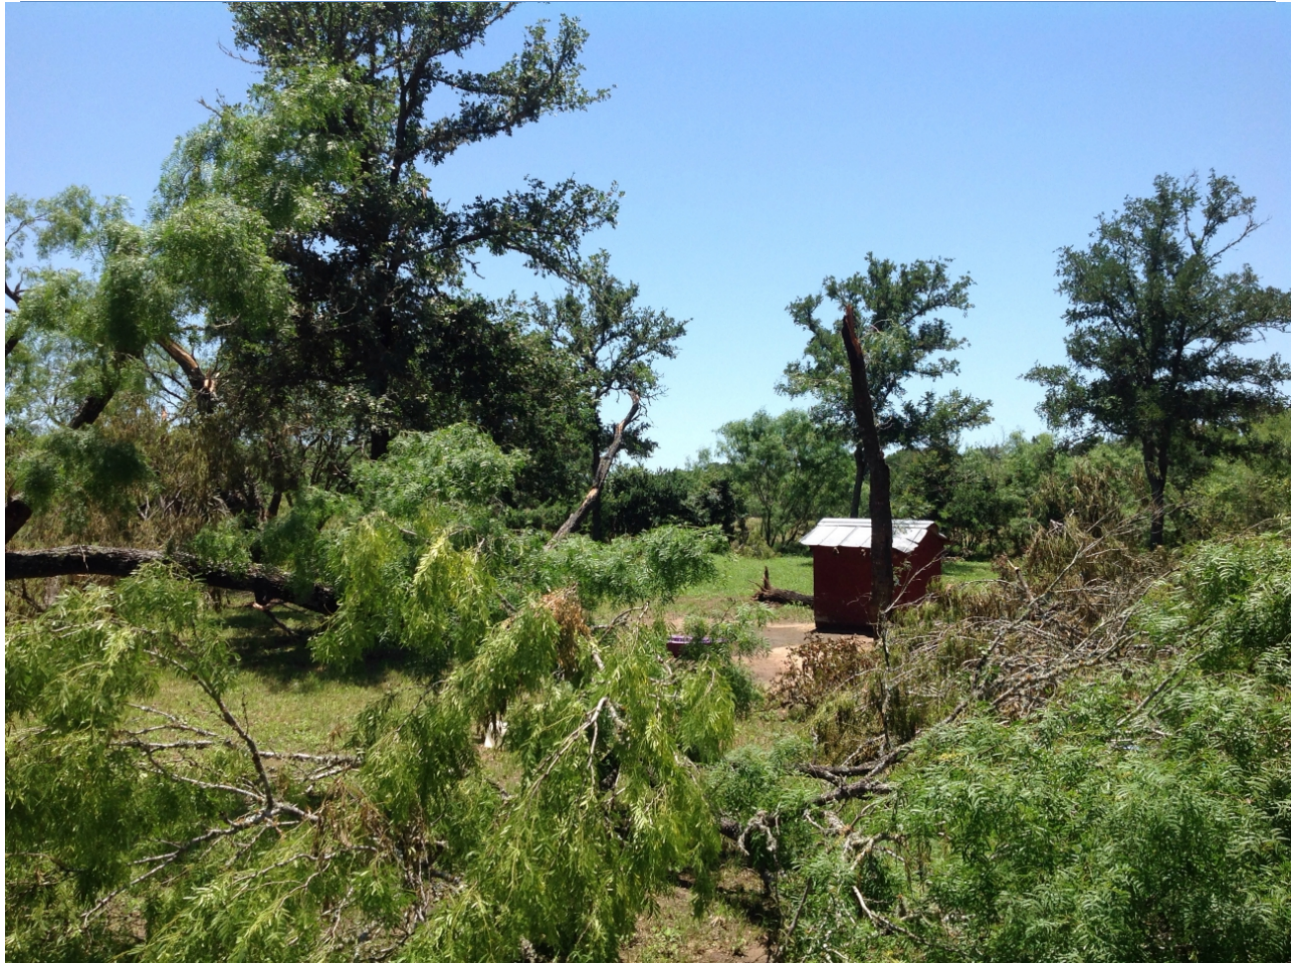
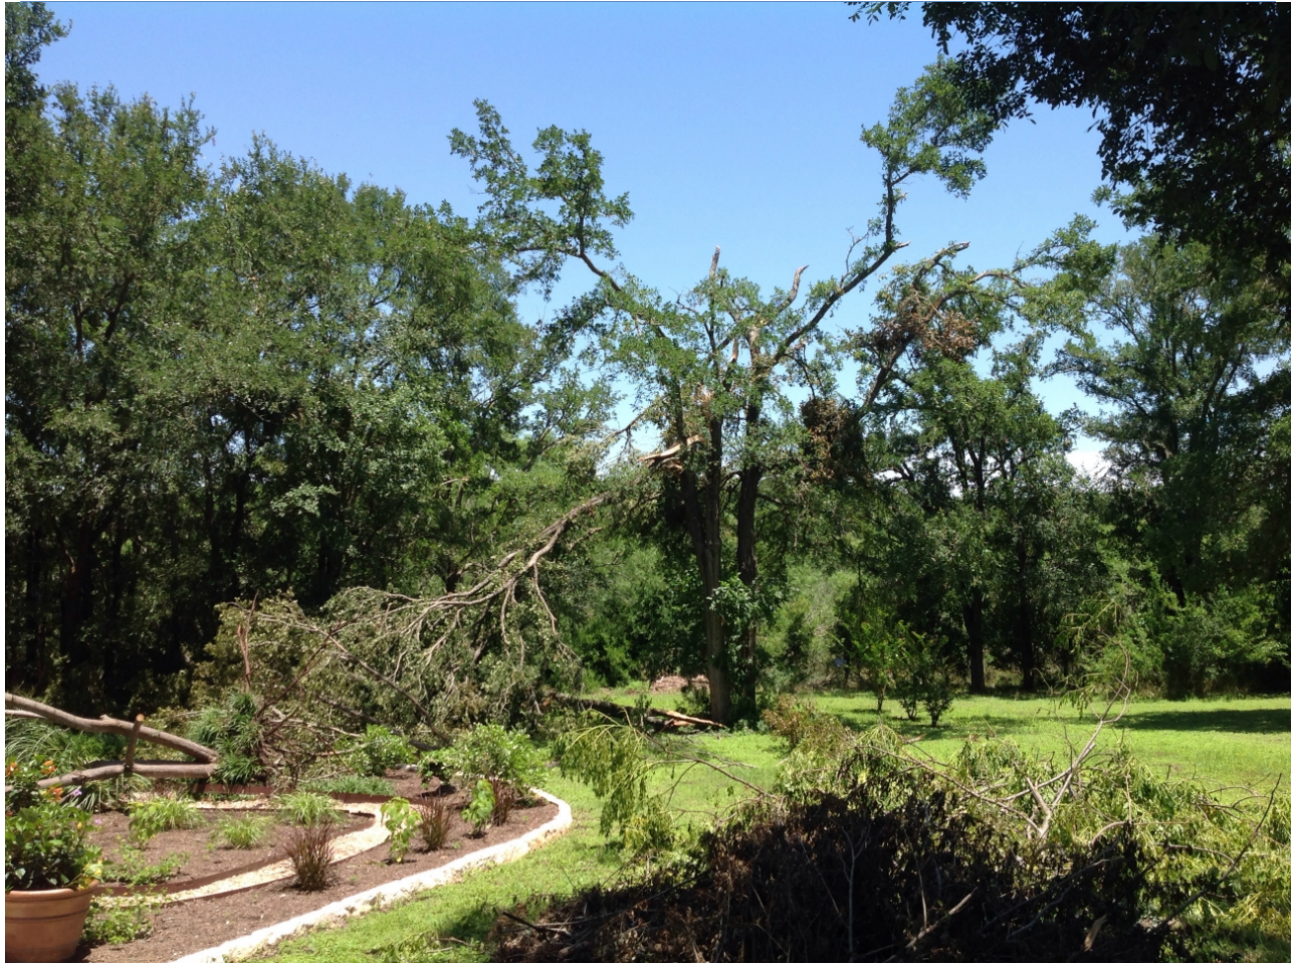
## River Crossing Tornado (Bastrop County)

#	Rating	Max Winds	Time	Start	End	Length	Width	Fatalities	Injuries
1	EF1	95 MPH	2143-2144	30.1692/-97.4940	30.1734/-97.4813	0.8 mi	200 yds	0	0

The NWS Survey Team concluded an EF1 tornado touched down around Frio Court in the River Crossing subdivision producing tree and roof damage at a residence. The tornado moved east-northeast and crossed several streets in the subdivision. Several trees were uprooted and large oak trees suffered substantial damage.
