# Austin/San Antonio Weather Forecast Office WEATHER EVENT SUMMARY

## 2015 Memorial Day Weekend Tornadoes

23 – 25 May 2015

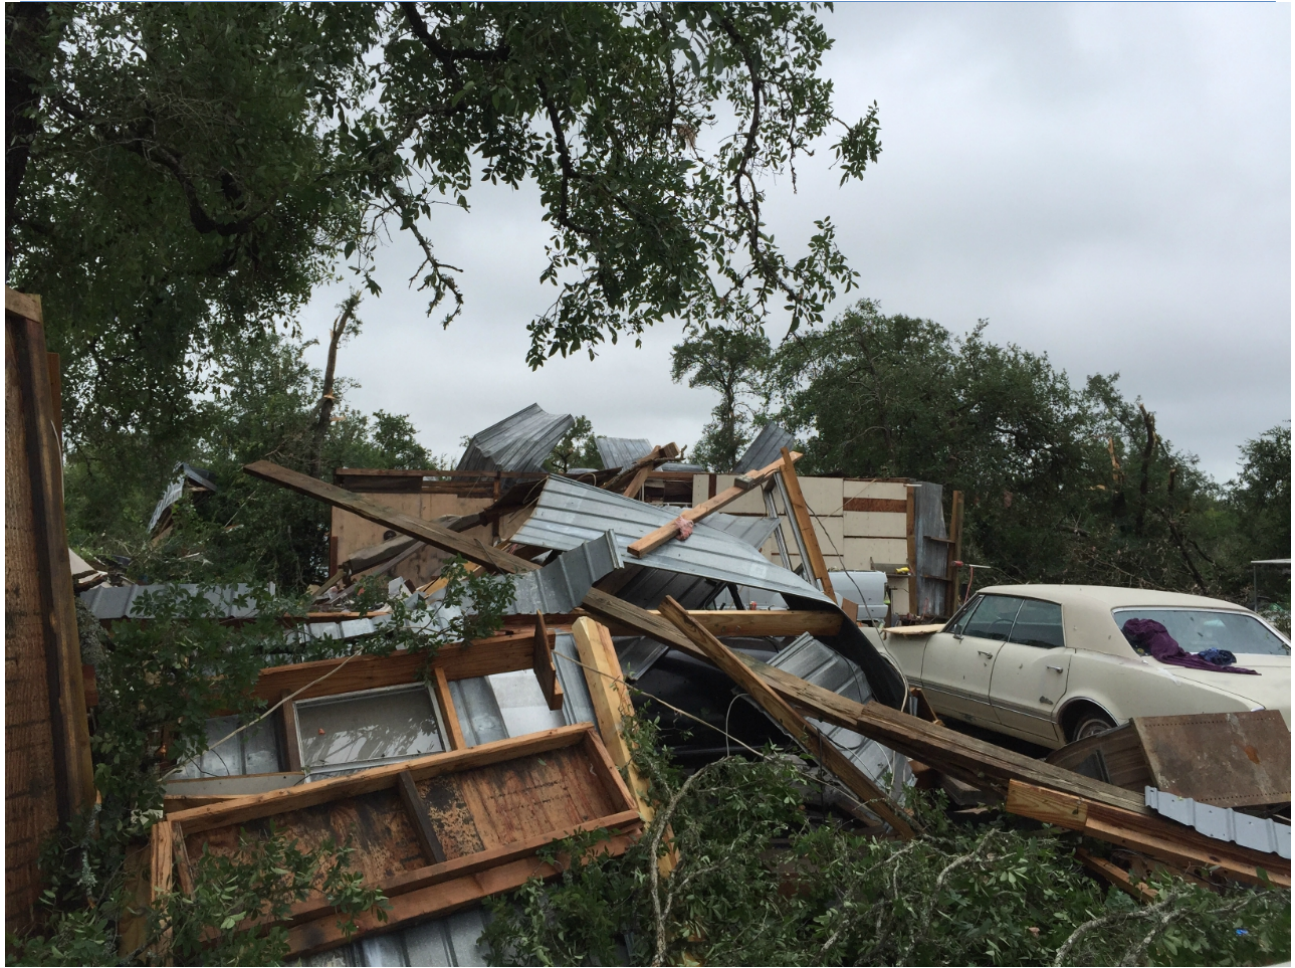
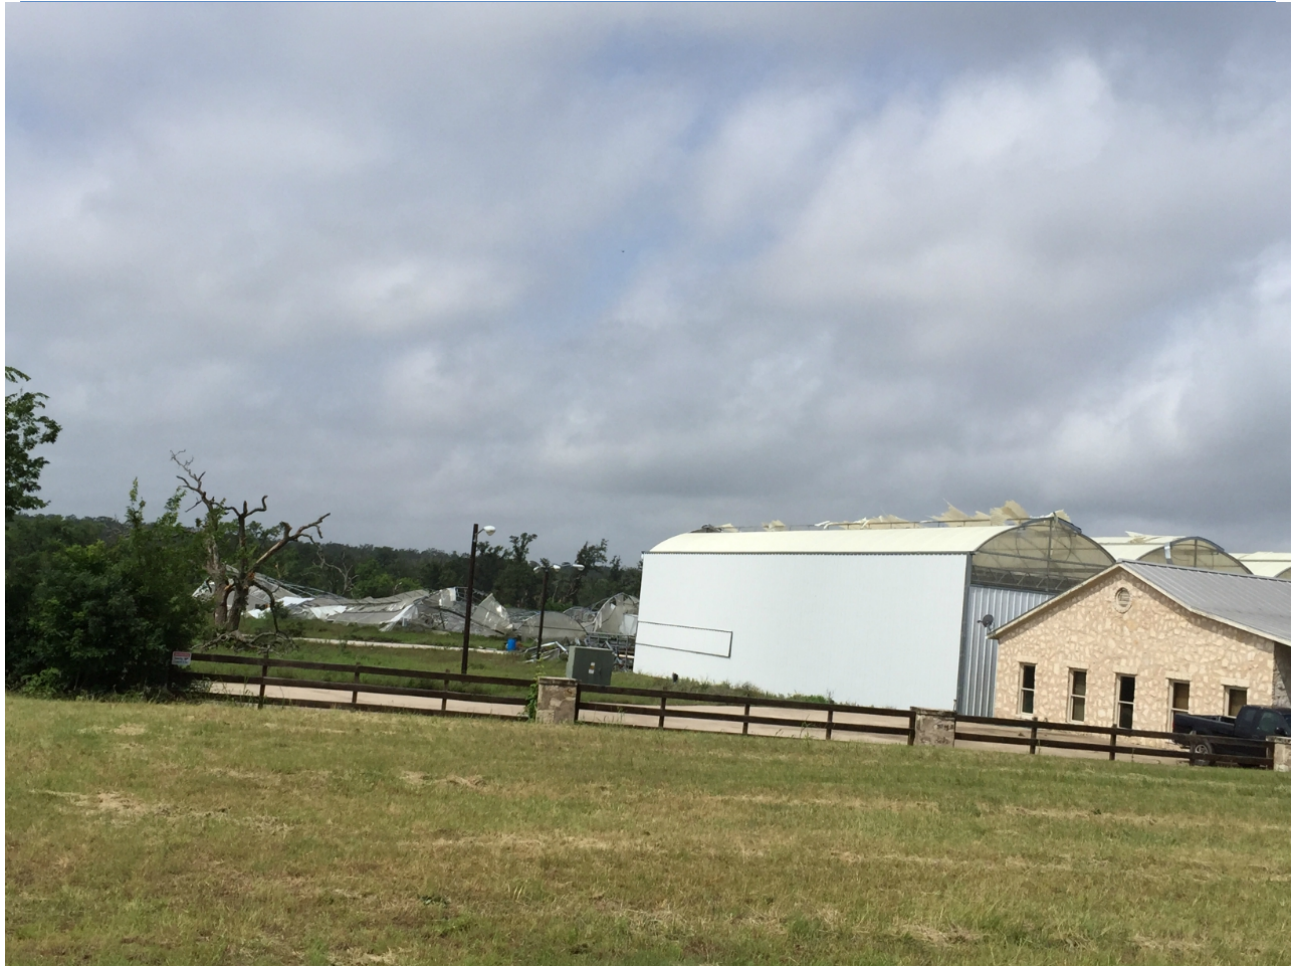
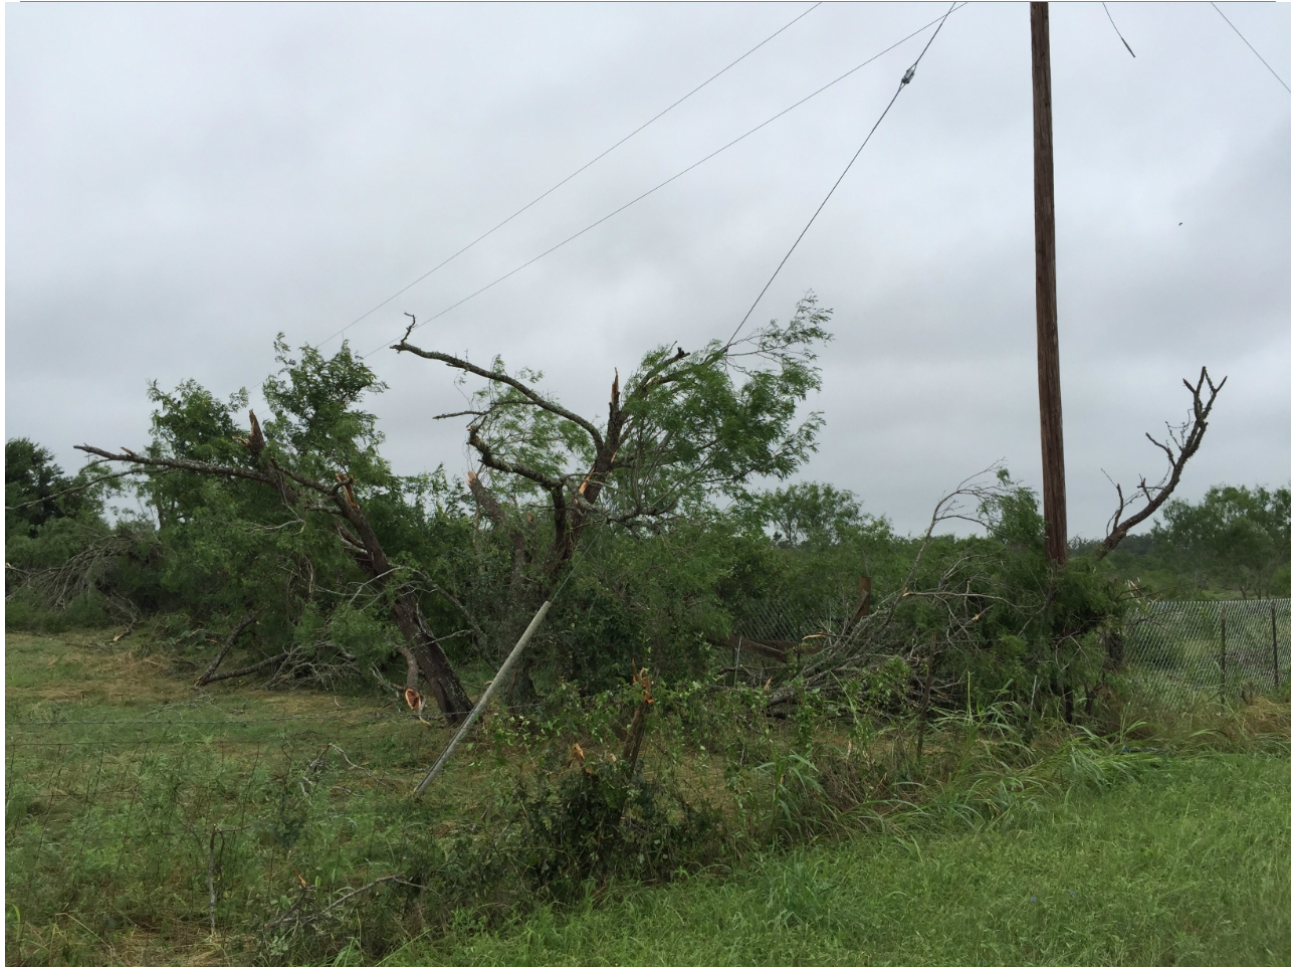
**Cedar Creek Tornado (Bastrop County)**

#	Rating	Max Winds	Time	Start	End	Length	Width	Fatalities	Injuries
1	EF1	105 MPH	1624-1633	30.0850/-97.5420	30.1230/-97.5160	3.0 mi	0.25 mi	0	1

The NWS Storm Survey Team concluded a tornado touched down just west of Cedar Creek in Bastrop County. The tornado snapped and uprooted many trees. Twelve homes along the path of the tornado were damaged...with barns and a large greenhouse destroyed.

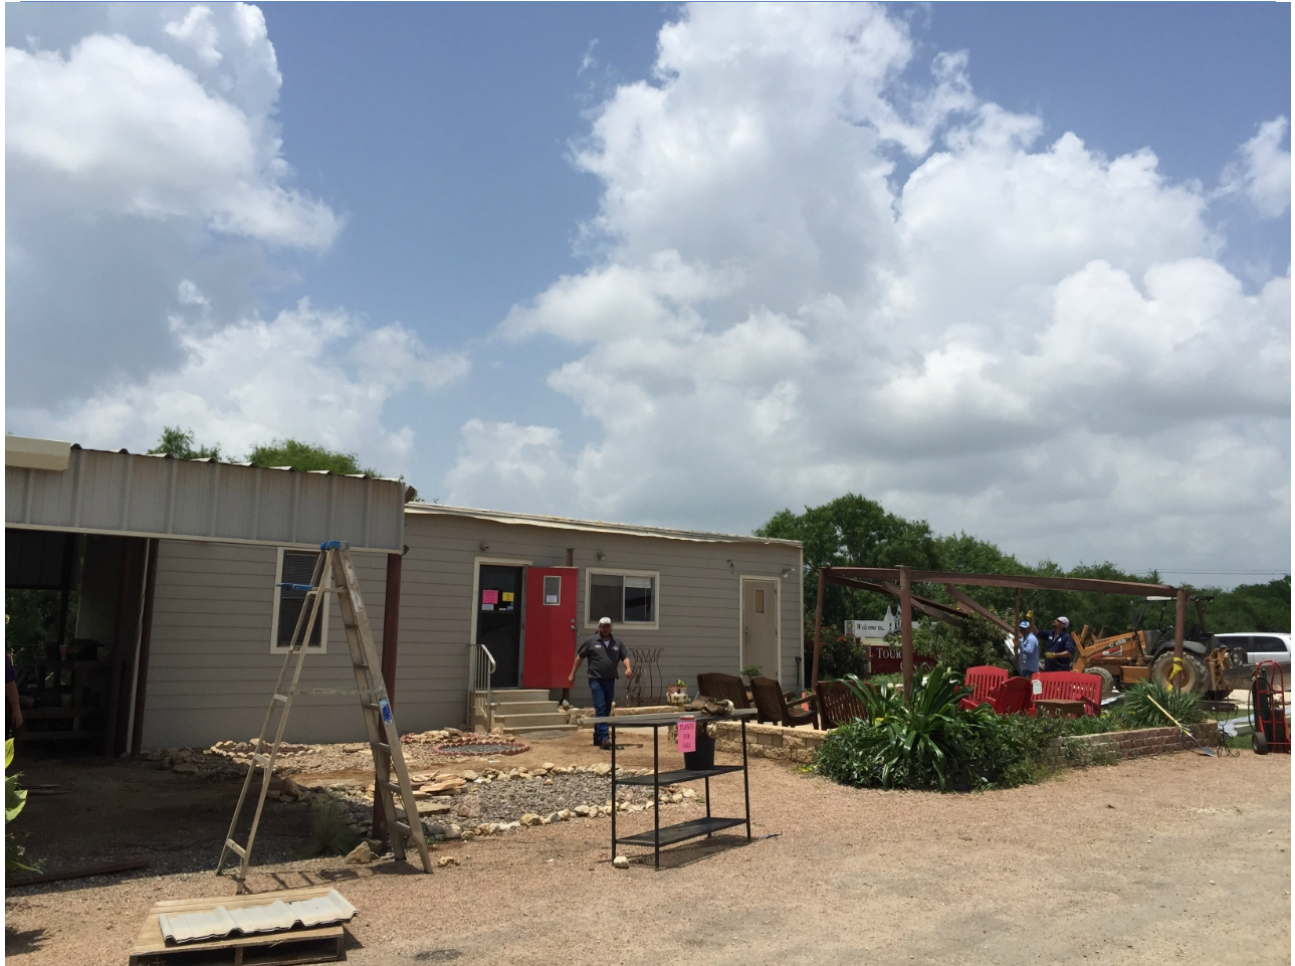
## Floresville Tornado (Wilson County)

#	Rating	Max Winds	Time	Start	End	Length	Width	Fatalities	Injuries
1	EF0	70 MPH	1810-1814	29.0990/-98.1300	29.1230/-98.1240	1.0 mi	50 yds	0	0

The NWS Storm Survey Team concluded a tornado touched down to the south of Floresville in Wilson County. A car port awning of a business was ripped off. A few tree limbs were also reported down.

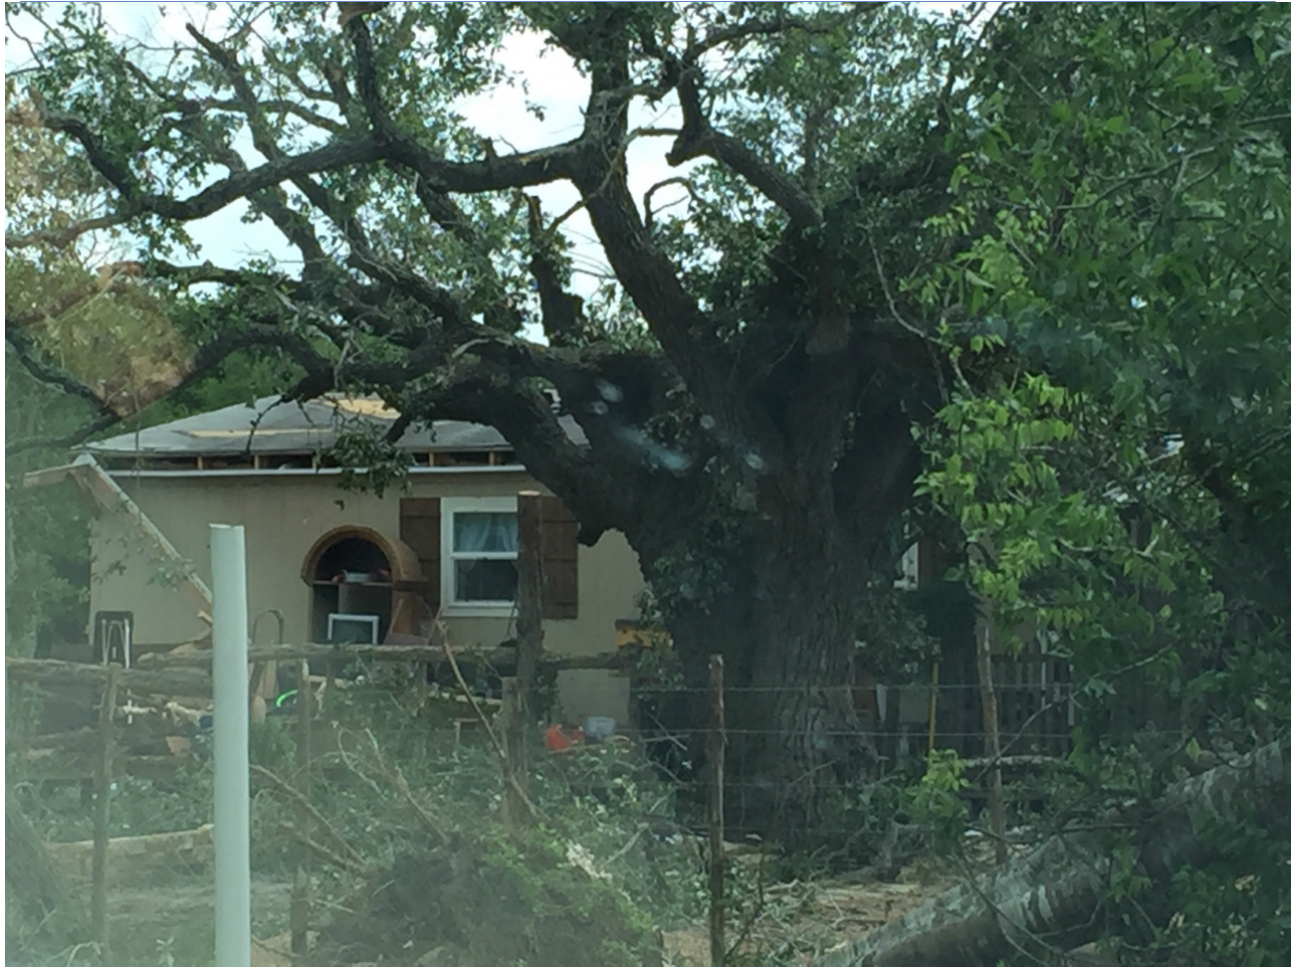
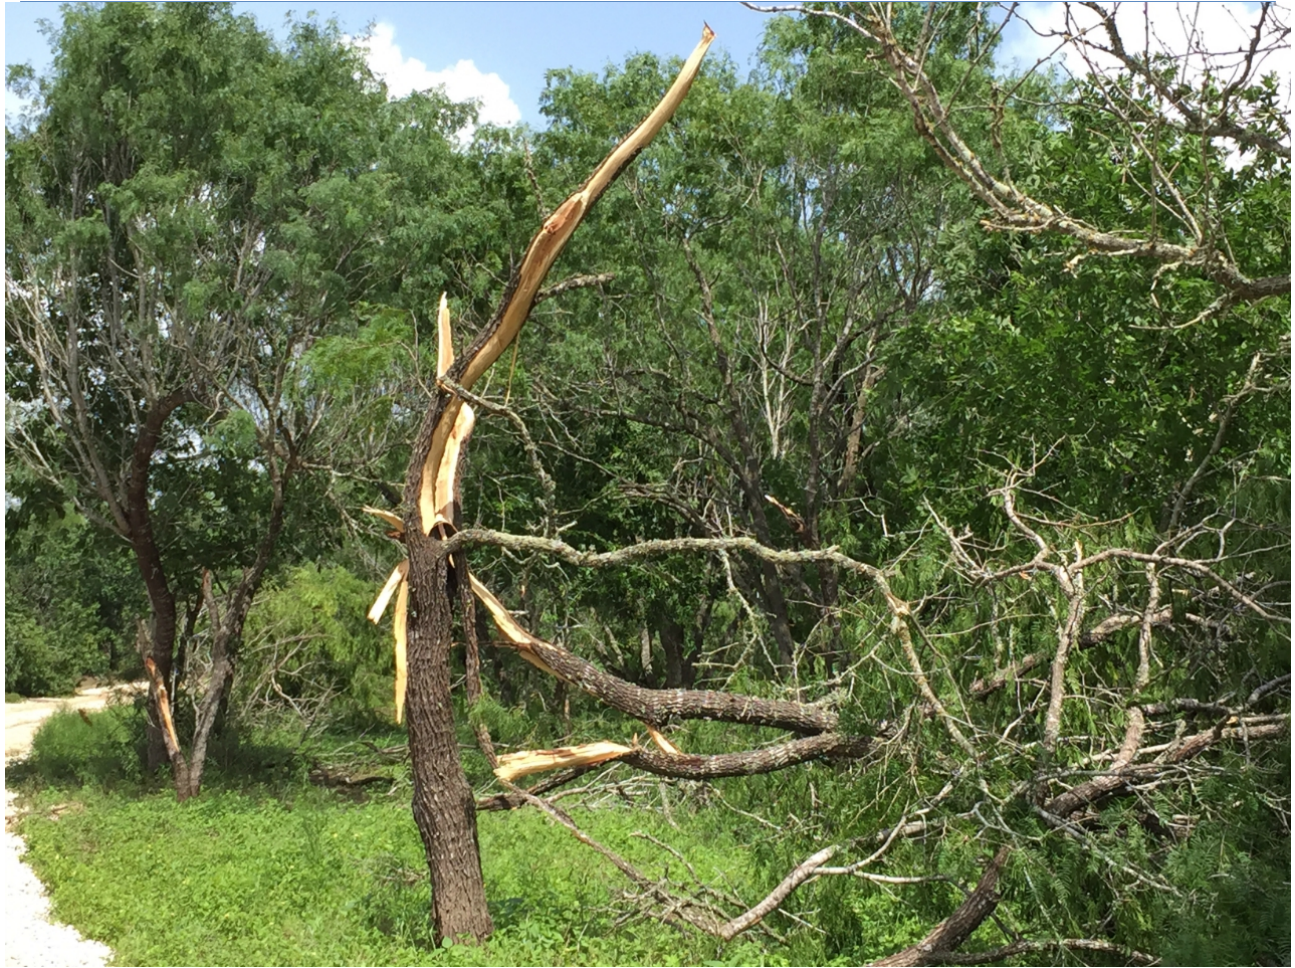
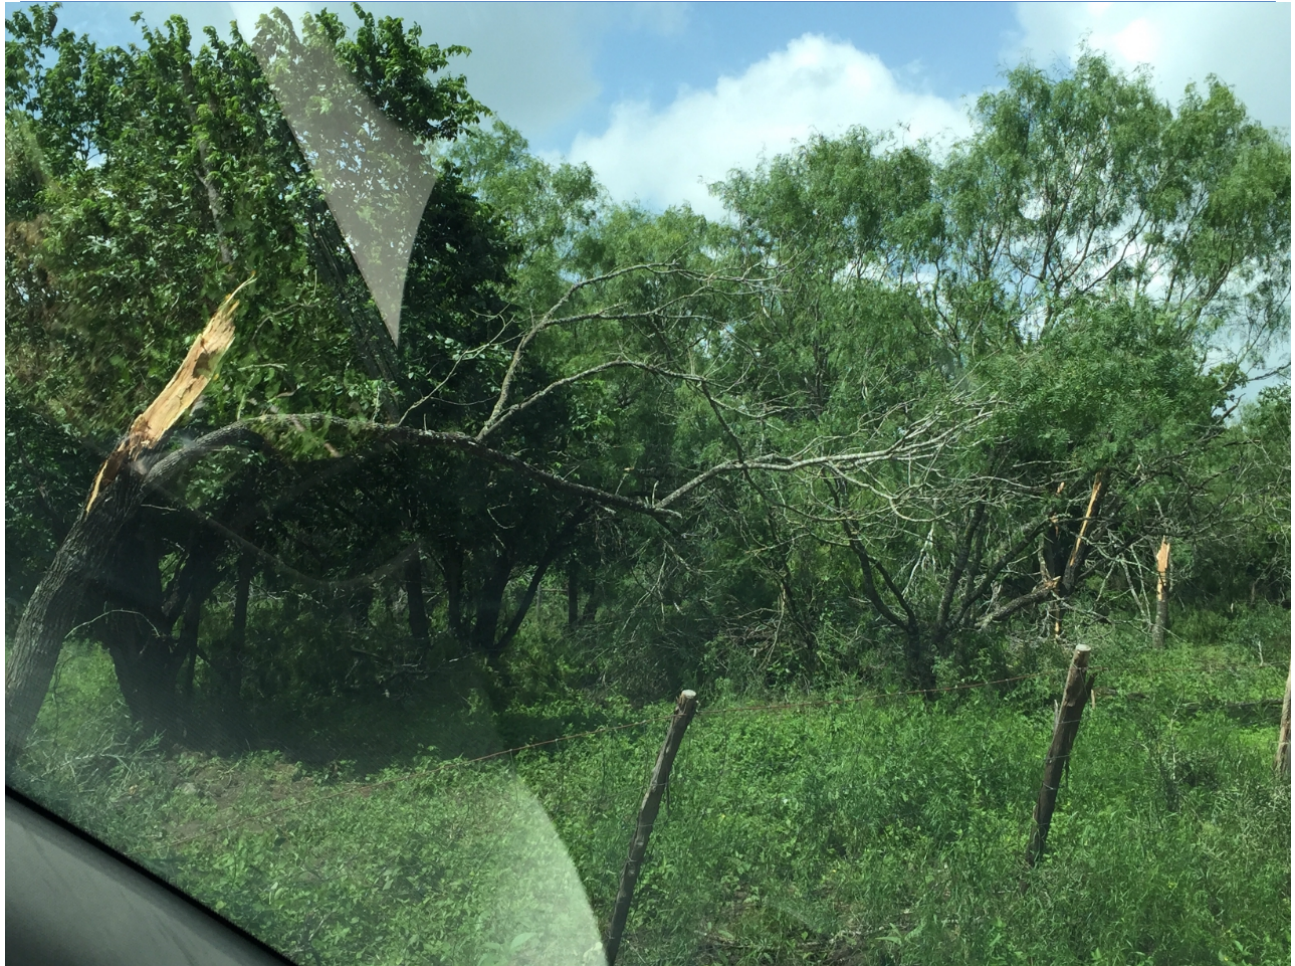
## Pandora Tornado (Wilson County)

#	Rating	Max Winds	Time	Start	End	Length	Width	Fatalities	Injuries
1	EF0	85 MPH	1857-1902	29.2470/-97.8740	29.2600/-97.8480	1.75 mi	150 yds	0	0

The NWS Storm Survey Team concluded a tornado touched down near Pandora, just west of County Road 472. The tornado damaged crops in an open field. The tornado crossed County Road 472 and continued to the east-northeast. Several large tree limbs were snapped and a few trees uprooted. A mobile home had damage to the skirting and a tin roof of a patio cover peeled off. A metal carport was also collapsed. Another home had shingle damage. A small barn was also heavily damaged.

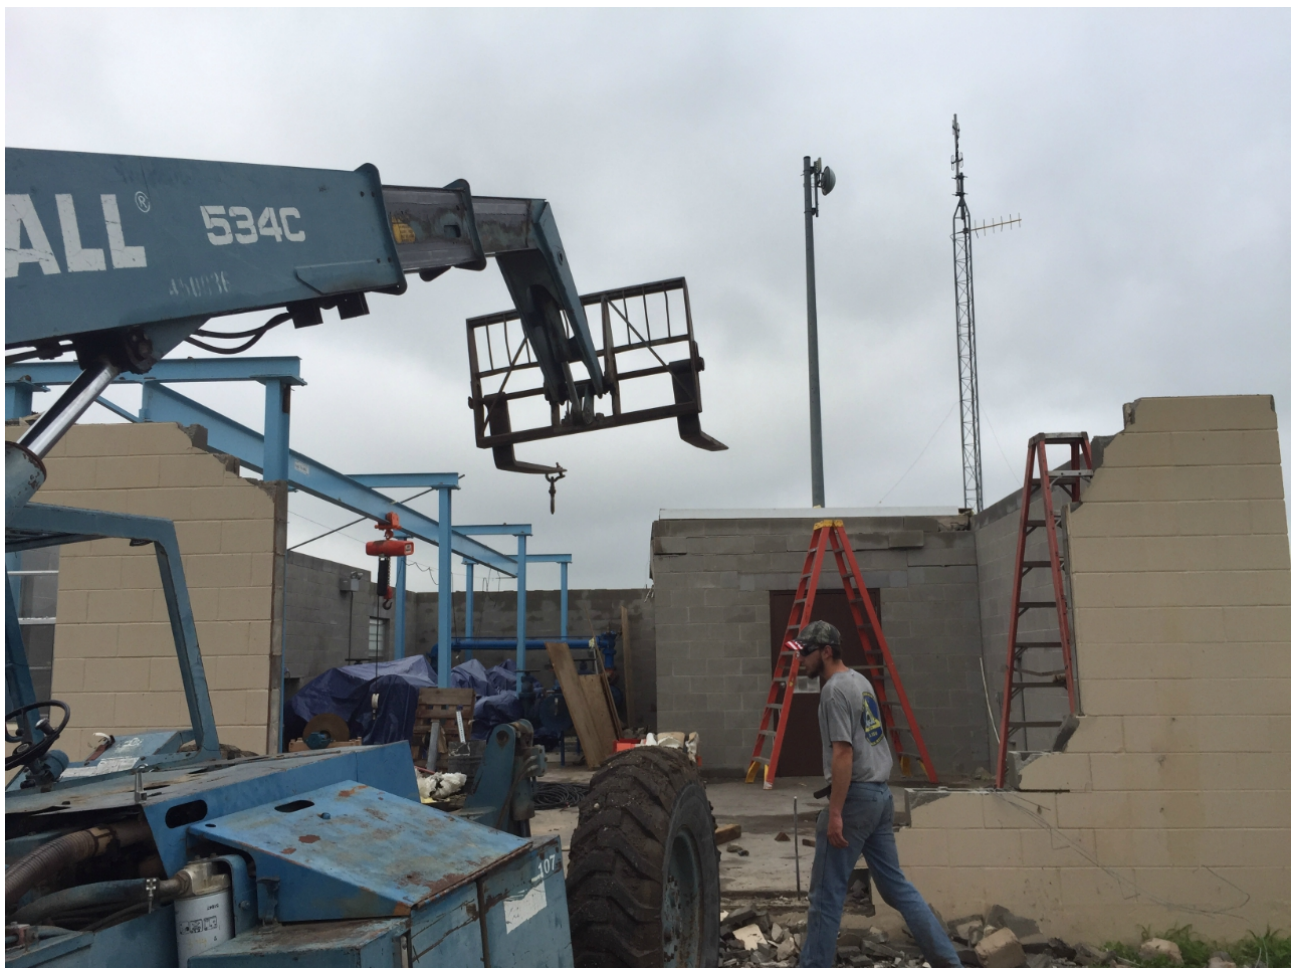
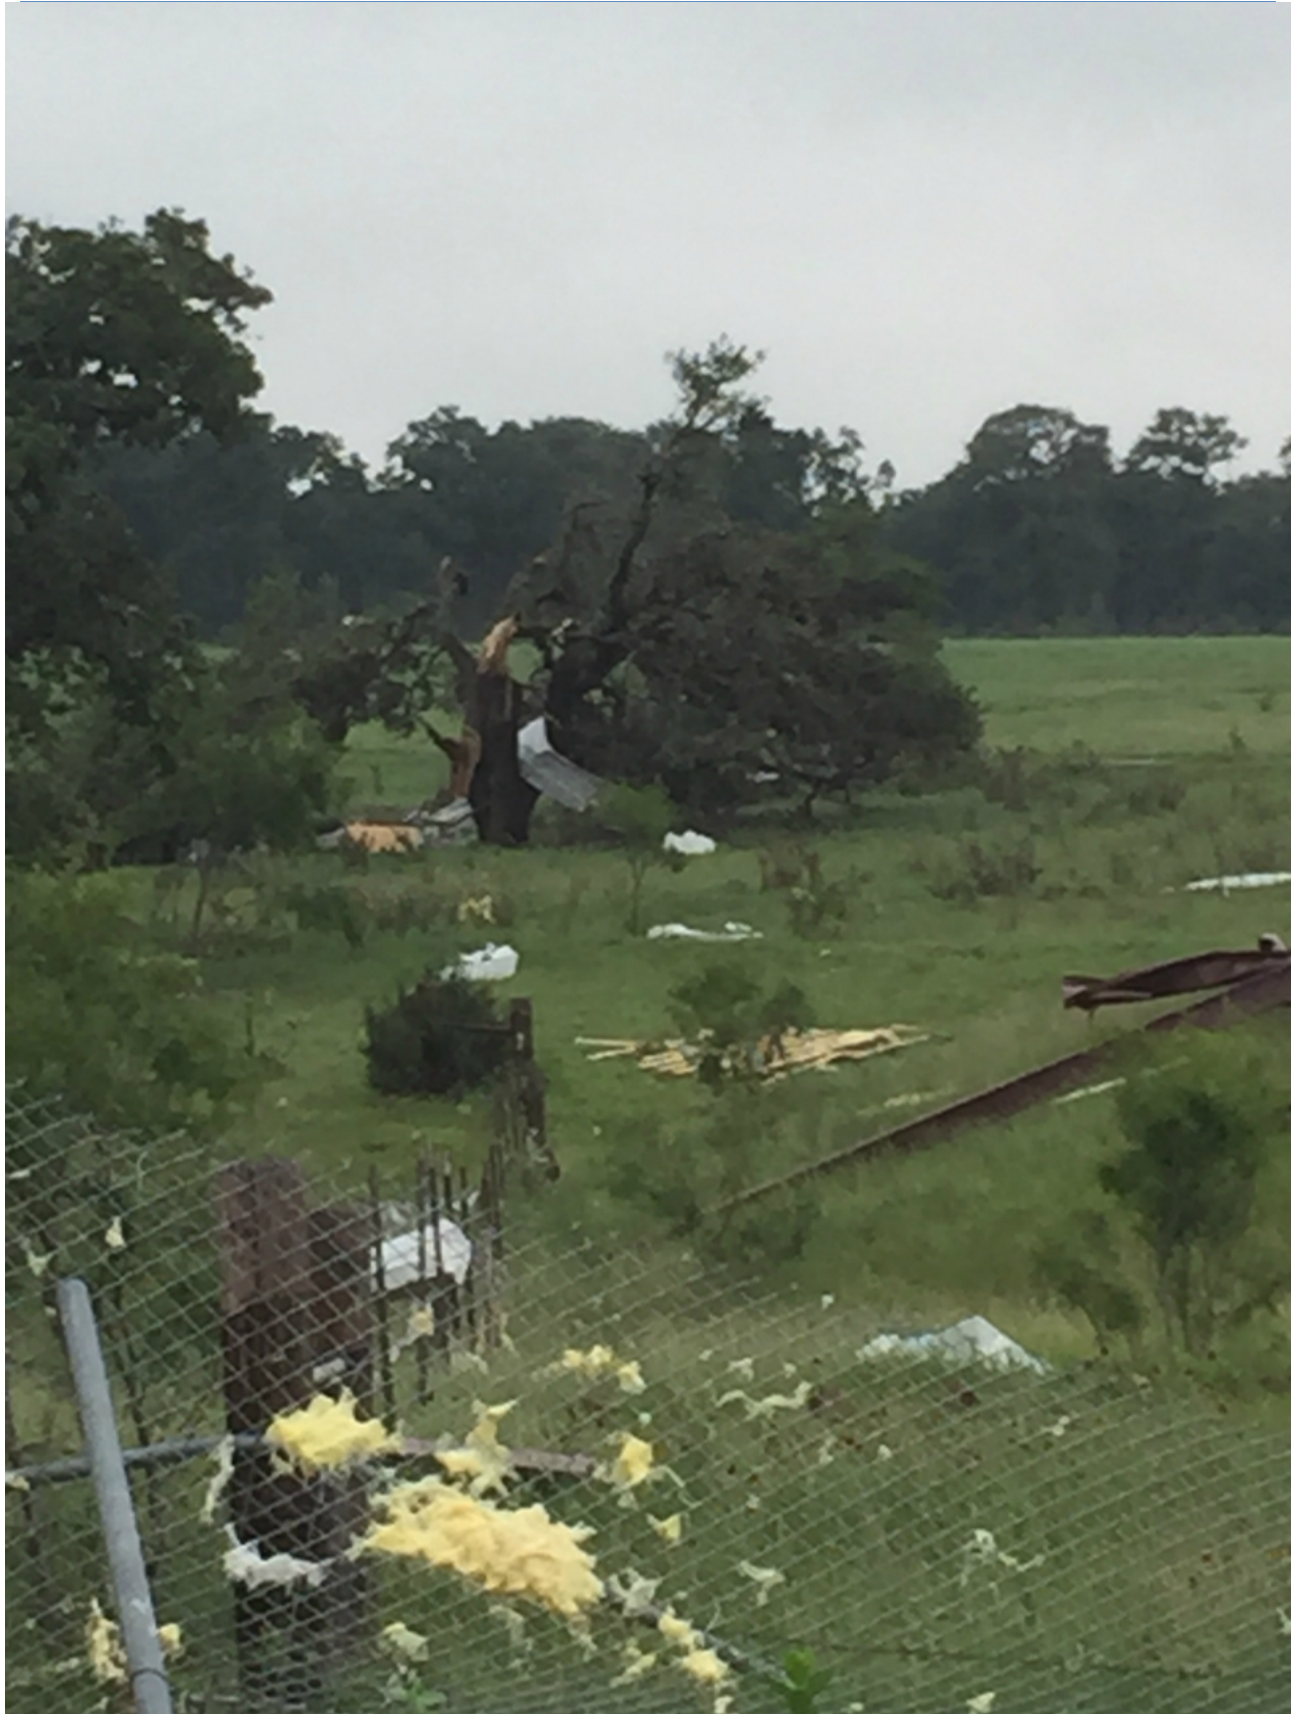
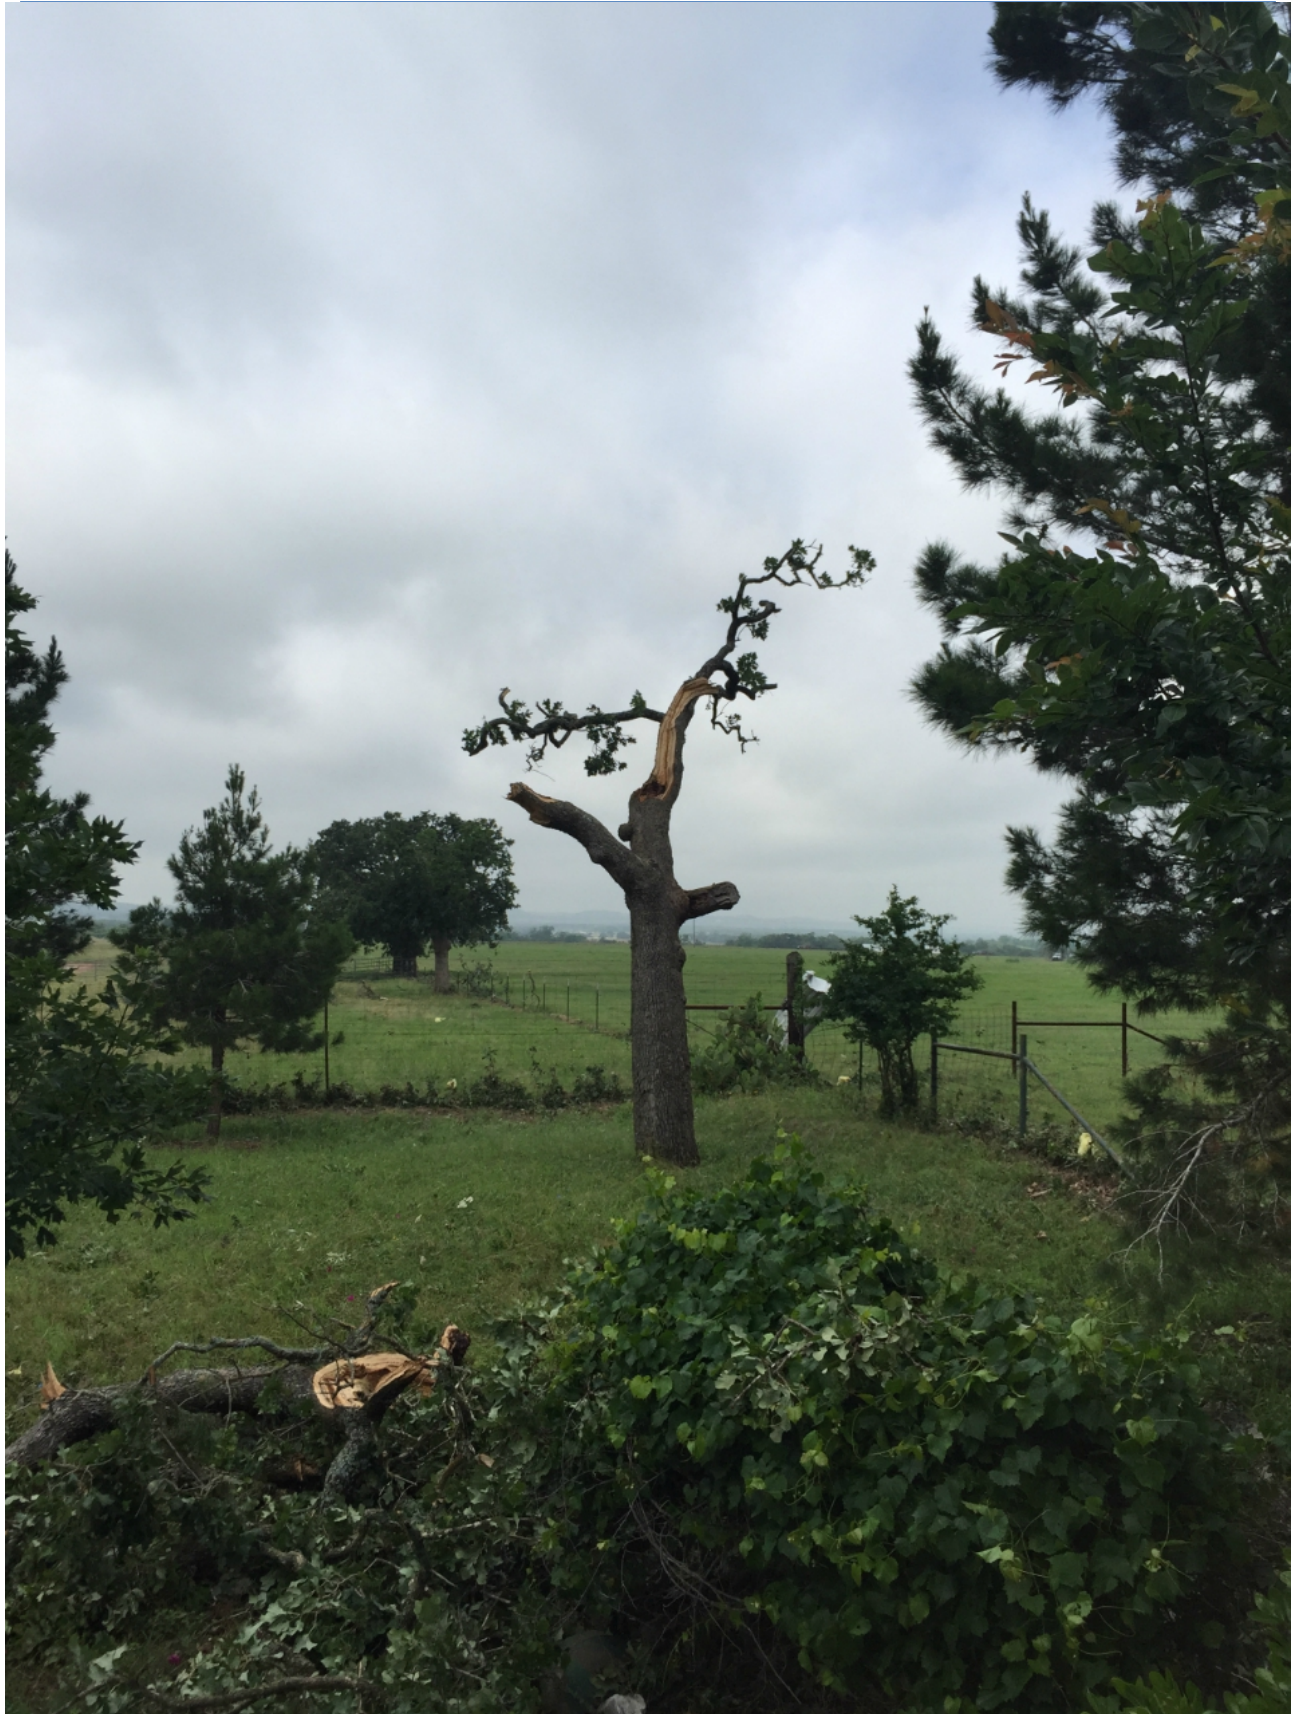
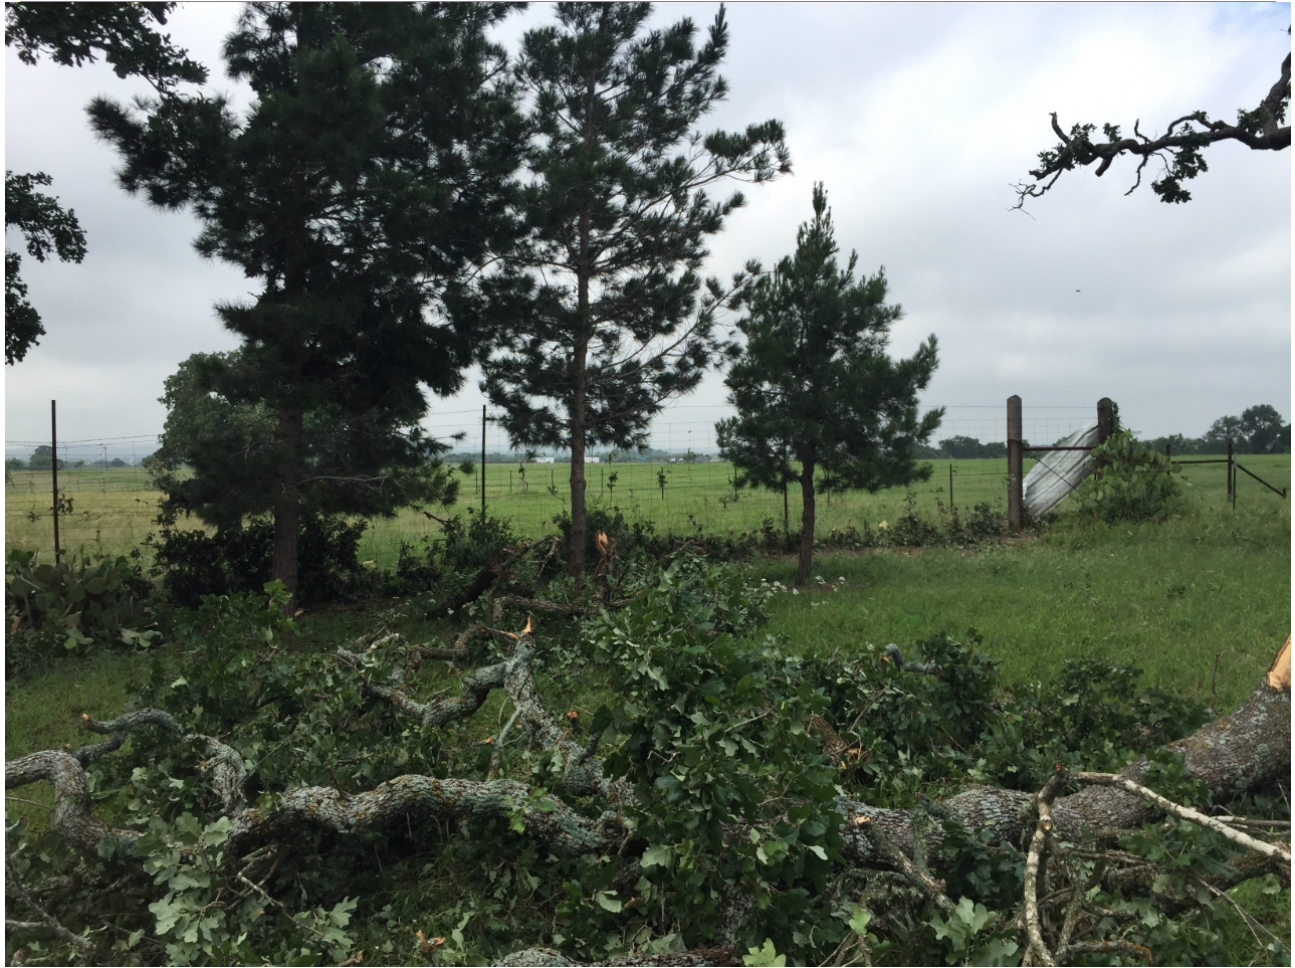
### Fredericksburg Tornado (Gillespie County)

#	Rating	Max Winds	Time	Start	End	Length	Width	Fatalities	Injuries
1	EF1	95 MPH	1233-1236	30.2462/-98.8038	30.2710/-98.7758	2.4 mi	100 yds	0	0

The NWS Storm Survey Team concluded a tornado touched down near Goehmann Lane on the eastern portions of Fredericksburg. The tornado traveled to the northeast crossing Pedernales Estates Road before lifting near Lonesome Trail. Damage was primarily to trees but a water pump station on Goehmann Lane lost its roof and one brick wall.

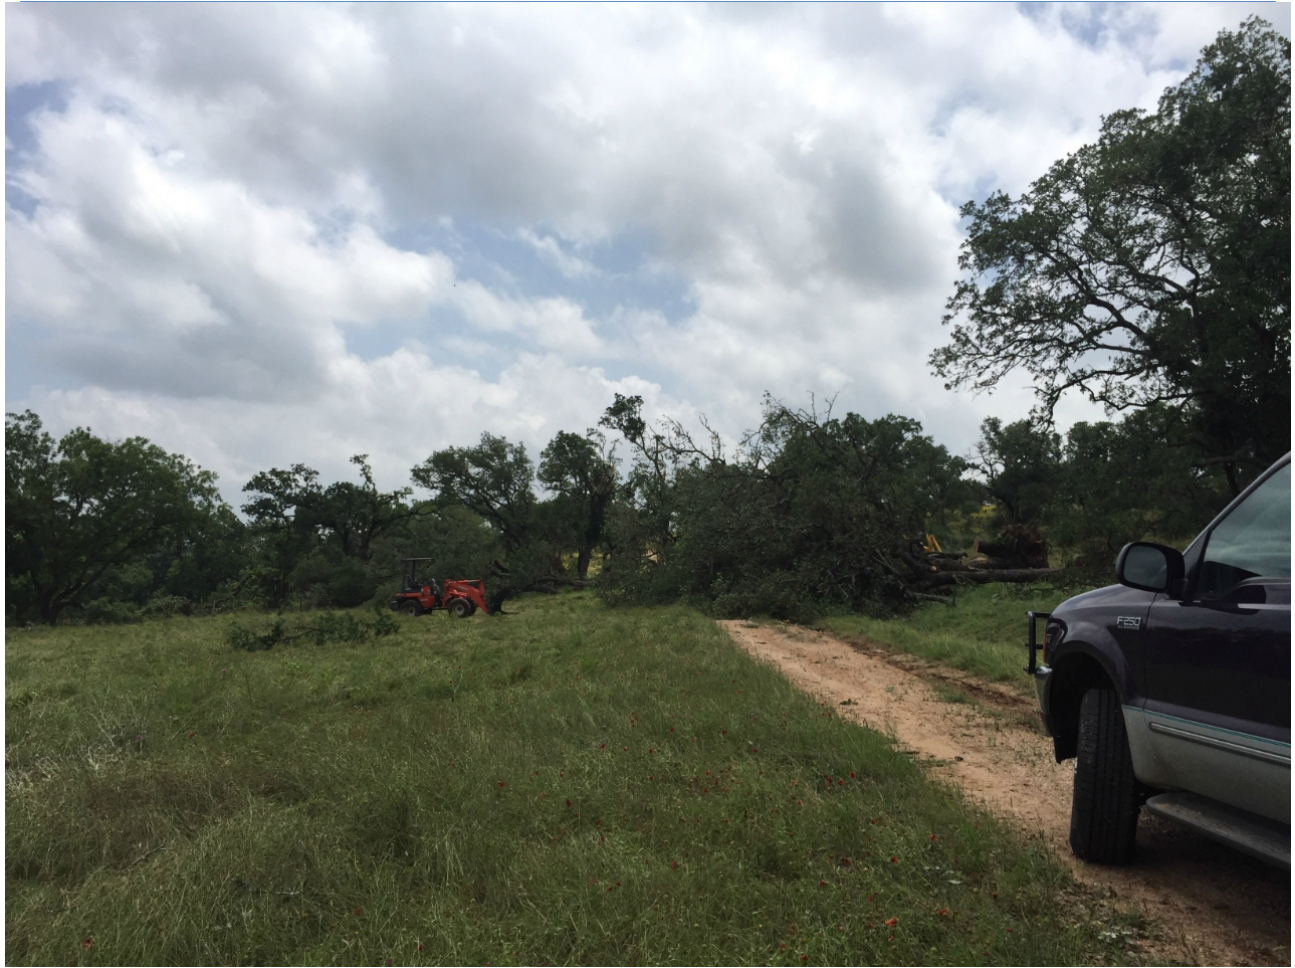
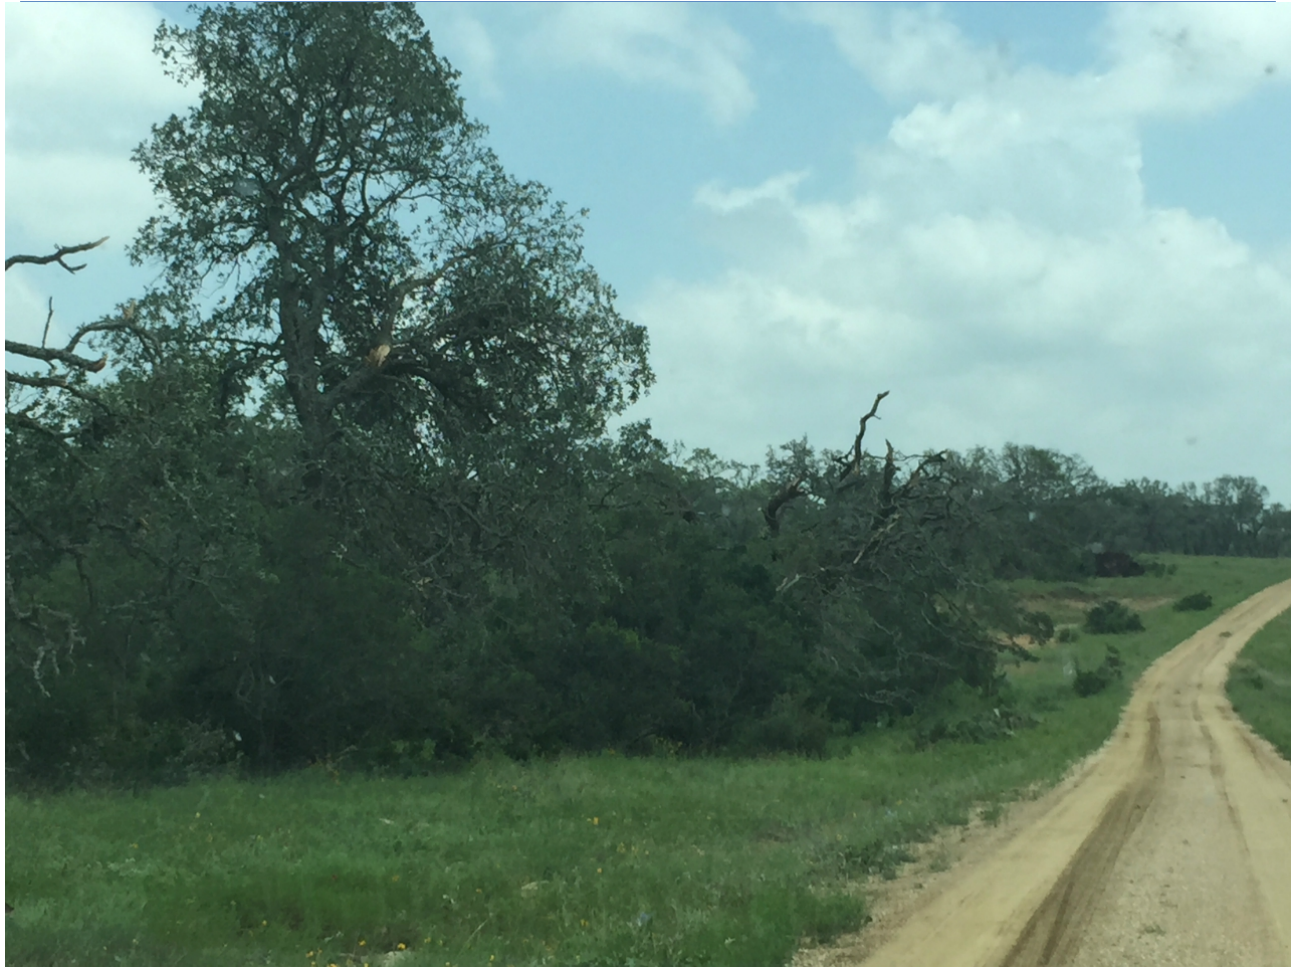
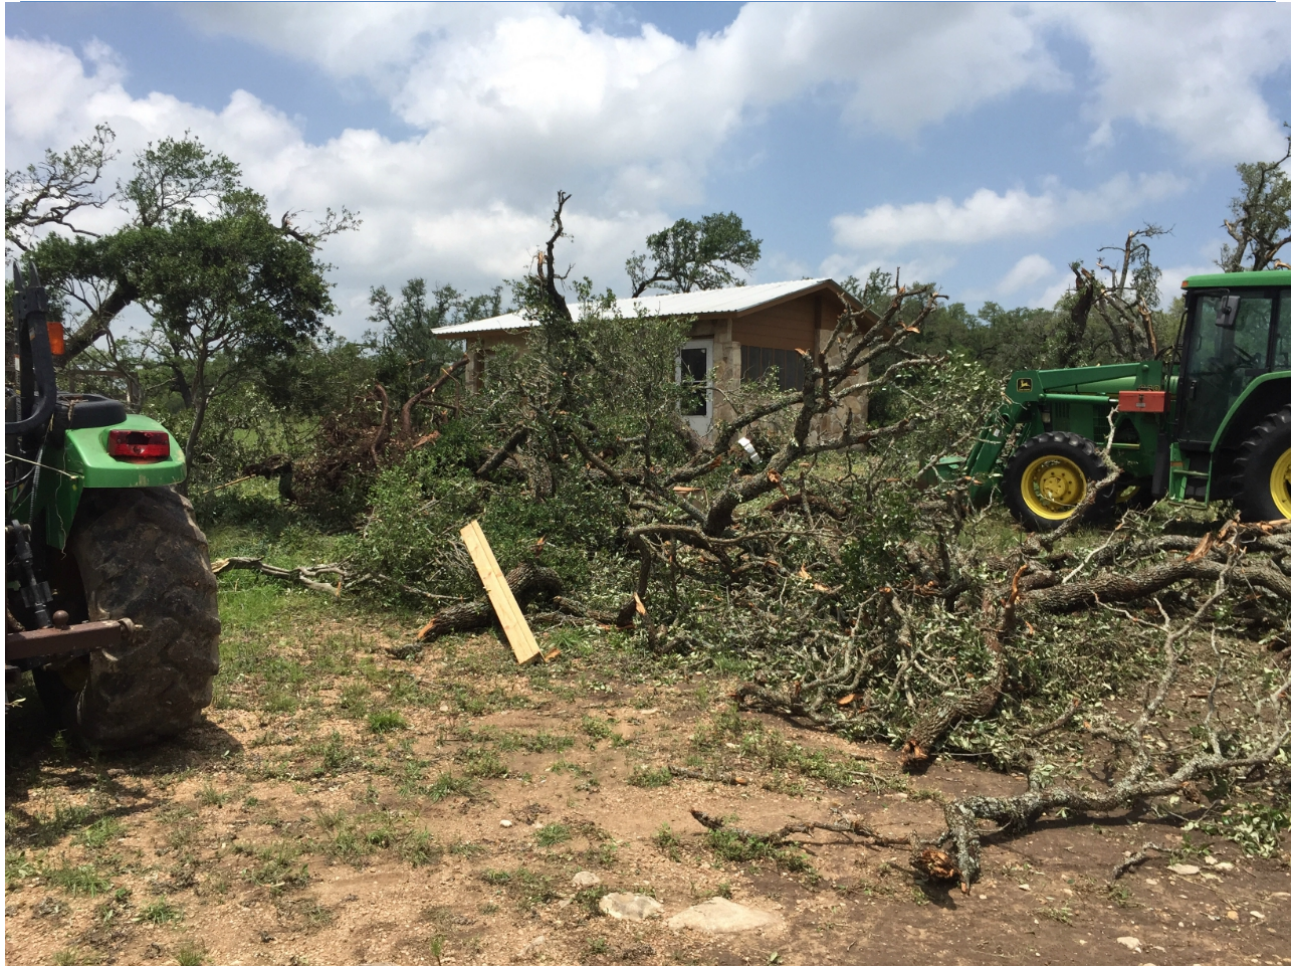
## Sandy Tornado (Blanco County)

#	Rating	Max Winds	Time	Start	End	Length	Width	Fatalities	Injuries
1	EF0	85 MPH	1304-1309	30.3375/-98.4931	30.3751/-98.4244	4.9 mi	200 yds	0	0

The NWS Storm Survey Team concluded a tornado touched down near the intersection of Ranch Road 1320 and North Grape Creek. The tornado traveled to the northeast along Ranch Road 1320 eventually crossing Ranch Road 1323 and lifting before highway 281. Damage was primarily to numerous trees which were uprooted or suffered damage to large limbs. Two barns suffered damage as well.
