# Austin/San Antonio Weather Forecast Office WEATHER EVENT SUMMARY

## 2015 Memorial Day Weekend Tornadoes

23 – 25 May 2015

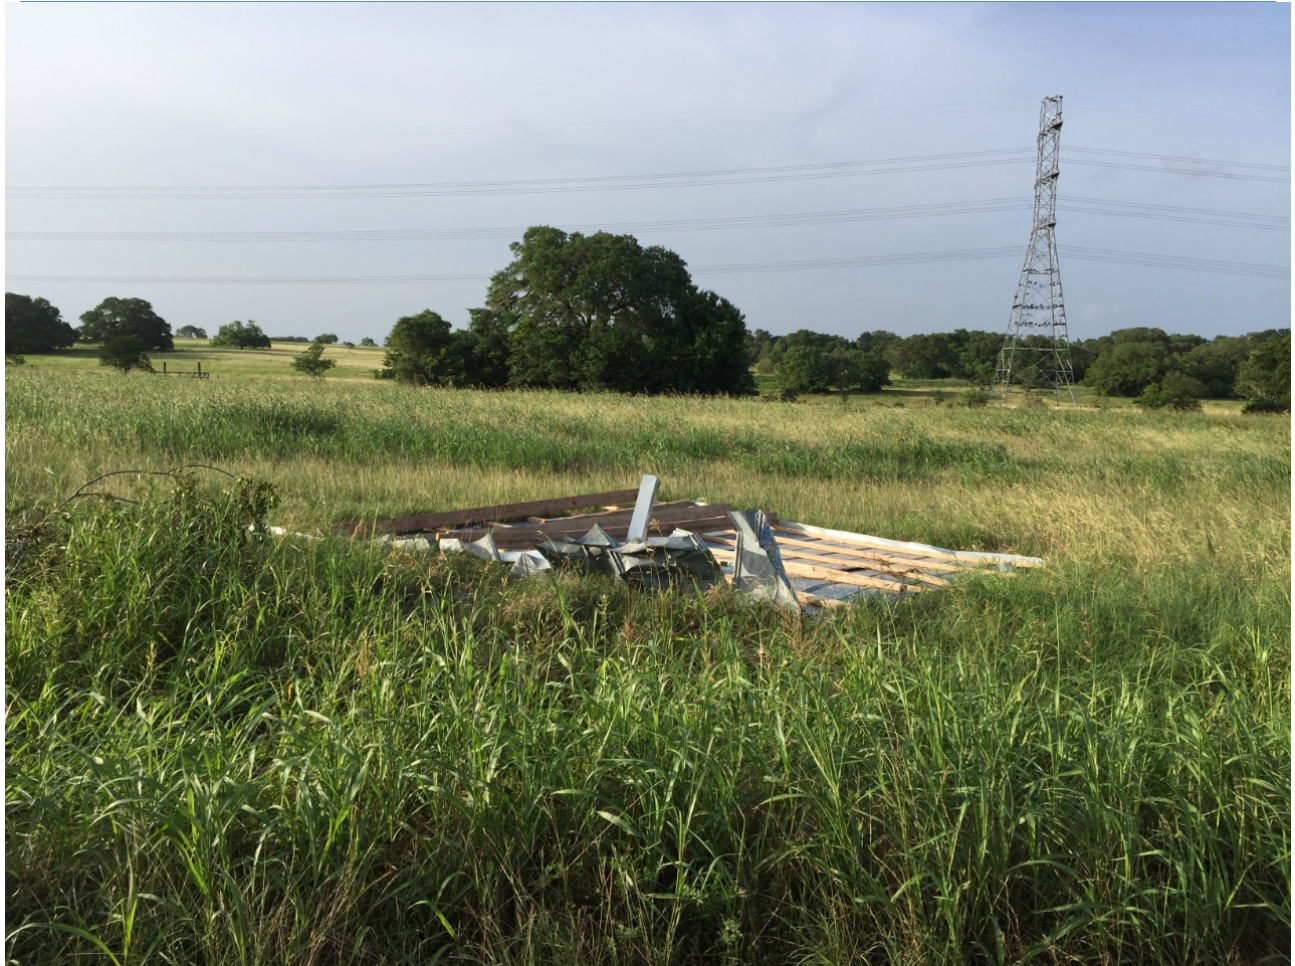
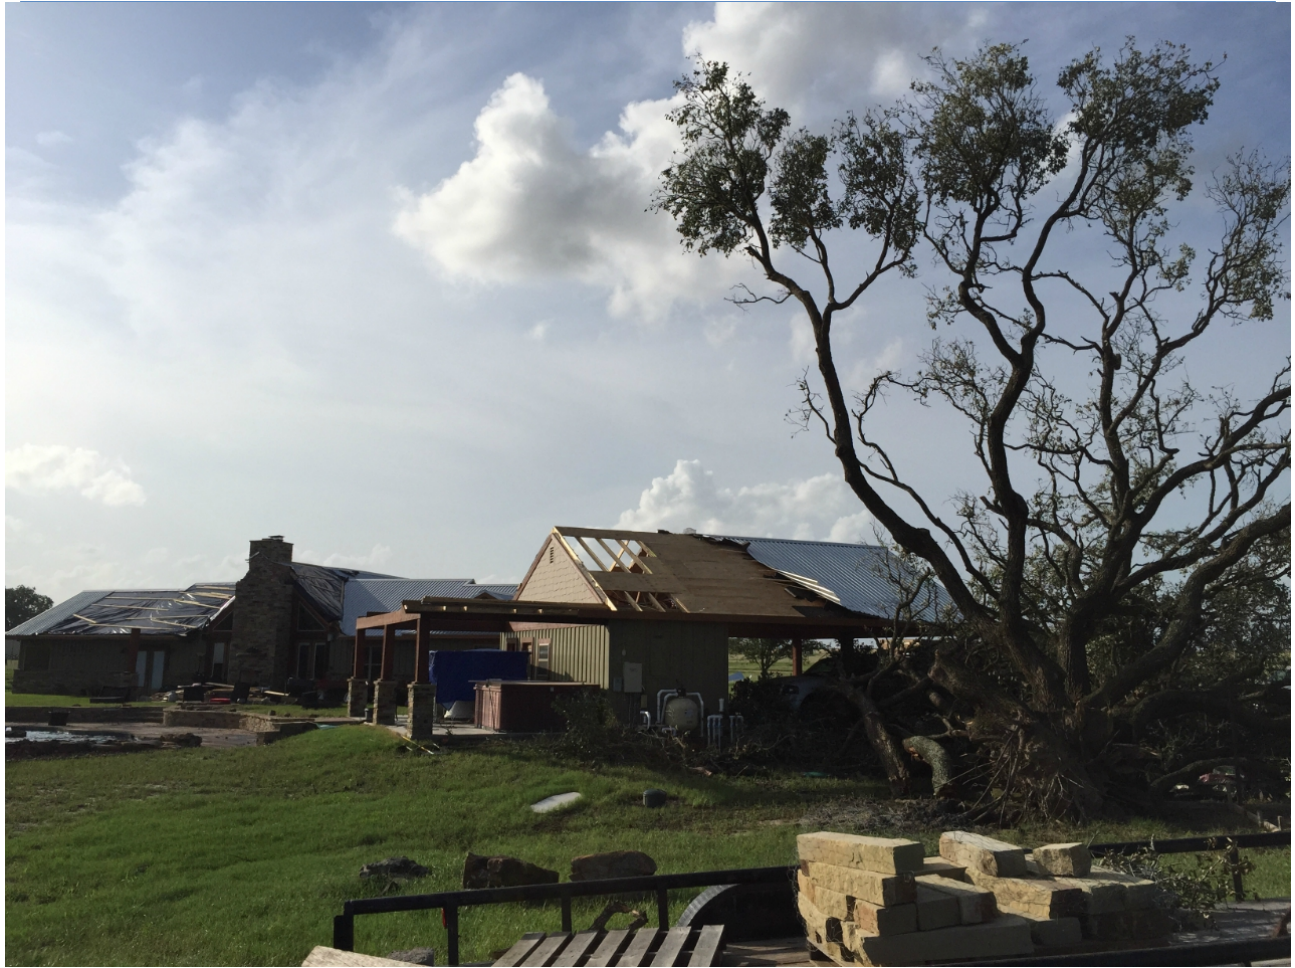
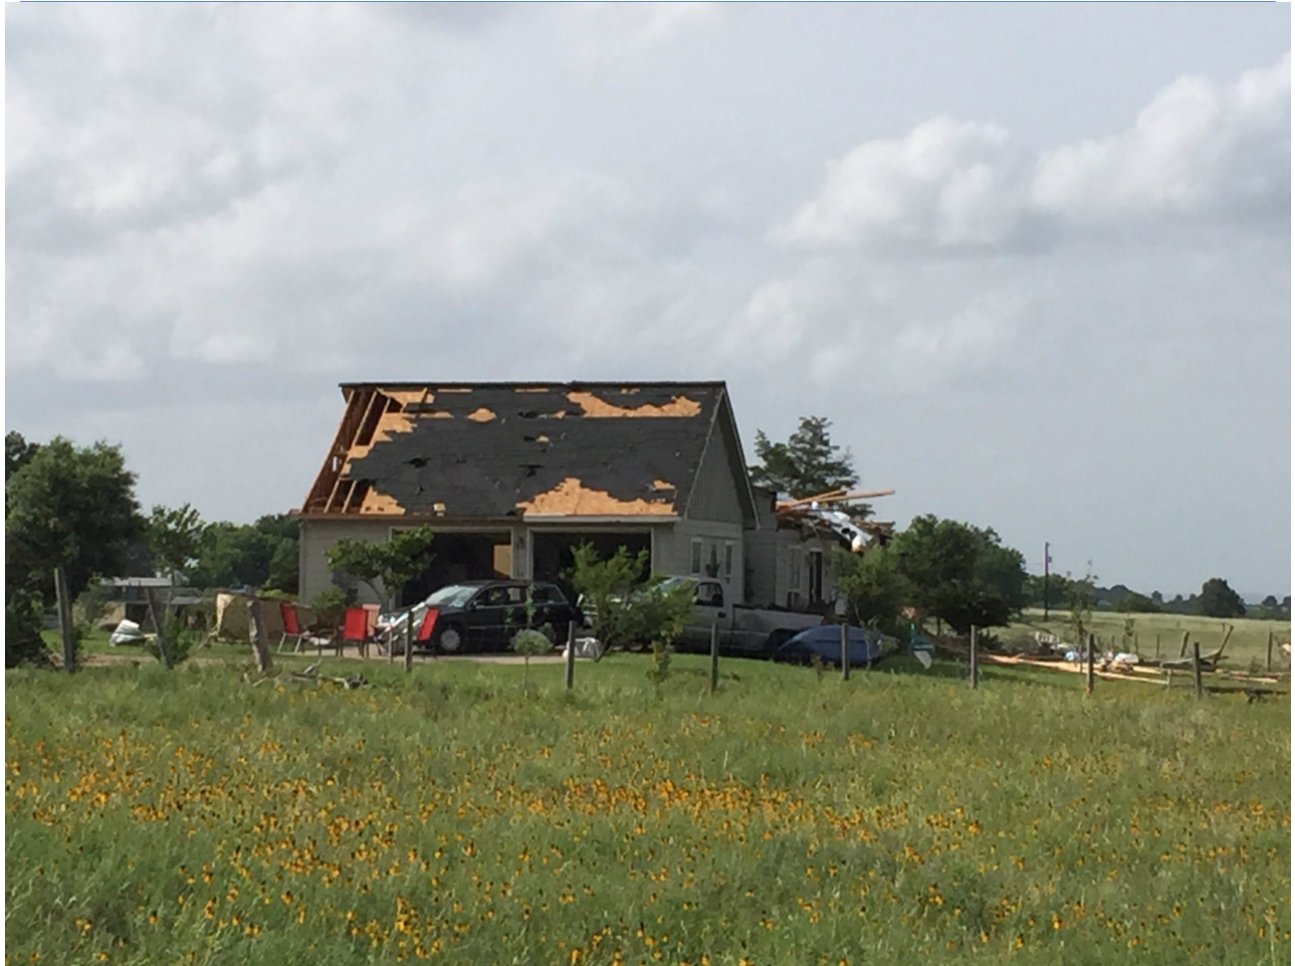
### Swiss Alp Tornado (Fayette County)

#	Rating	Max Winds	Time	Start	End	Length	Width	Fatalities	Injuries
1	EF1	105 MPH	1816-1824	29.7870/-96.9510	29.8310/-96.9060	4.0 mi	100 yds	0	0

The NWS Storm Survey Team concluded a tornado touched down just west of Swiss Alp and moved northeast for four miles. Two homes sustained substantial roof damage. Several trees were snapped at their trunks. Multiple barns sustained roof damage and a few small structures were destroyed.

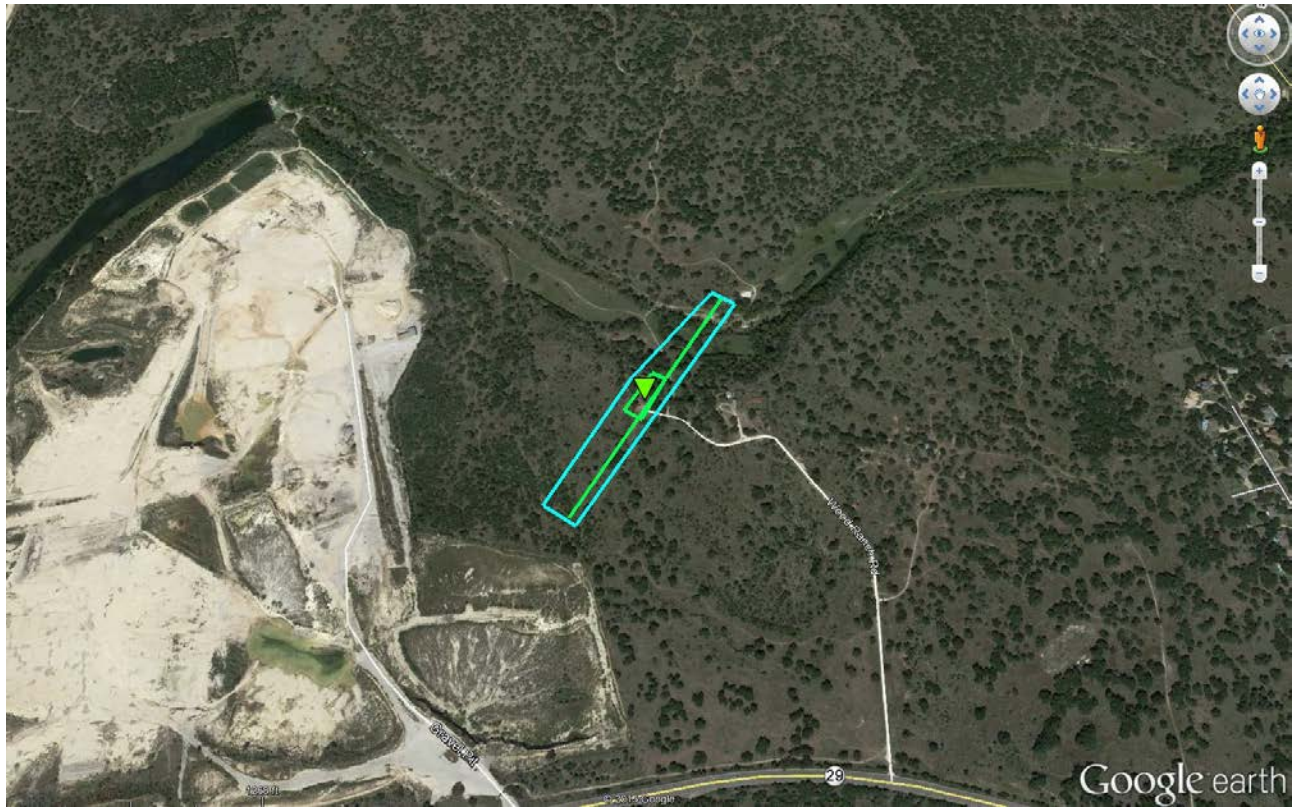
#	Rating	Max Winds	Time	Start	End	Length	Width	Fatalities	Injuries
1	EF1	110 MPH	1945-1947	30.6380/-97.7315	30.6423/-97.7291	0.33 mi	100 yds	0	0
