# **Hurricane Alicia Galveston and Houston, Texas August 17-18, 1983**

**Committee on Natural Disasters  
Commission on Engineering and Technical Systems  
National Research Council**

NATIONAL ACADEMY PRESS Washington, D.C. 1984

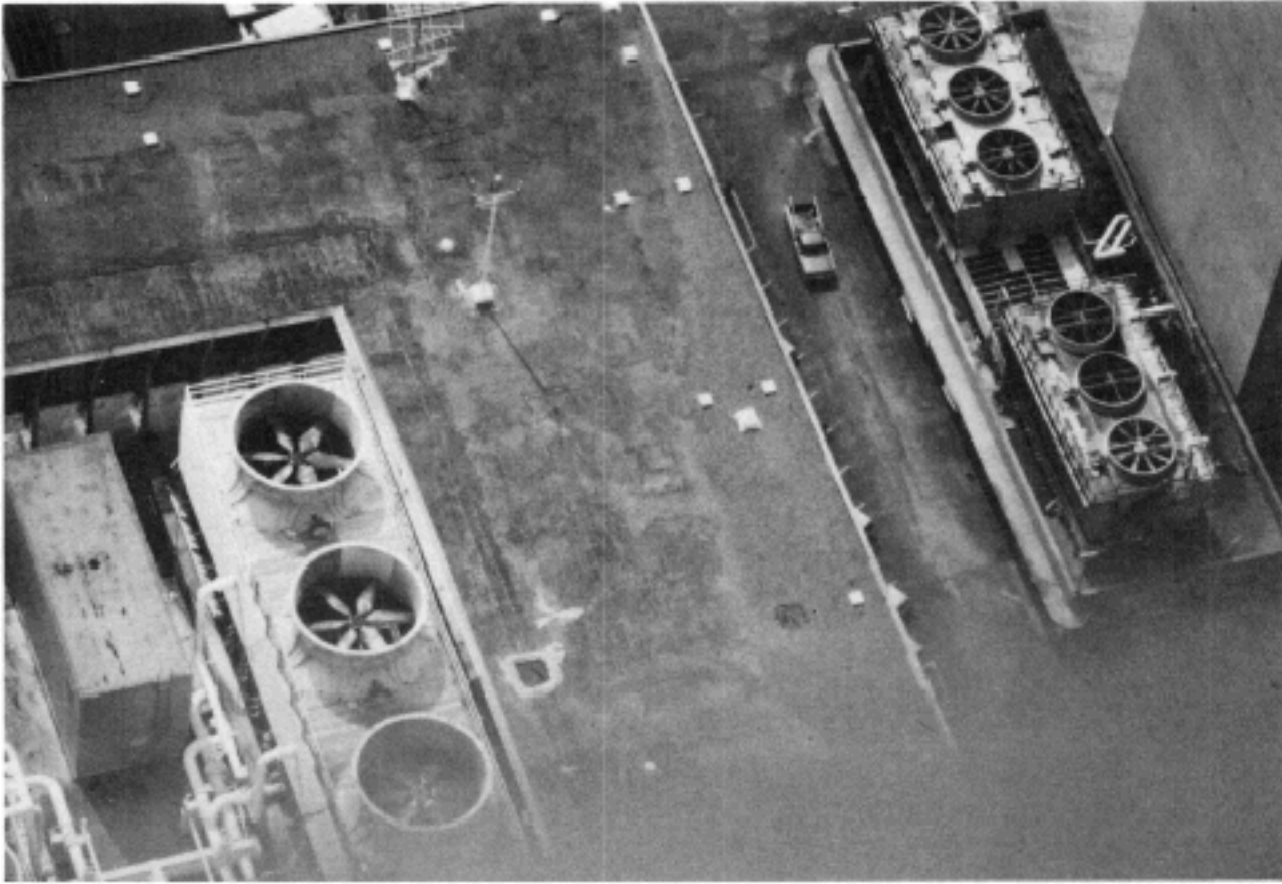
in roof design methods. [Figures 4.11 and 4.12](#) show a general view of the roofs of the Tenneco and Entex buildings. The scour pattern on the Tenneco roof indicates southerly winds, which were prevalent during the latter part of the morning as the eye of the storm passed to the west of the central business district.

FIGURE 4.11 General view of the roof of the Tenneco Building.

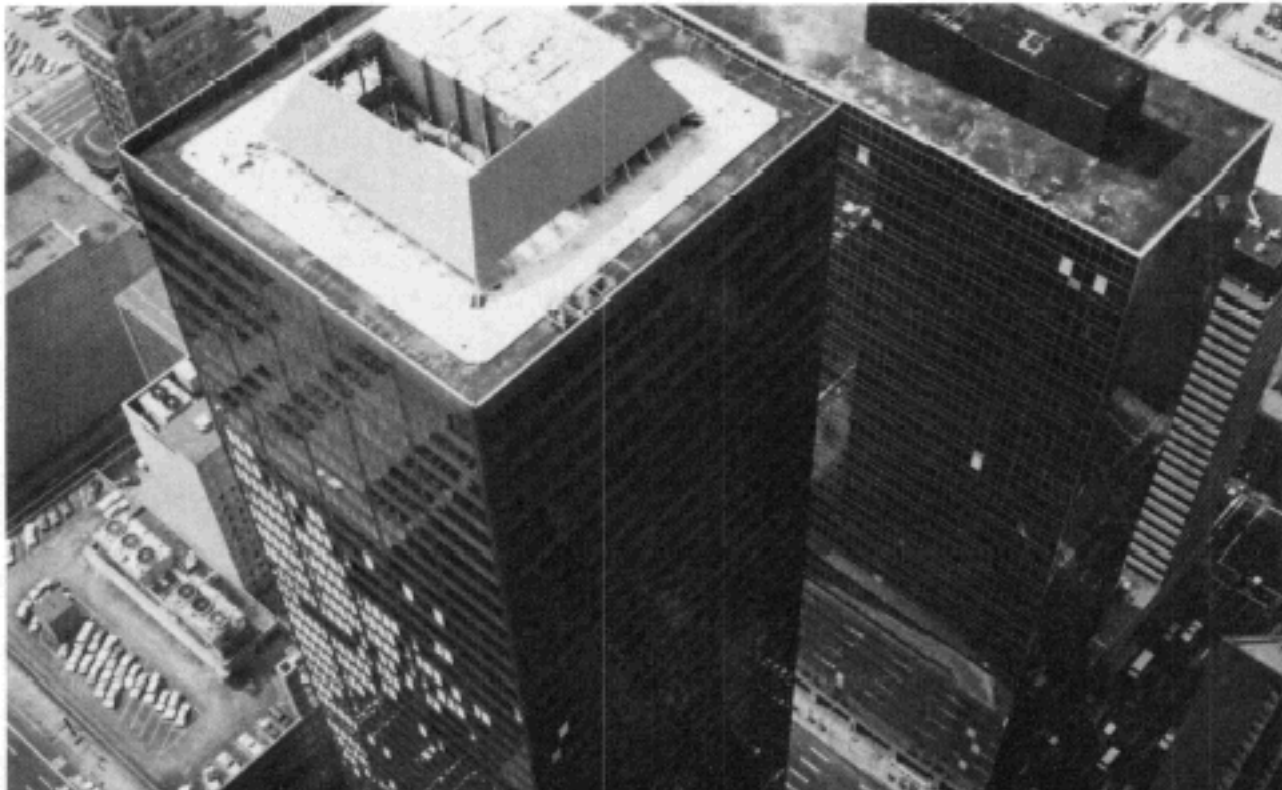
**FIGURE 4.12** General view of the roofs of the Milam and Entex buildings.

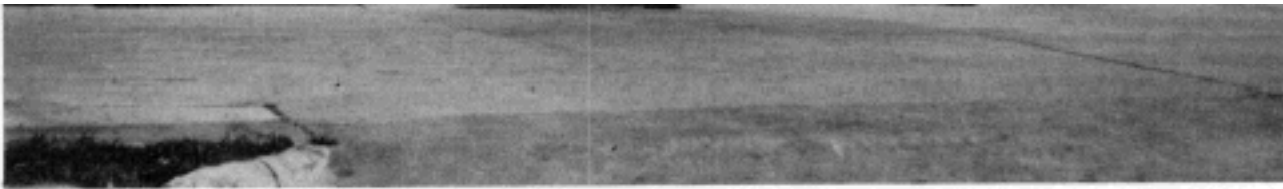
FIGURE 4.15 Example of failure of a roof support pedestal column.

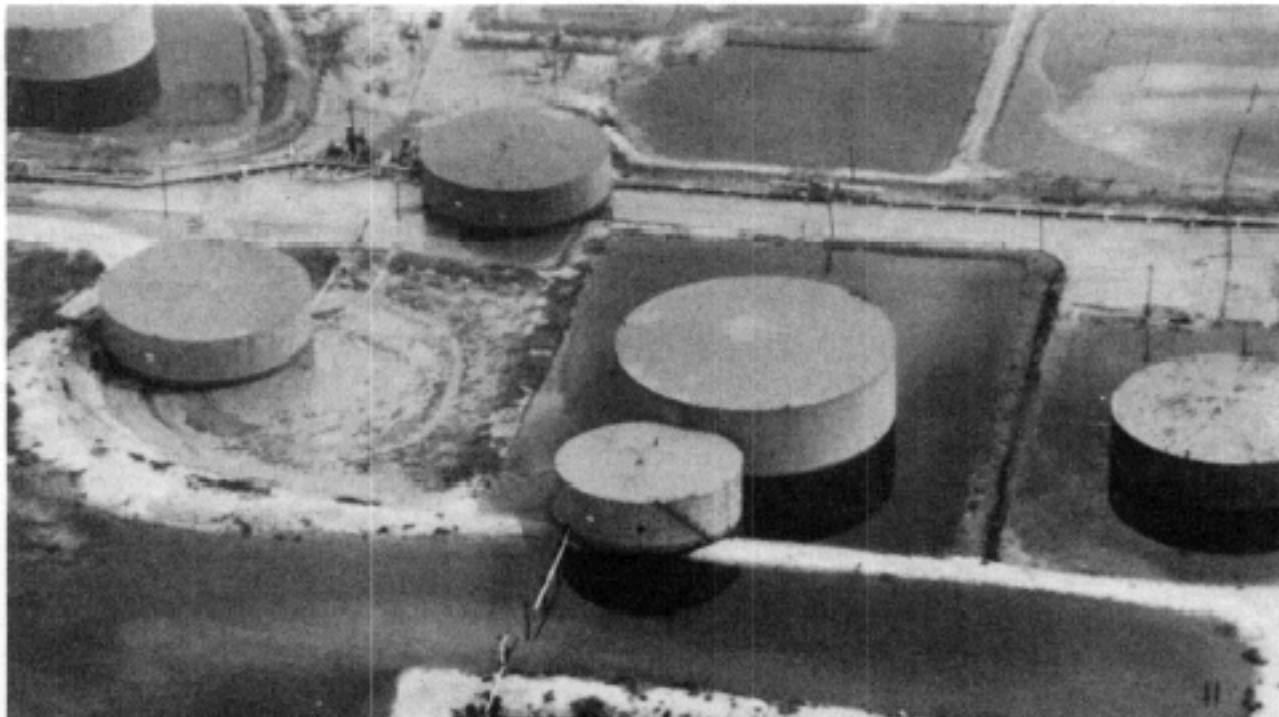
Destruction of boats in the Houston Yacht Club marina was almost total as Hurricane Alicia ripped through the area and piled boats on top of each other. Boats moored in individual docking bays were picked up and hurled about by winds and surge. Some large barges in the Houston ship channel got loose as well during the storm, resulting in damage to dock facilities ([Figure 4.17](#)). Some of the oil storage tanks near the Houston ship channel were floated from their original locations by high water ([Figure 4.18](#)).

**FIGURE 4.18** Displaced oil storage tanks.

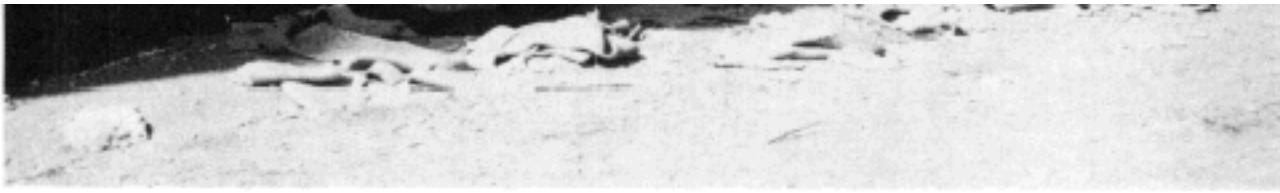
The Galvestonian is a very large high-rise condominium, crescent-shaped in plan, under construction next to the Islanders Inn on East Beach ([Figure 4.19](#)). It bore the brunt of winds, waves, and flooding directly from the Gulf. The facade of the building experienced minor damage, and extensive erosion occurred around its foundation. However, the structural integrity of the foundation was not affected ([Figure 4.20](#)). The reinforced concrete structural system performed satisfactorily.

**FIGURE 4.20** Erosion around the foundation of the Galvestonian.

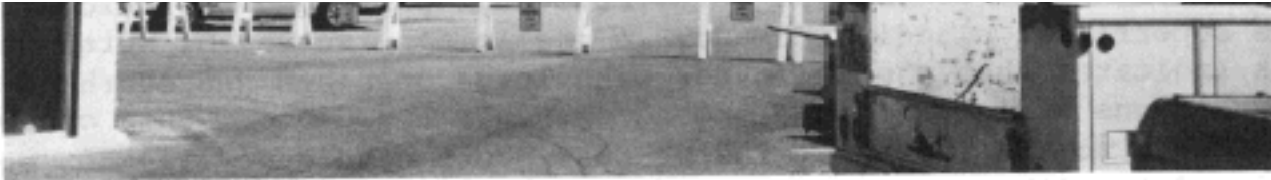
**FIGURE 4.23** Damage to the facade of the Flagship Hotel.

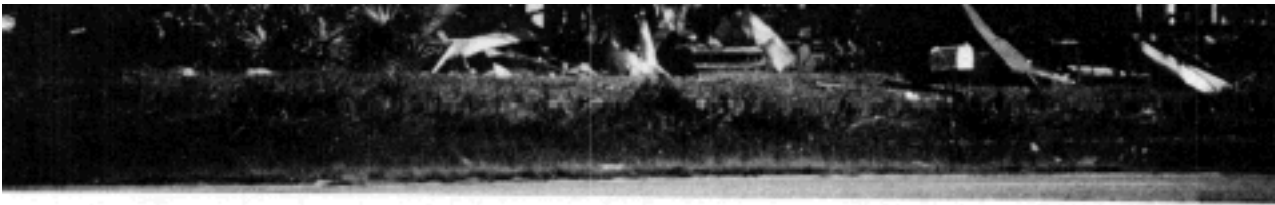
FIGURE 4.27 Damage to an elevated mobile home on West Beach.

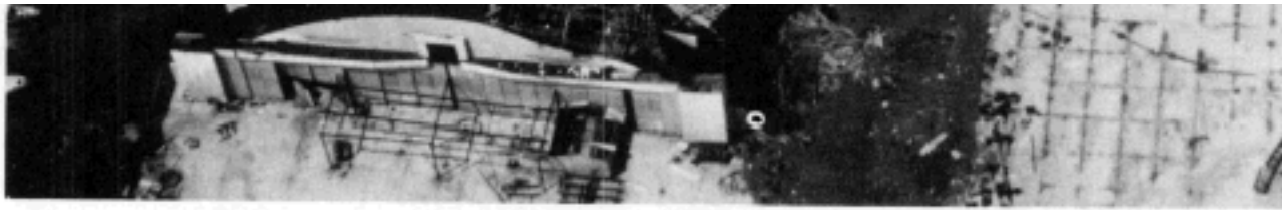
FIGURE 4.37 Wind damage to the roof of a hangar at Galveston Airport.

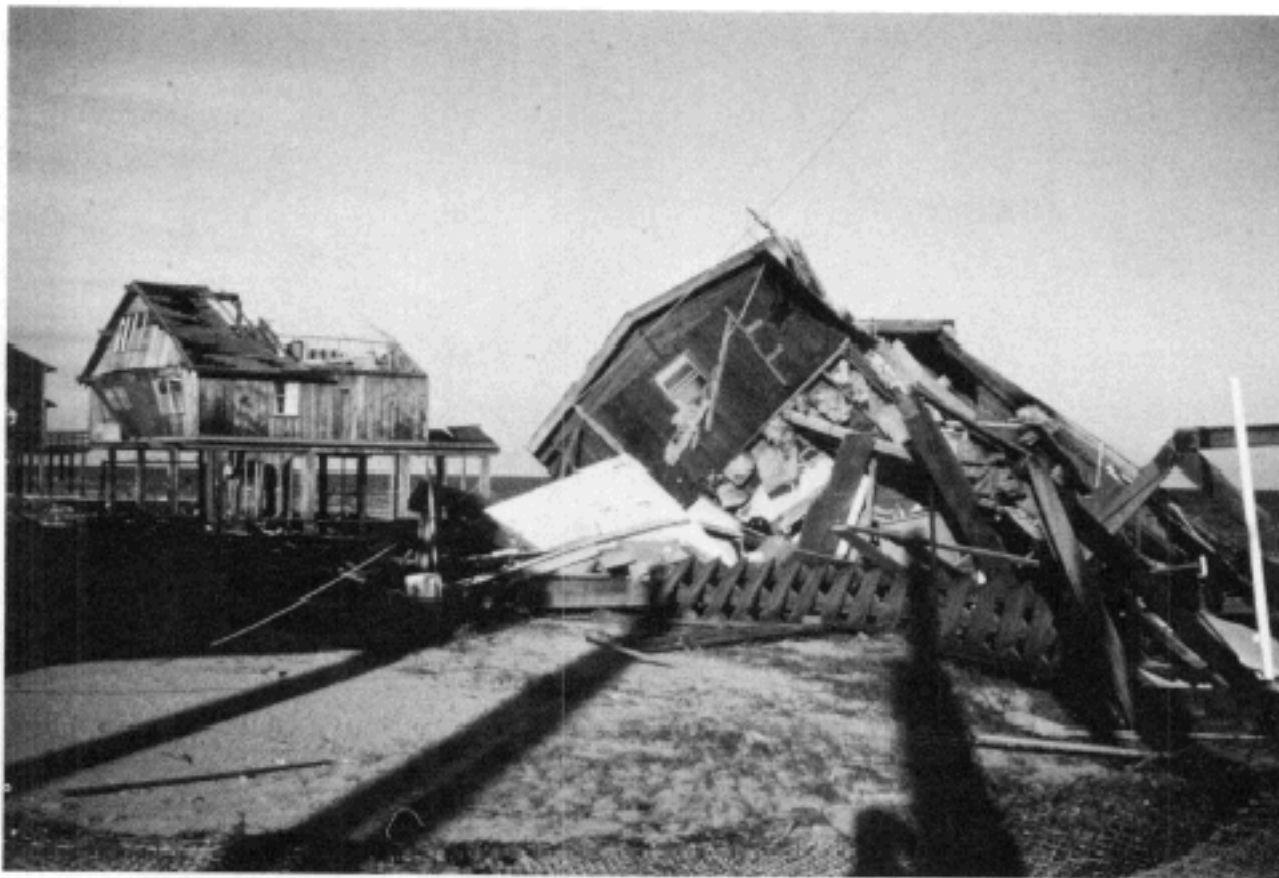
FIGURE 4.41 Example of overall collapse of a house and supporting structure.

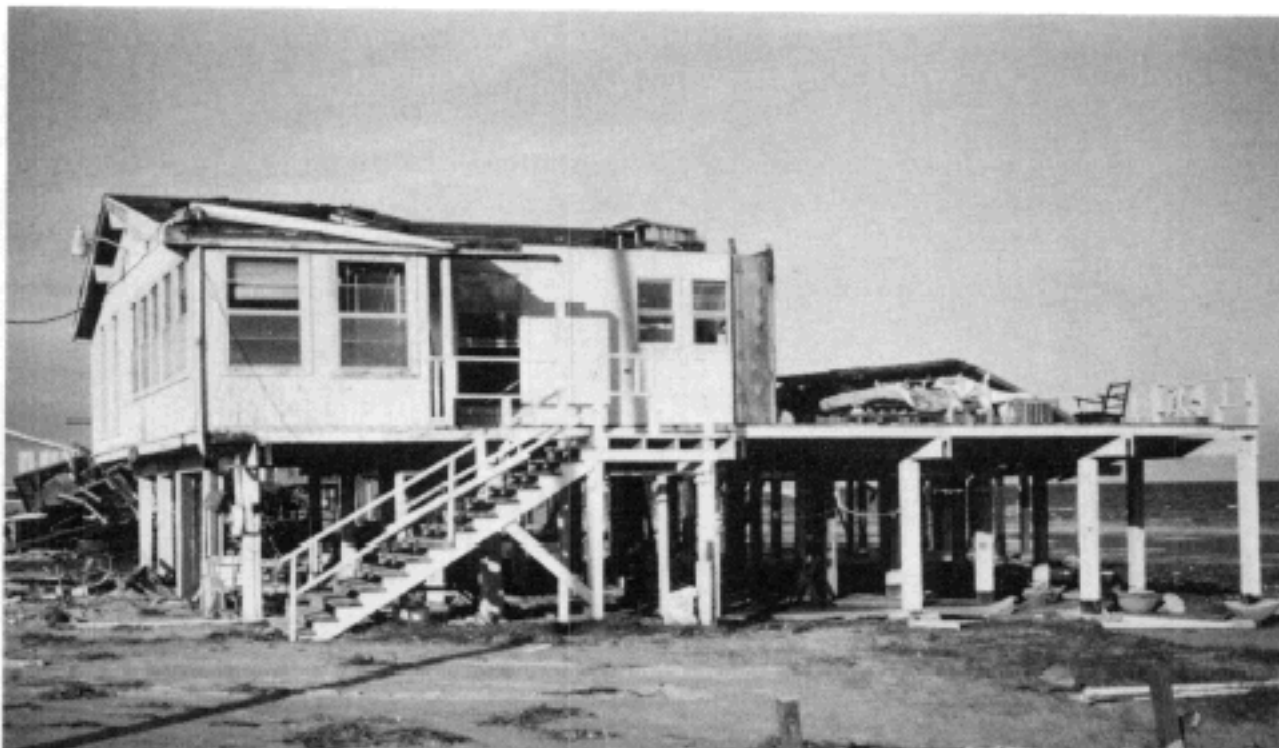
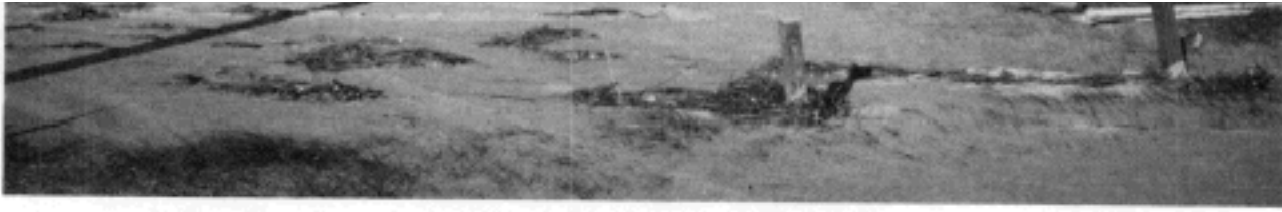
**FIGURE 4.42** Typical example of partial collapse of a large house in Terramar Beach.

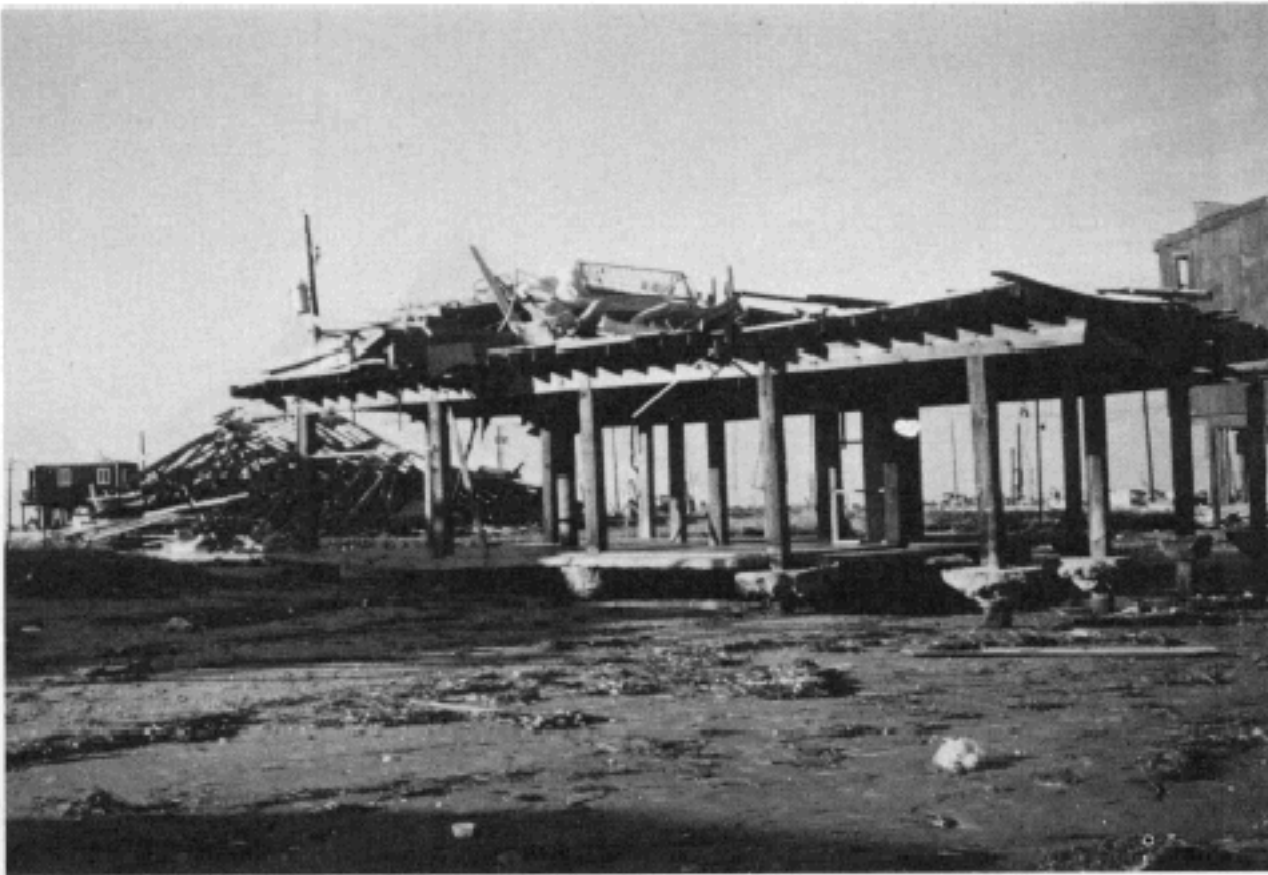
FIGURE 4.43 Example of a superstructure blown away by the wind. A mound of lumber, furniture, and appliances is in the backyard of the house.

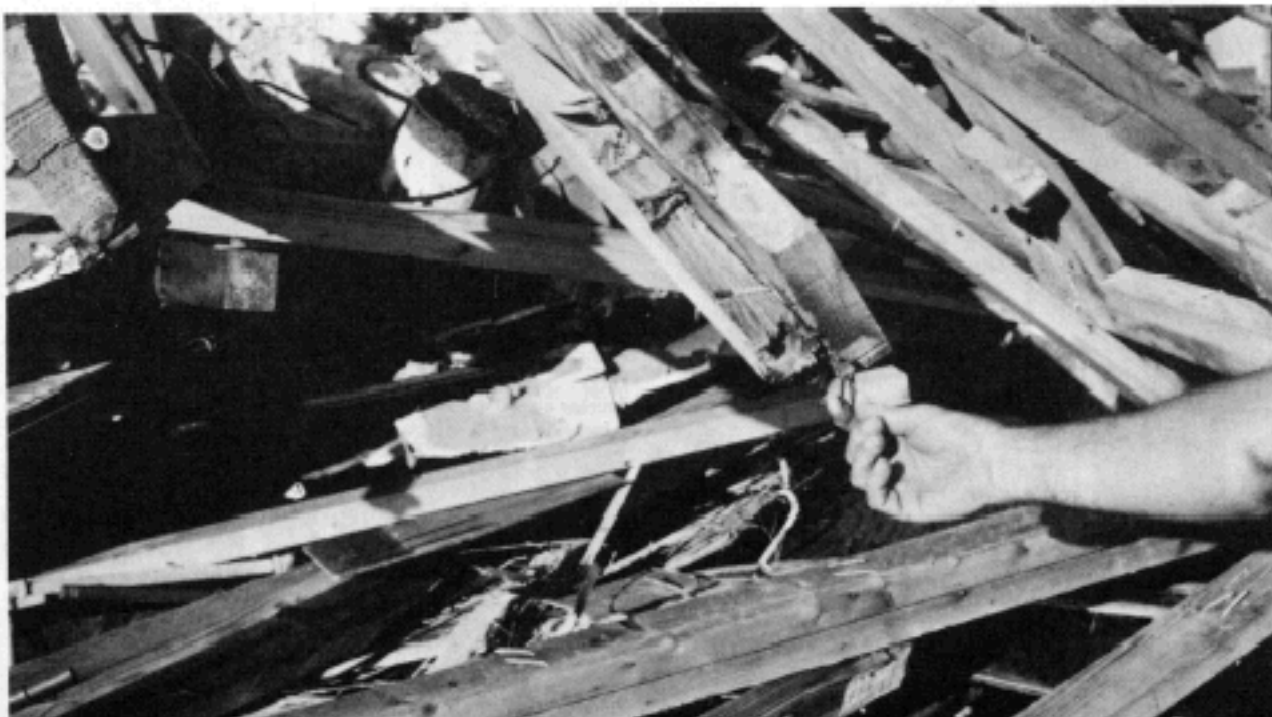
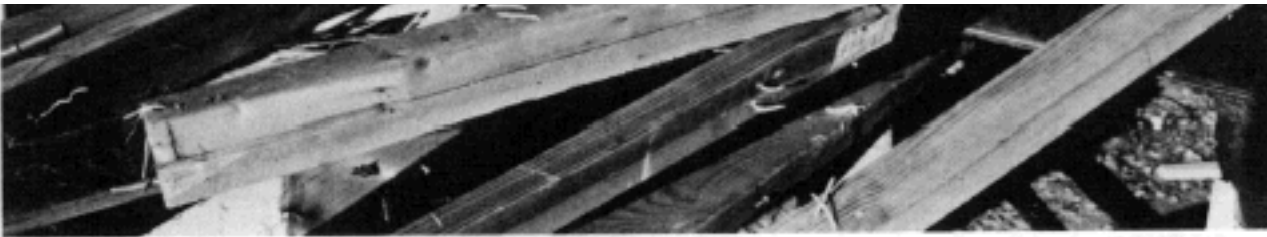
**FIGURE 4.44** Details of toe nail connections.

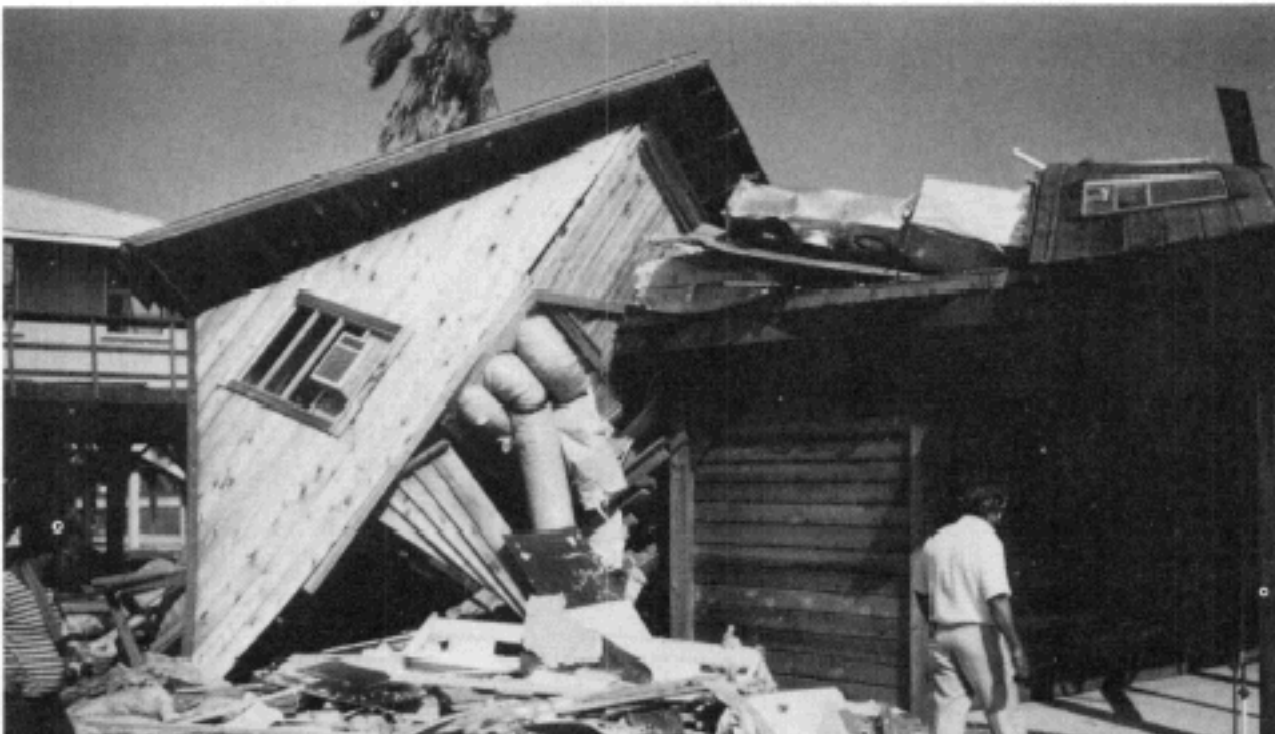
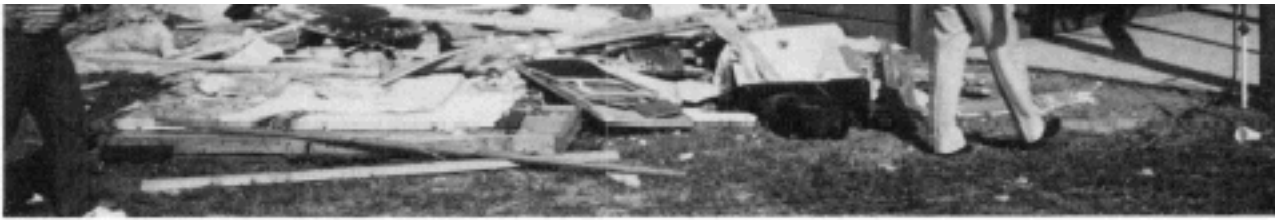
FIGURE 4.48 Typical example of poor connections between sub-systems.

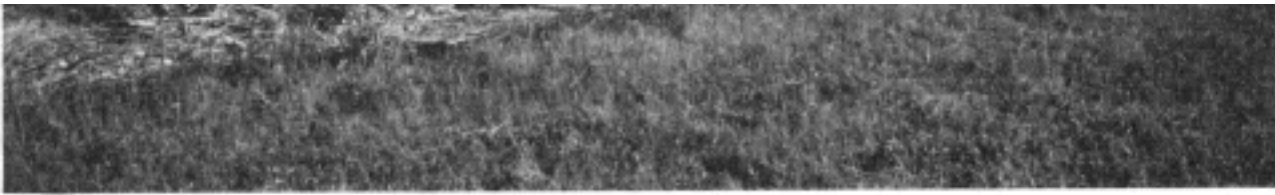
**FIGURE 4.52** Damage to the roof and erosion around foundations of condominium units on the west side of San Luis Pass.

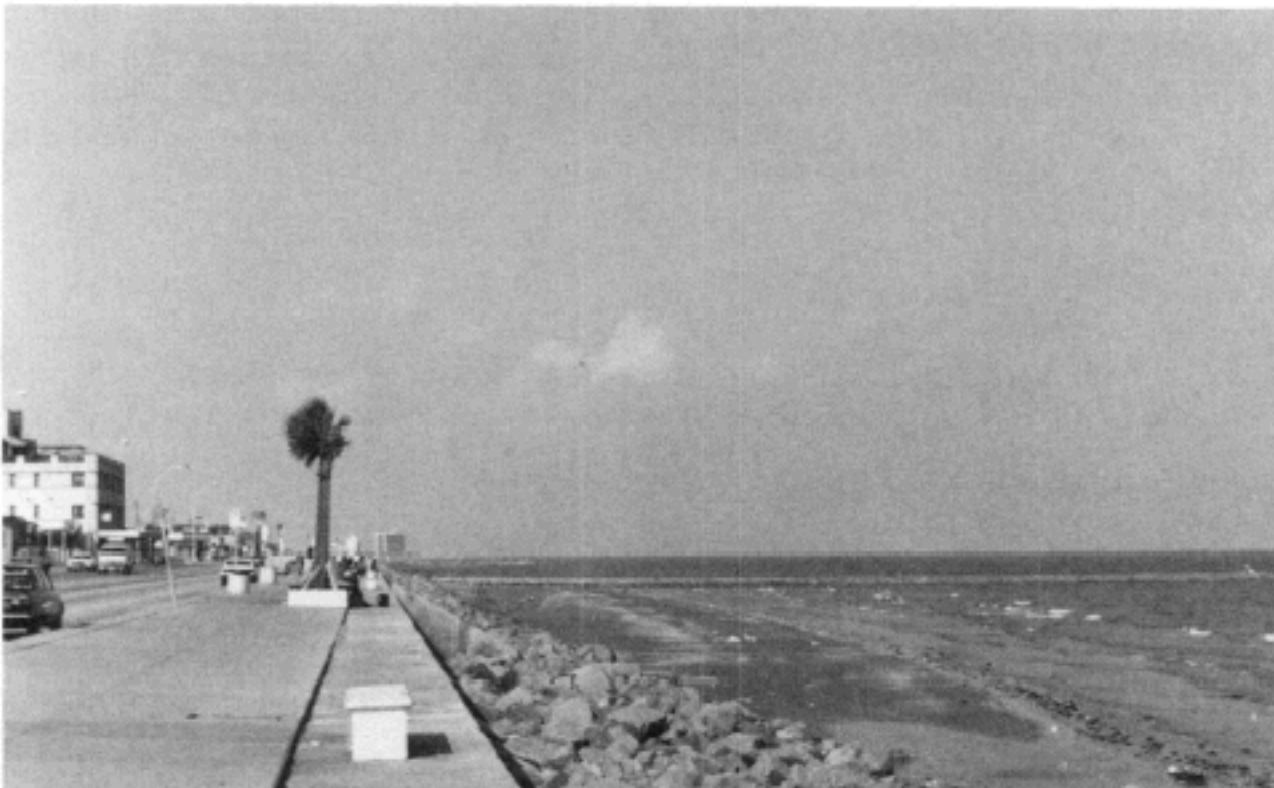
There were no reports of damage to major coastal structures or to the coastal flood protection projects at Texas City and Freeport. Neither the Galveston seawall nor its toe protection was damaged, and the groins in front of the seawall had only minor damage. There was little or no damage to the Galveston entrance jetties.

FIGURE 4.56 Galveston seawall and groin.

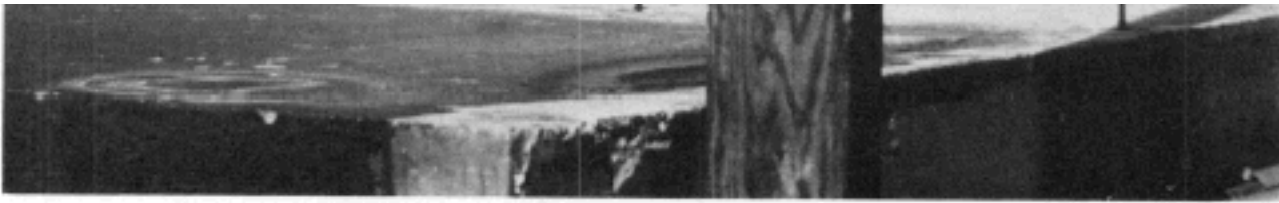
**FIGURE 4.60** House washed away from its foundation slab by storm surge.

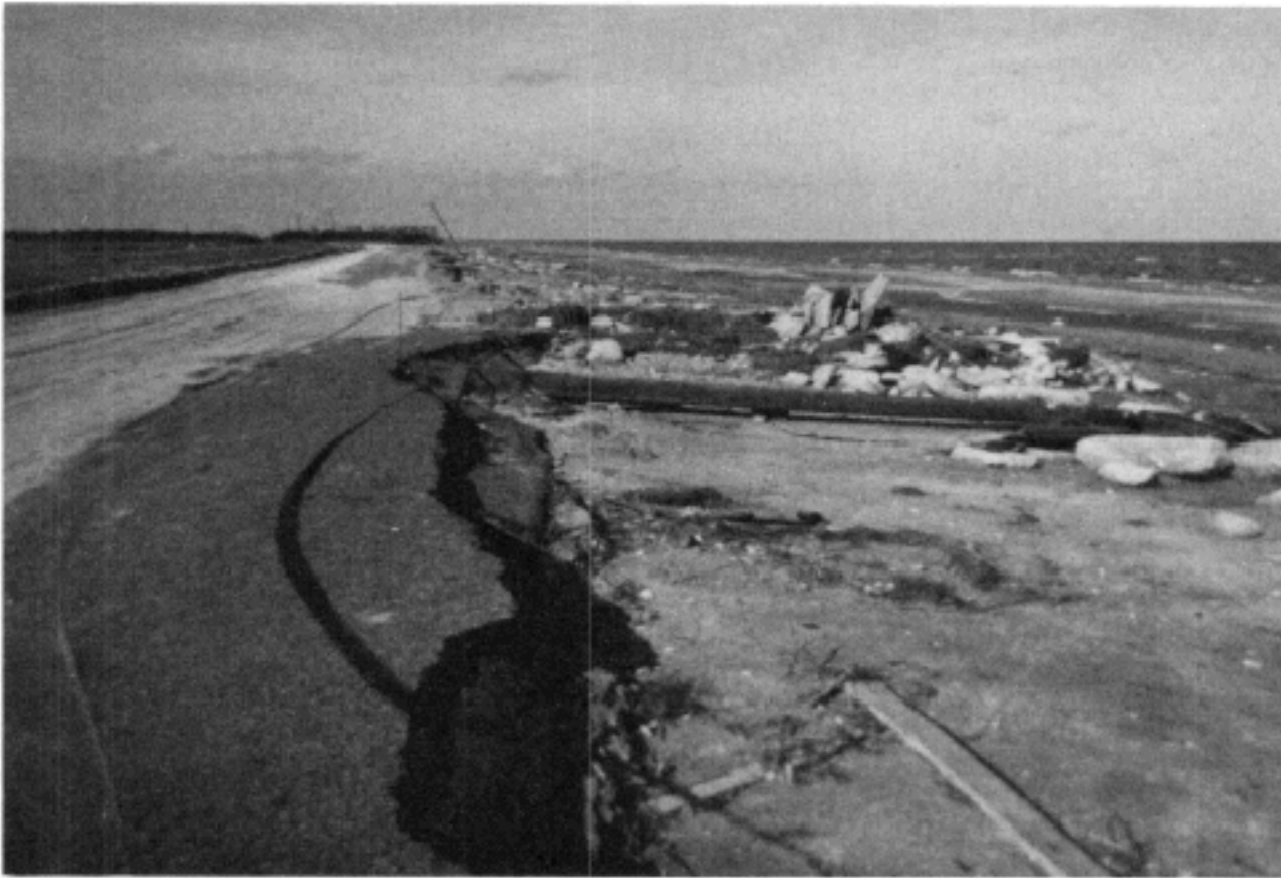
FIGURE 5.1 Typical washout of shoulder on San Luis Pass Road, Follets Island.

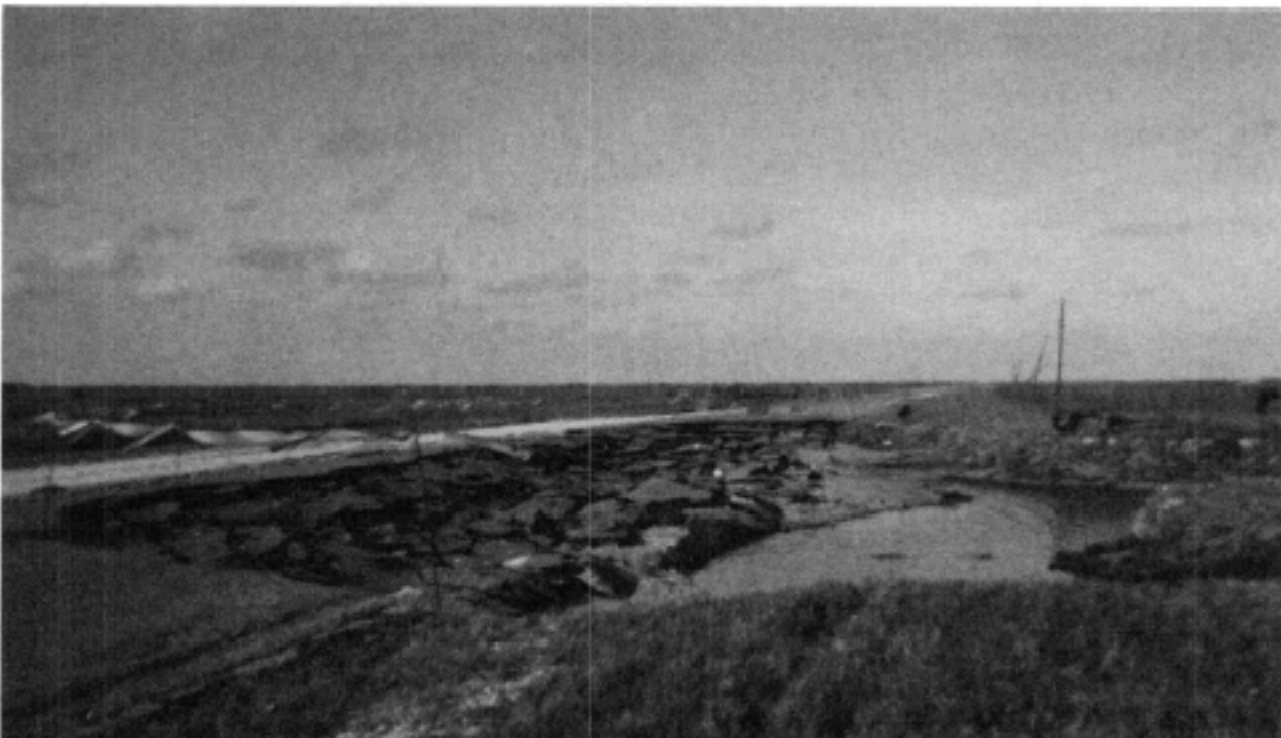
FIGURE 5.2 Typical undercut of roadbed on San Luis Pass Road, Follets Island.

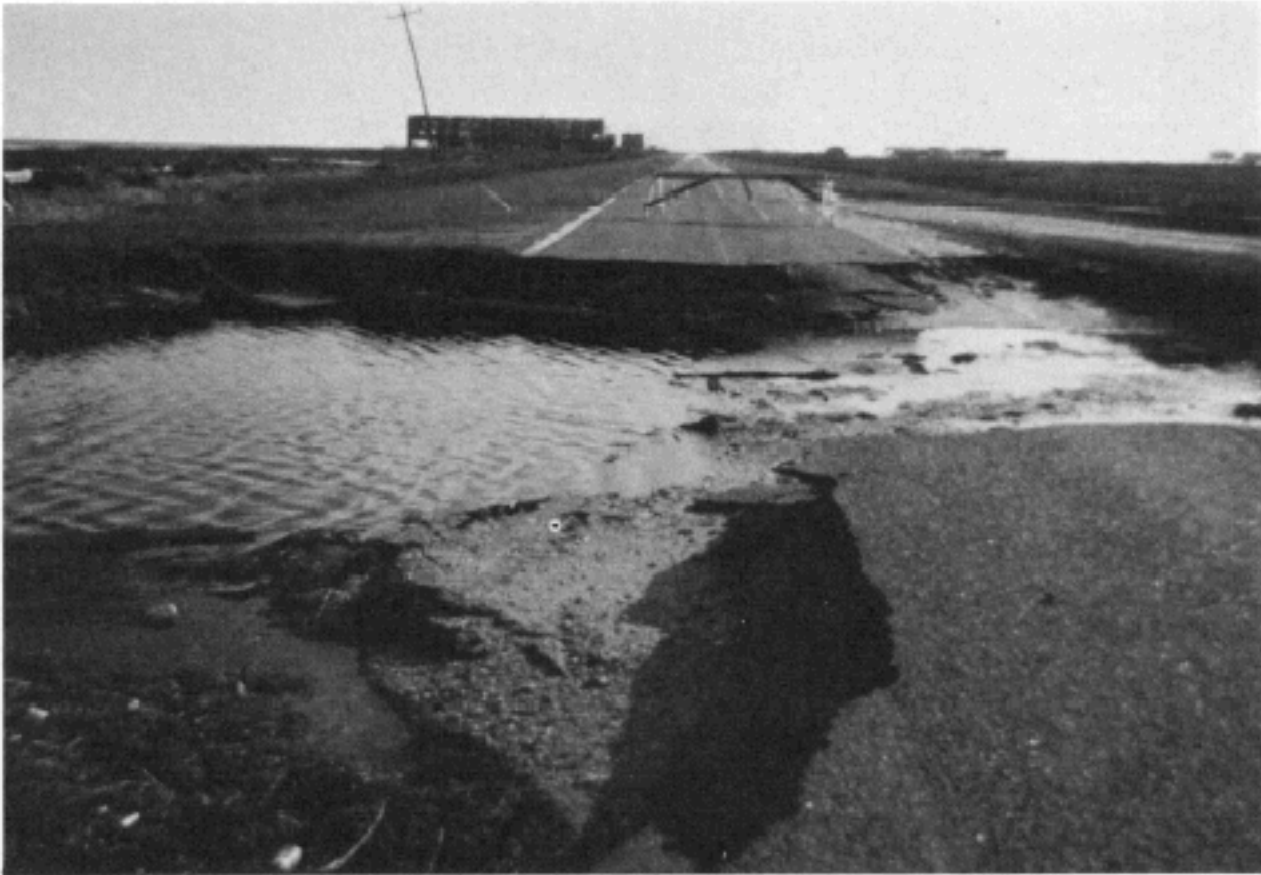
FIGURE 5.3 Total washout of shoulder and road on San Luis Pass Road, Follets Island.

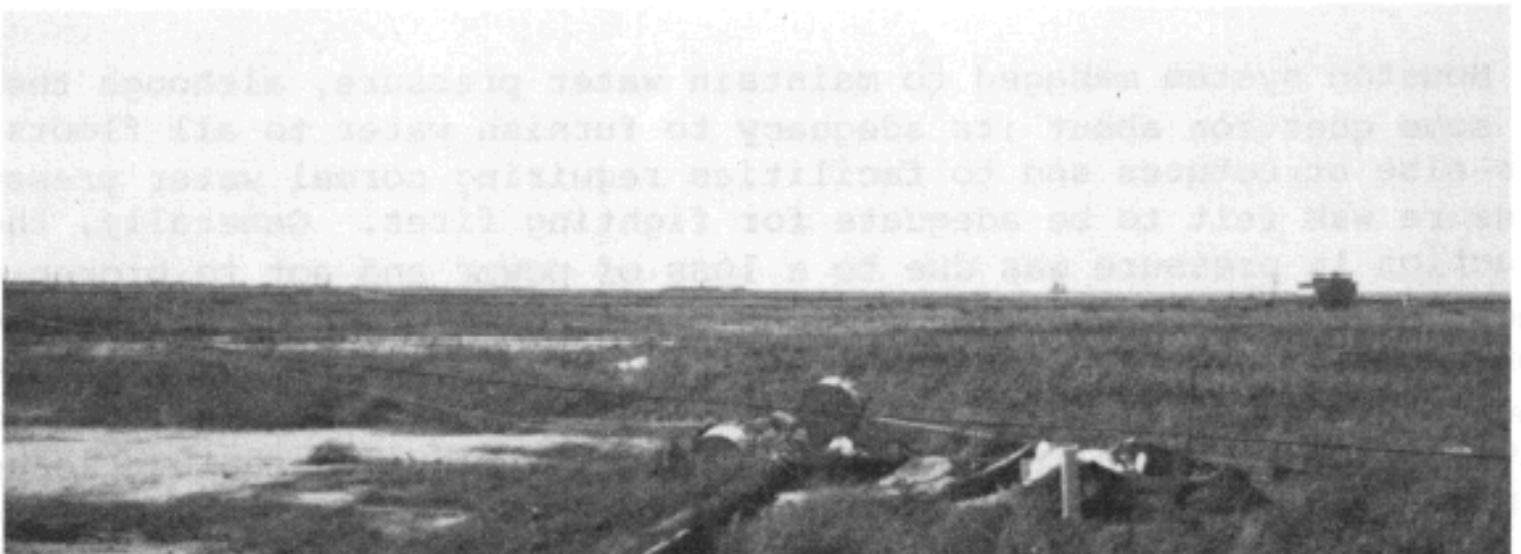
**FIGURE 5.5** Typical failure of utility pole on East Beach, Galveston Island.

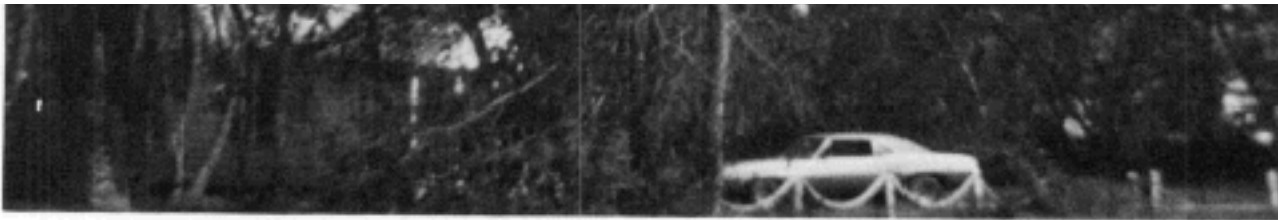
**FIGURE 5.7** Typical failure of utility line caused by fallen trees in Seabrook.

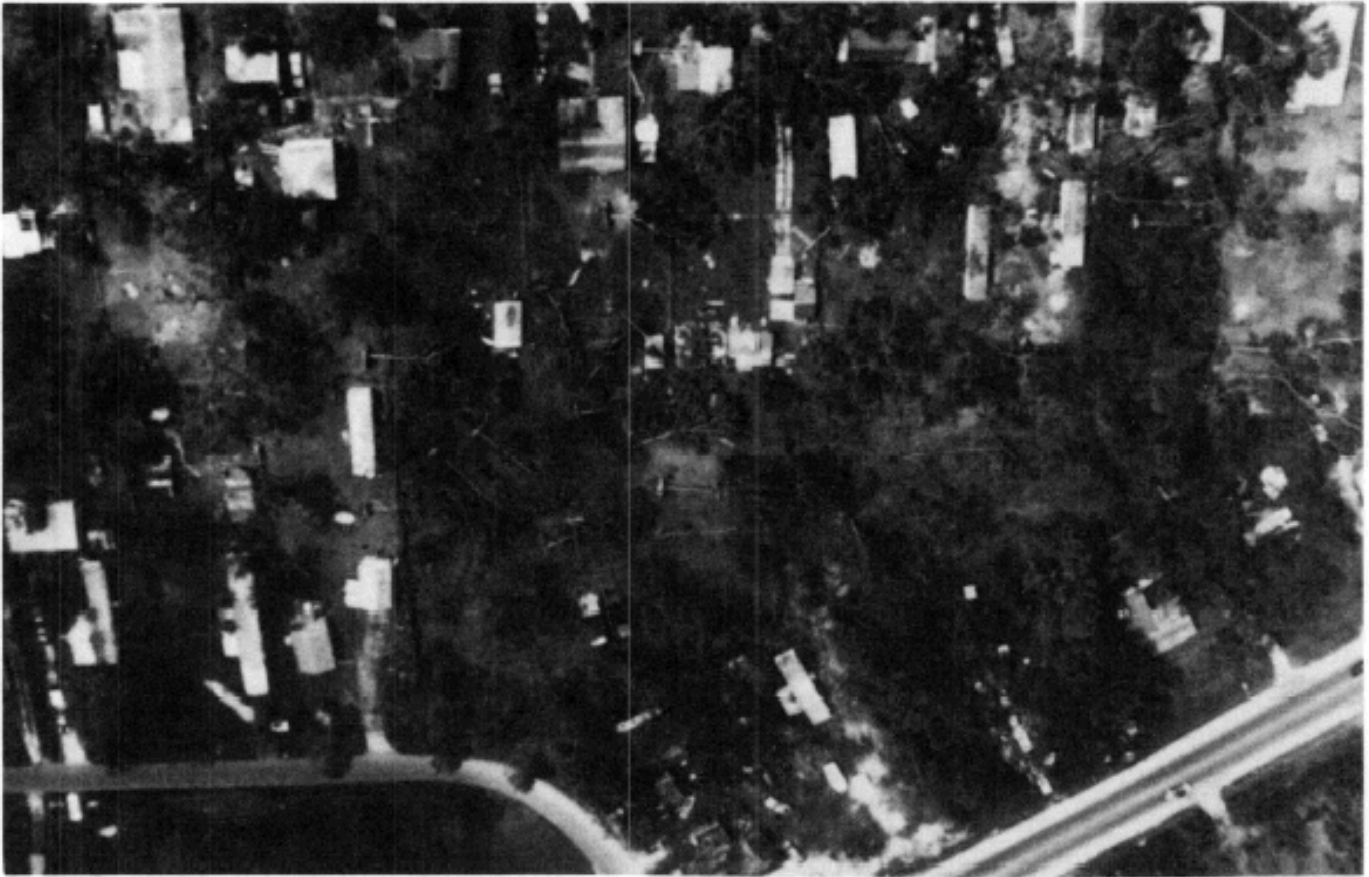
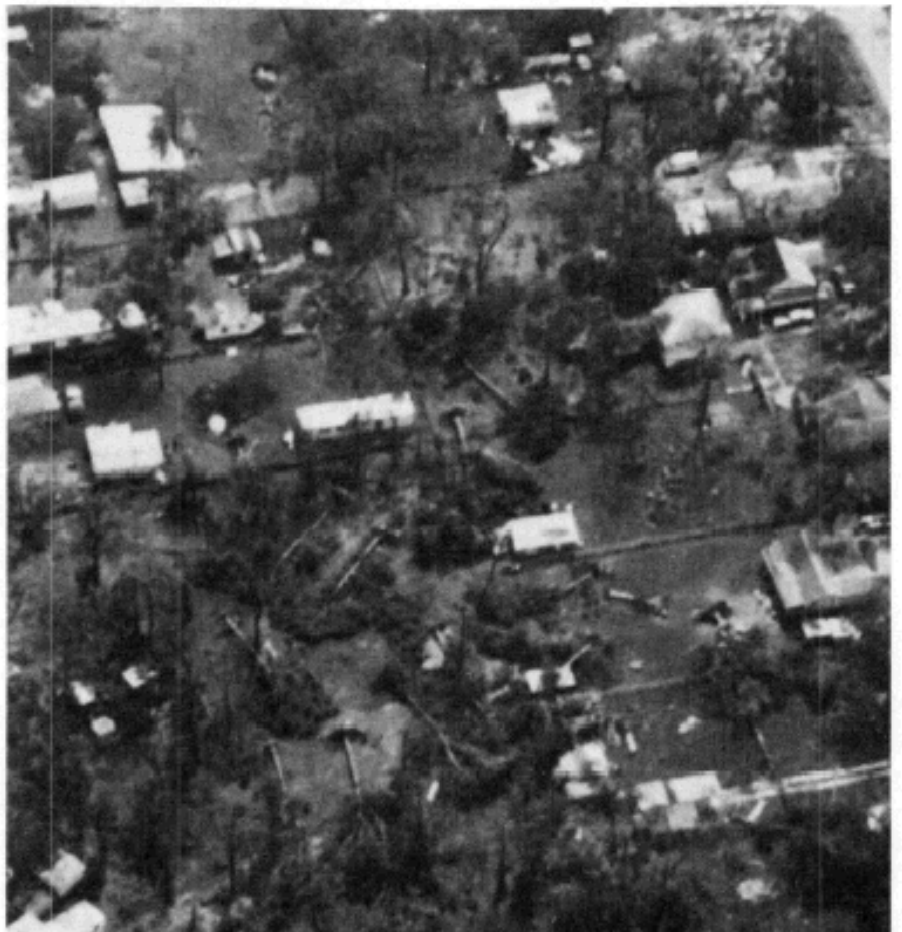
FIGURES 2.11A-2.11B Aerial damage photographs taken from a NOAA helicopter at 1,000 ft on August 25, 1983.

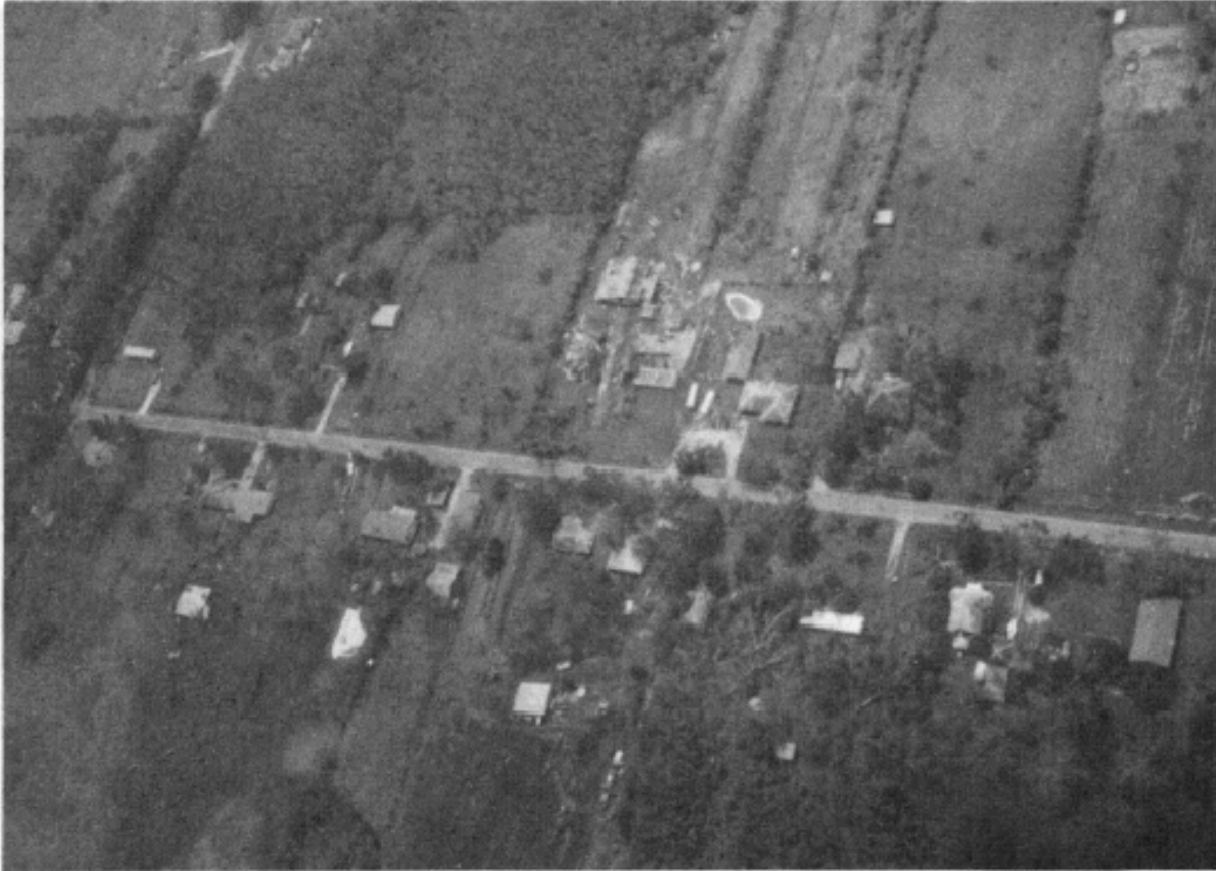
FIGURE 2.11C Aerial damage photograph taken from a NOAA helicopter at 1,000 ft on August 25, 1983.

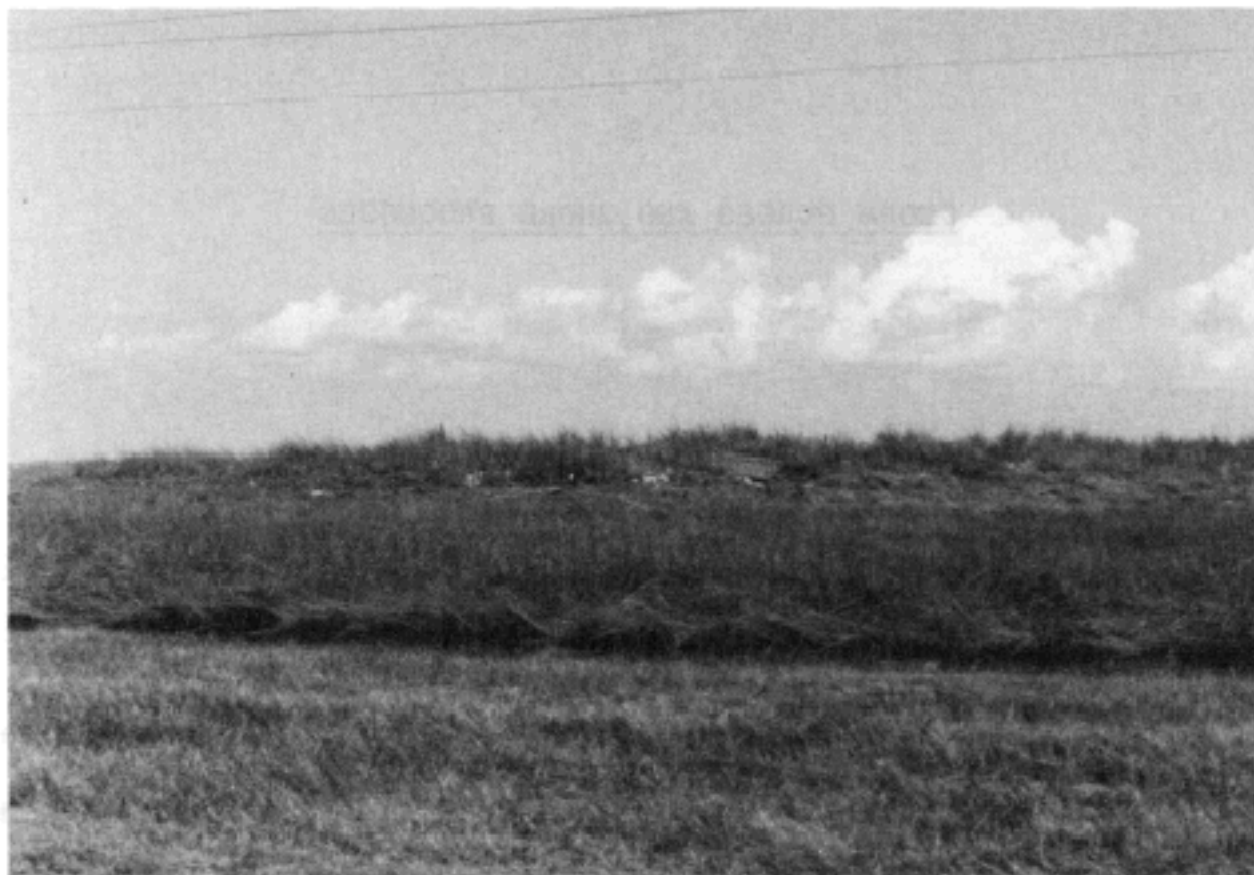
Fig. 3-1 below

**FIGURE 3.1** Debris line on bay (north) side of the foredune on Follets Island about 1-1/2 miles east of San Luis Pass.

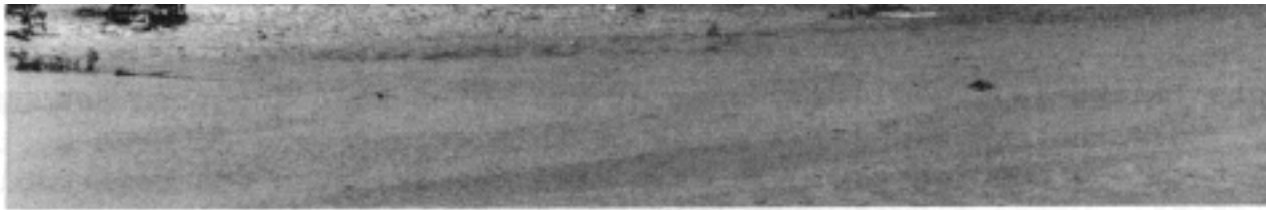
Some of the higher dunes on the front of East Beach were not overtopped. However, they were partially eroded while acting as headlands and causing accelerated flow in lower areas between high dunes and between high dunes and adjacent structures. [Figure 3.5](#) shows the seaward side of an eroded high dune and the seaward portion of the associated erosion channel. [Figure 3.6](#) shows the body and landward end of the same erosion channel looking toward the Gulf. This channel was between the dune shown and a condominium immediately to the east.

**FIGURE 3.5** Front of scour channel and frontal dune on East Beach showing dune erosion. Scour channel was caused by flow confined between the dune and an adjacent beachfront condominium.

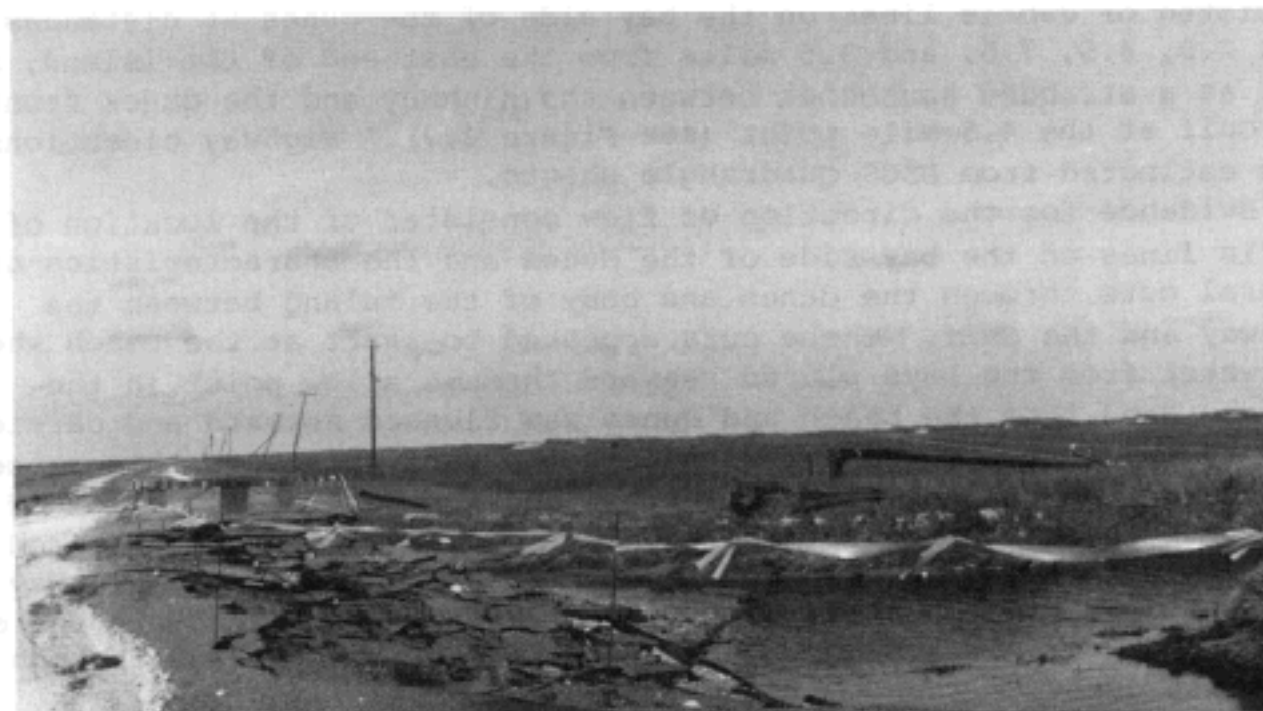
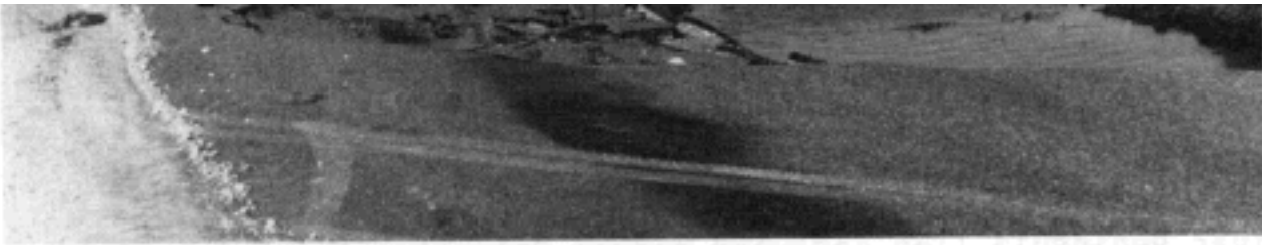
Evidence for the direction of flow consisted of the location of debris lines on the bay side of the dunes and the characteristics of several cuts through the dunes and body of the island between the highway and the Gulf. These cuts appeared to start at the beach when the water from the bays poured seaward through a low point in the dunes. Sand from the beach and dunes was flushed seaward and carried away by the currents and turbulence in the surf zone. As this process continued, the channel was cut further and further inland. Most of the cuts ended seaward of or at the highway. However, one cut extended completely through the highway, and other cuts ended in the highway pavement (see Figures 5.1-5.3). [Figure 3.8](#) shows the landward end of one cut, and [Figure 3.9](#) shows the extent of the breach made through the backbeach dunes.

**FIGURE 3.8** Washout channel looking south toward the Gulf about 7 miles west of San Luis Pass on Follets Island.
